Pavement Condition Report

Park Rapids Municipal Airport (PKD)

December 2016

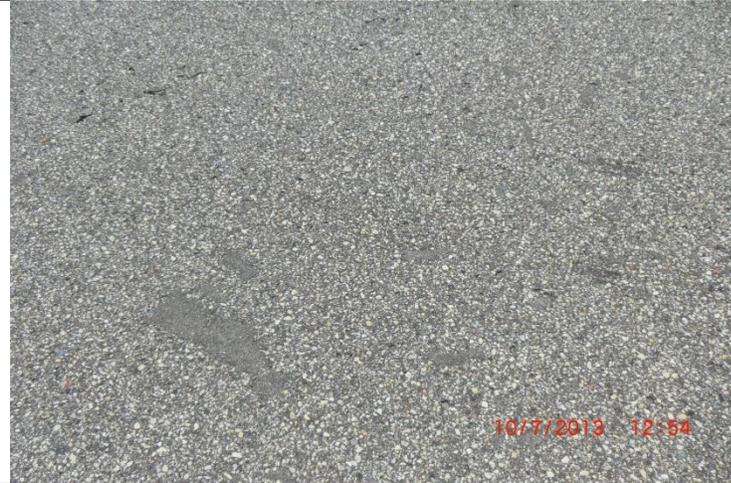
Low severity

Weathering – At low severity, the coarse aggregate is slightly exposed due to the wearing away of the fine aggregate. At medium severity, the coarse aggregate is exposed up to $\frac{1}{4}$ the width of the longest side. At high severity, the coarse is exposed greater than $\frac{1}{4}$ the width of the longest side.

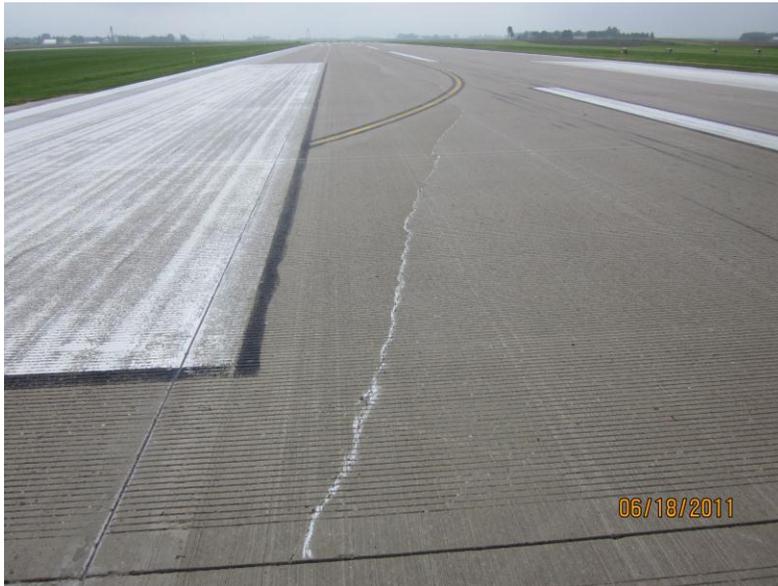
Example of Longitudinal, Transverse, and Diagonal Cracking

LTD cracking is most often a result of externally applied loads and/or constrained temperature deformations. External loads cause LTD cracking through flexure. Temperature changes on restrained slabs will result in stresses due to friction or curling. When any of these stresses exceed the strength of the slab, cracking will occur. LTD cracking is recorded at low, medium, or high severity, depending on the width of crack opening and degree of deterioration. At low severity, the crack is less than 1/8th inch wide with little spalling and no corrective action is indicated. At medium severity, LTD cracks can be up to 1 inch wide with moderate spalling, and should be repaired and sealed using procedures similar to joint sealing. At high severity, cracks exceed 1 inch in width and may be severely spalled. High-severity LTD cracking is evidence of serious load failure of the slab, and correction may require patching or slab replacement. If the distress occurs in several adjacent slabs at medium or high severity, major rehabilitation of that pavement area is indicated.

When a slab is divided by LTD cracks into four or more pieces, the slab is said to be "divided" or "shattered." Shattered slab is a separate distress category and is indicative of significant structural failure as the slab loses its ability to distribute loads to subgrade and further slab deterioration can be expected. Shattered slabs are rated in three severities, with slab replacement recommended for medium and high severities.

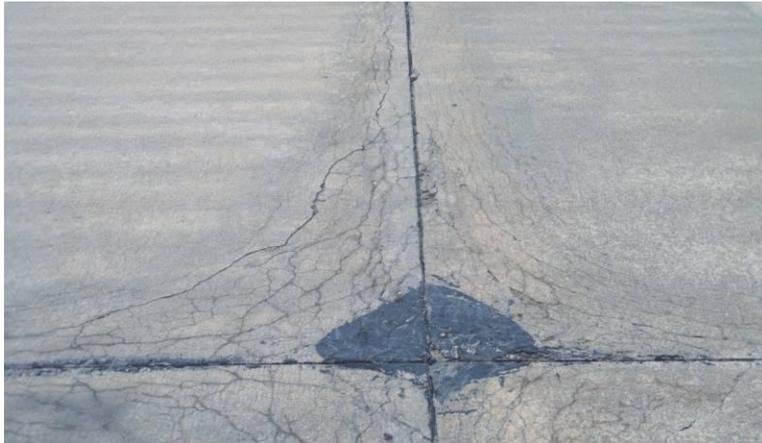
Example of Durability Cracking

Durability cracking (D-cracking) is caused by environmental factors, the most common of which is freezing/thawing. It usually appears as a pattern of hairline cracks running parallel to a joint or crack, or in a corner, where water tends to collect. This type of cracking eventually leads to disintegration of the pavement, creating FOD potential. At low severity, D-cracking is evident, but no disintegration has occurred. As the distress advances to medium severity, the distress pattern is evident over a significant area of the slab, and some disintegration and FOD potential exists. High severity durability cracking is evidenced by extensive cracking with loose and missing pieces and significant FOD potential.

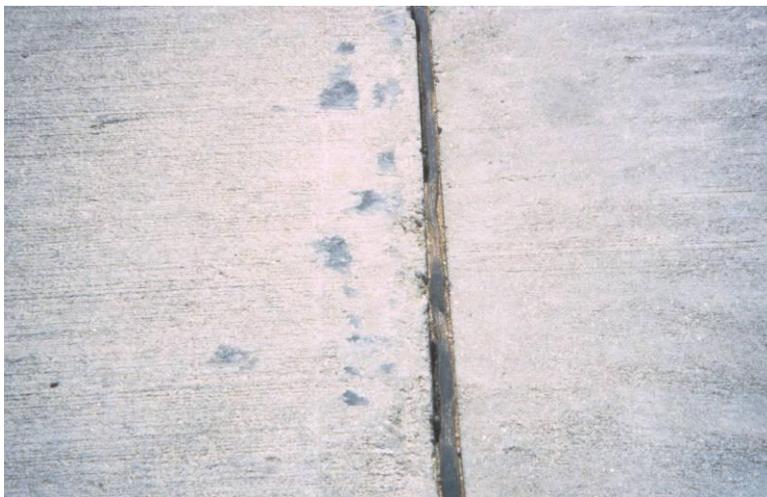
Example of Joint Seal Damage

Joint seal damage is recorded at three severities: low, medium, and high. When joint sealant is in perfect condition (no damage), it is not a distress. At low severity, at least 10 percent of the sealant is debonded but still in contact with the joint edges (i.e., joint sealant is in serviceable condition but should

be monitored for evidence of more serious failure). Medium-severity joint seal damage is recorded when at least 10 percent of the sealant has visible gaps smaller than 1/8th inch and is an indicator that replacement should be programmed as soon as is practicable. In the meantime, aggressive inspection and sustaining maintenance is recommended to minimize subsurface damage from moisture penetration. At high severity, visible gaps exceed 1/8th inch and the amount and degree of joint seal damage is such that repair is no longer feasible. The only appropriate corrective action is sealant replacement.

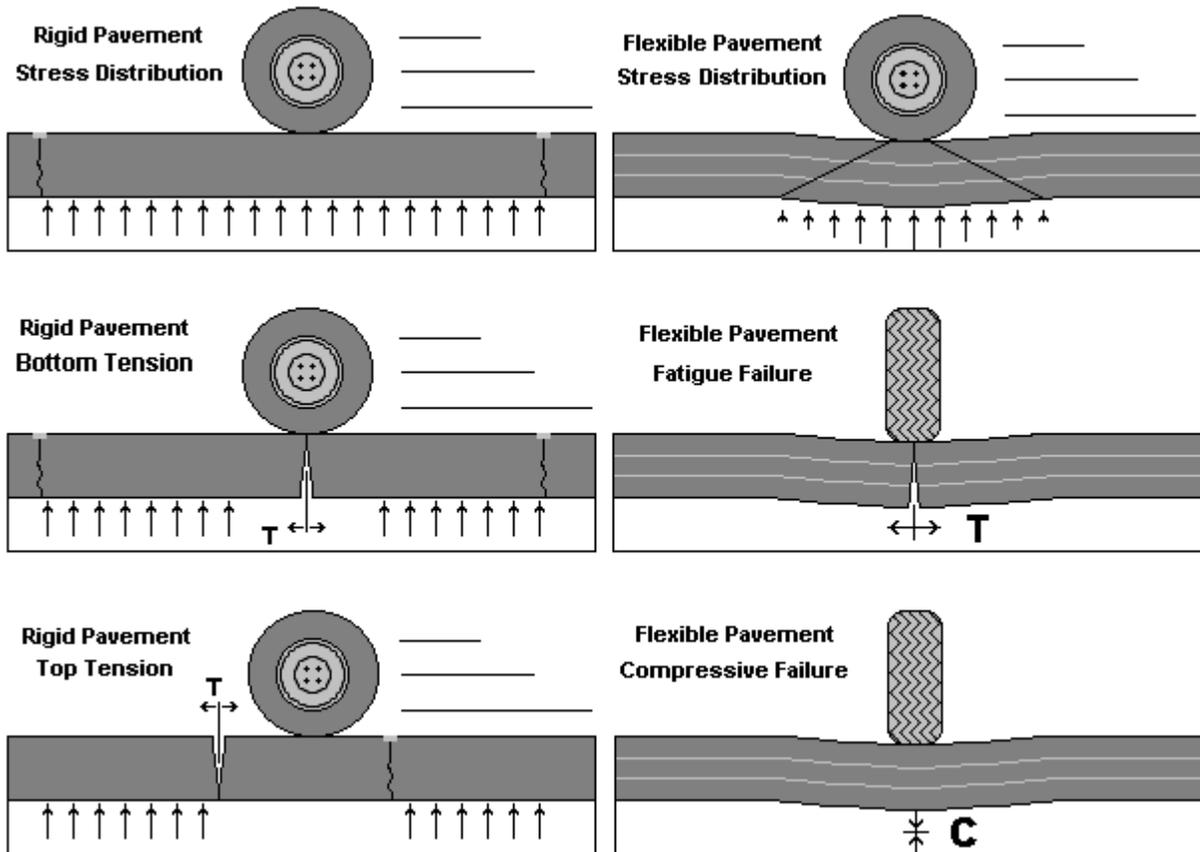
Figure 1. Pavement failure.

Load-related cracks can start at the top or bottom of a pavement section. In asphalt sections, load-related (fatigue) cracks start at the bottom. If a load-related crack reaches the surface, it usually indicates significant structural deficiency. In PCC pavement, corner breaks are caused by top tension, and the crack propagates downward. Mid-slab LTD cracks are examples of bottom tension.

Spalls can be caused by either wheel loads or environmental factors, anytime there is movement between adjacent slabs. If a small rock is allowed into a joint, a differential movement between adjacent slabs can cause a spall. Spalling can be minimized by keeping joint and crack sealant intact.
