Pavement Condition Report

New Ulm Municipal Airport (ULM)

December 2016

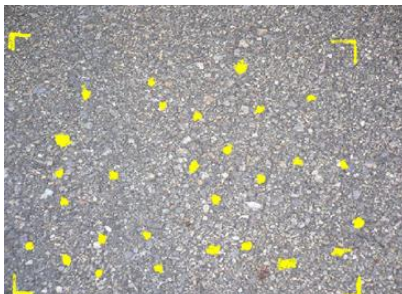
Raveling – At low severity, the number of missing coarse aggregates (> 3/8 inch) is between 5-20 missing/yd², medium severity (pictured below where the missing coarse aggregates have been dotted with yellow paint) is 21-40 missing/yd², and high severity is > 40 missing/yd².

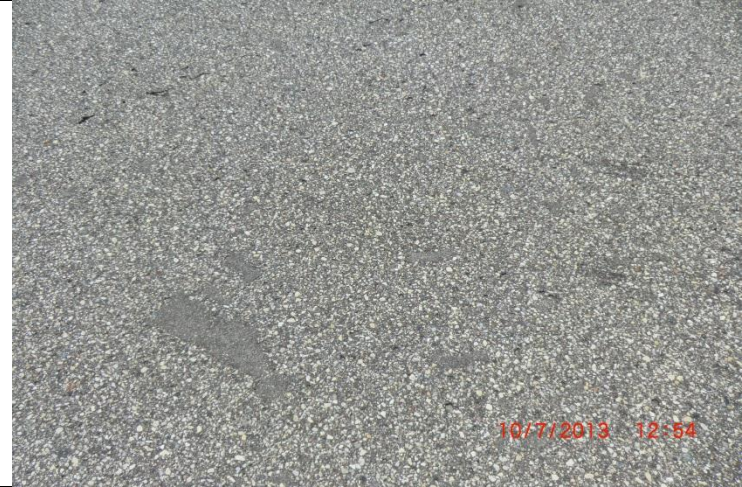
Low severity

Weathering – At low severity, the coarse aggregate is slightly exposed due to the wearing away of the fine aggregate. At medium severity, the coarse aggregate is exposed up to ¼ the width of the longest side. At high severity, the coarse is exposed greater than ¼ the width of the longest side.
