Pavement Condition Report

Fillmore County Airport (FKA)

Applied Research Associates, Inc.
6314 Odana Rd
Madison, WI 53719
(608) 274-6409

December 2017

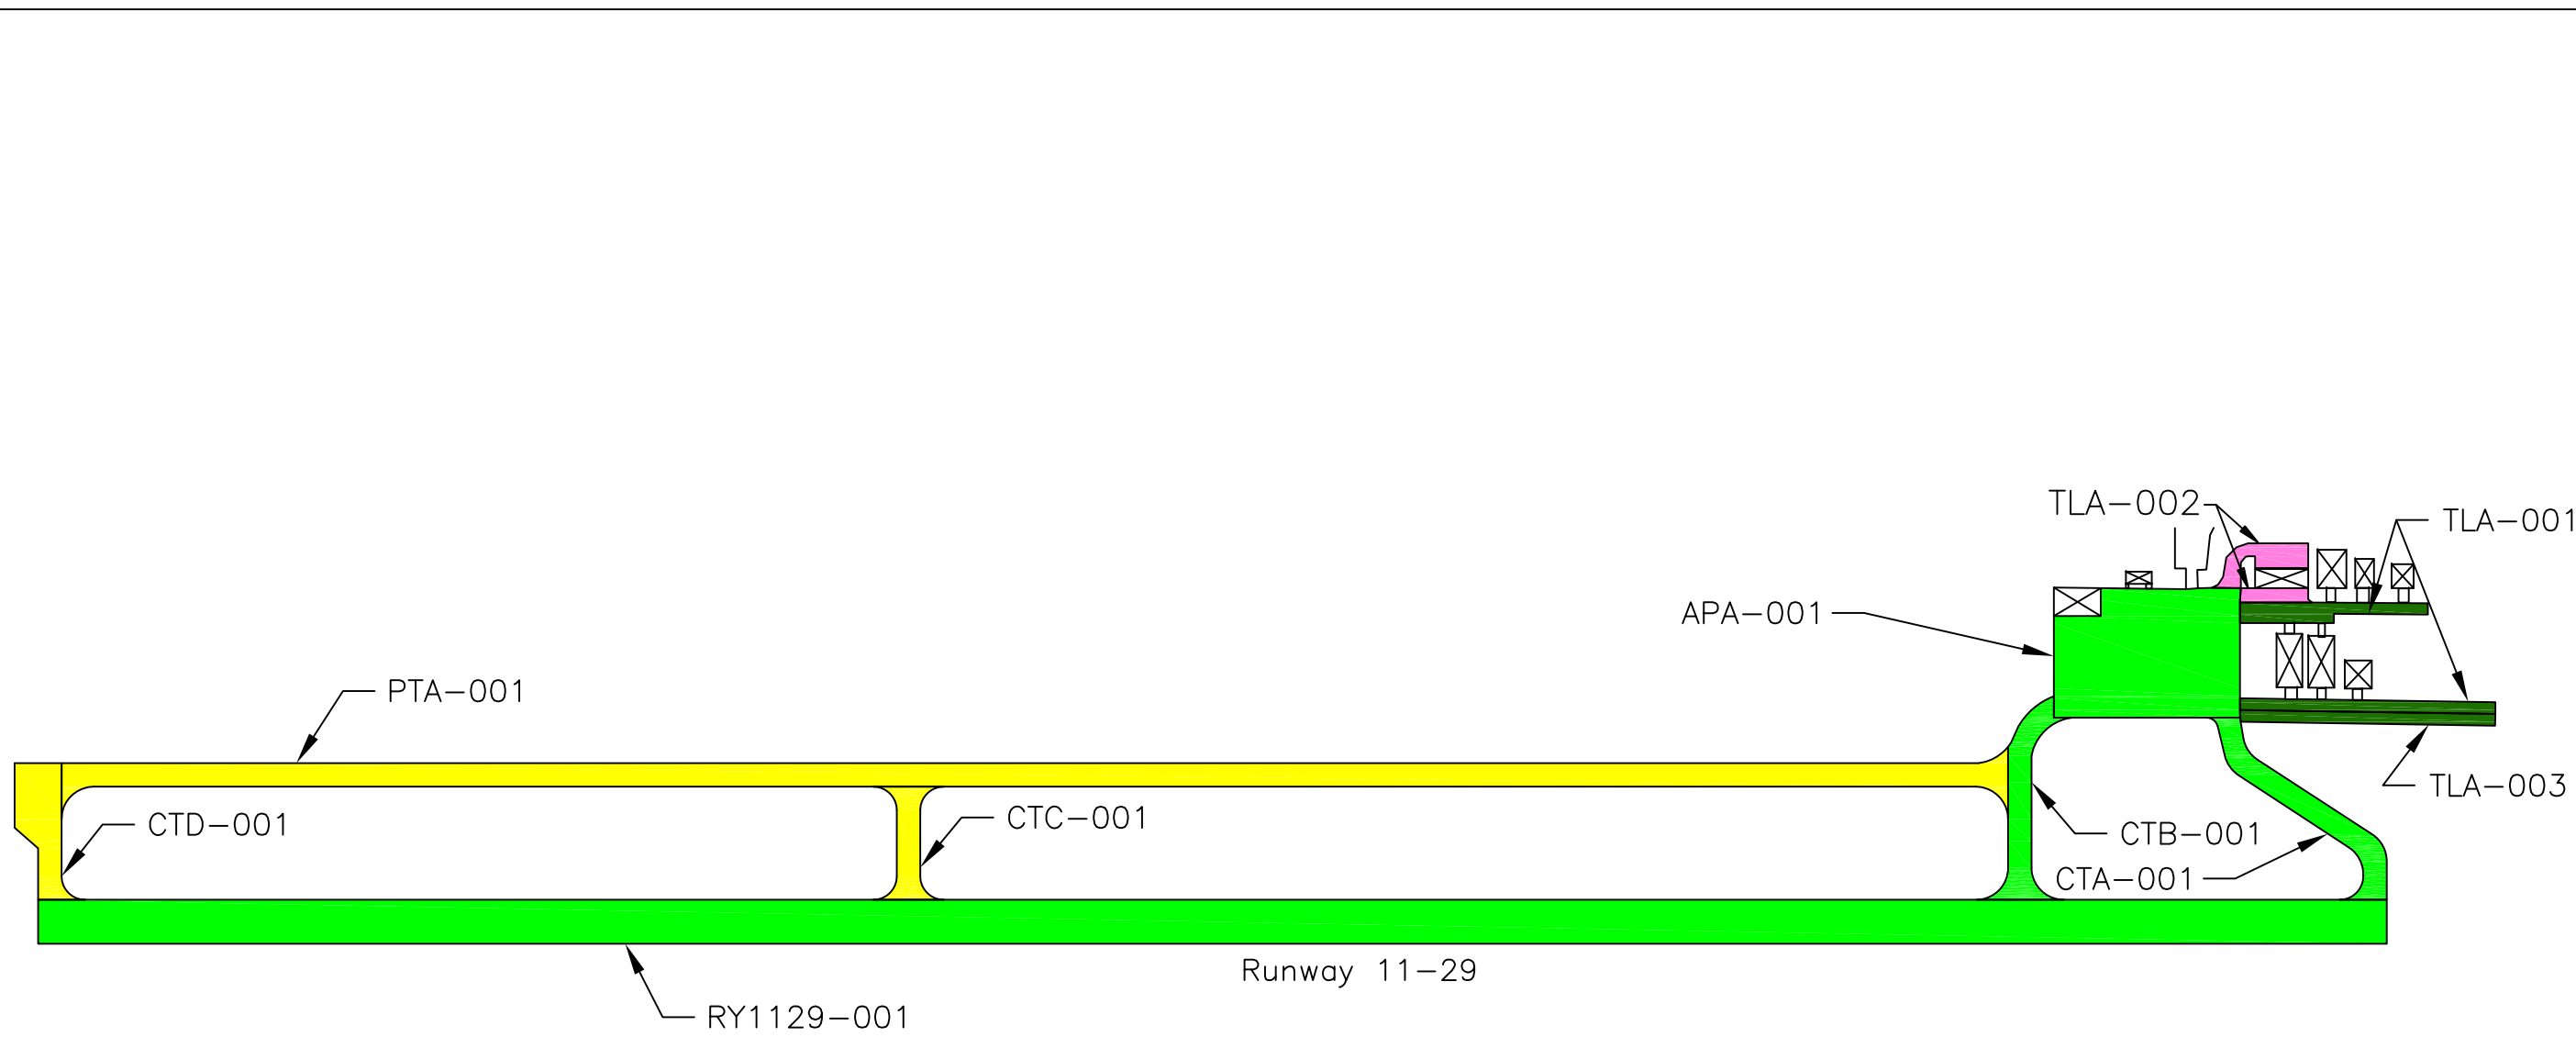
Figure 4. 2017 Pavement Condition Index Rating at Preston-Fillmore County Airport (FKA).

The results of the 2017 PCI inspection are presented in figure 4. The overall area-weighted, inspected PCI for FKA is 72. When summarizing PCI values, an area-weighted calculation is used instead of a straight mathematical average because the area-weighted calculations eliminate the skewing of the PCI due to the disparity of the section sizes.
