# Pavement Condition Report

## Stephen Municipal Airport (D41)

**December 2019**

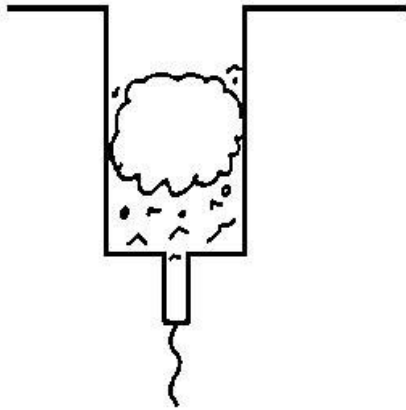
Typical joint with deficient sealant and a collection of debris & incompressibles.

Seal joints in PCC pavement when existing sealant has deteriorated to a degree that allows water and incompressibles to enter the joint. Hairline cracks are not yet candidates for sealing.
