Pavement Condition Report

Park Rapids Municipal Airport (PKD)

December 2019

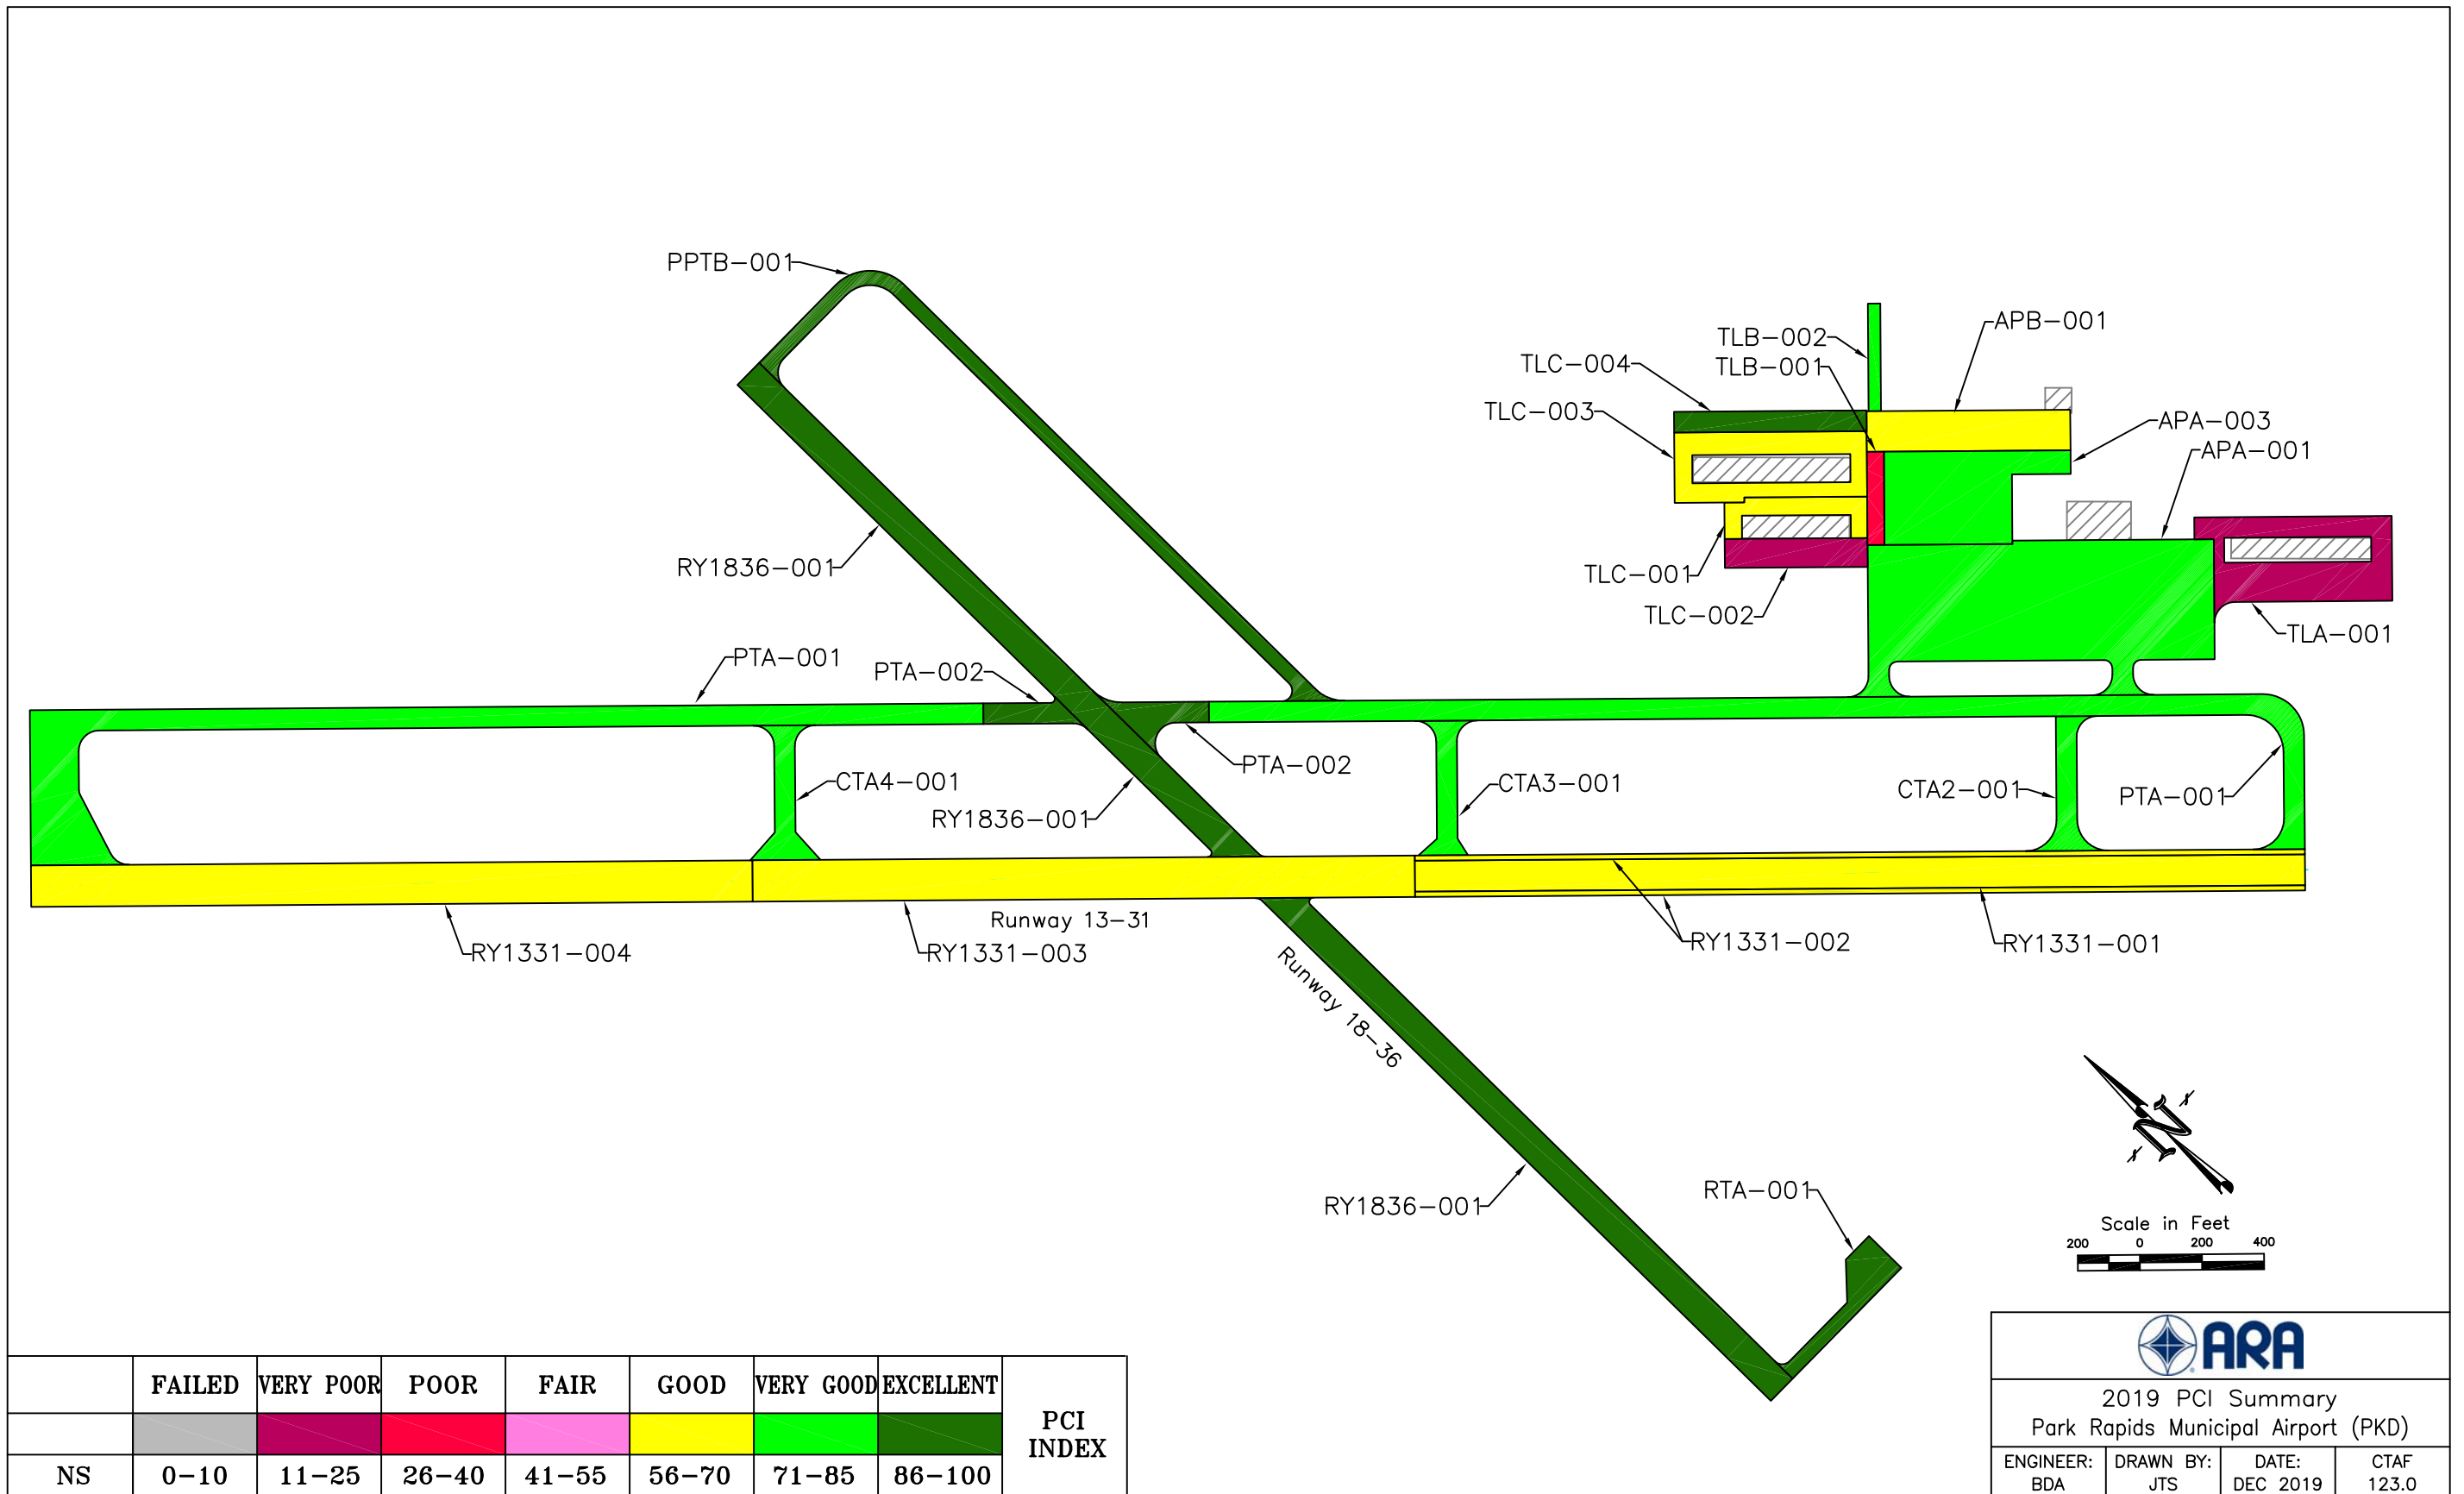
Figure 4. 2019 Pavement Condition Index Rating at Park Rapids Municipal Airport–Konshok Field (PKD).

The results of the 2019 PCI inspection are presented in figure 4. The overall area-weighted, inspected PCI for PKD is 73. When summarizing PCI values, an area-weighted calculation is used instead of a straight mathematical average because the area-weighted calculations eliminate the skewing of the PCI due to the disparity of the section sizes.
