UNDERWATER BRIDGE INSPECTION REPORT

STRUCTURE NO. 7254

KETTLE RIVER

MINNESOTA DEPARTMENT OF TRANSPORTATION  
UNDERWATER BRIDGE INSPECTION

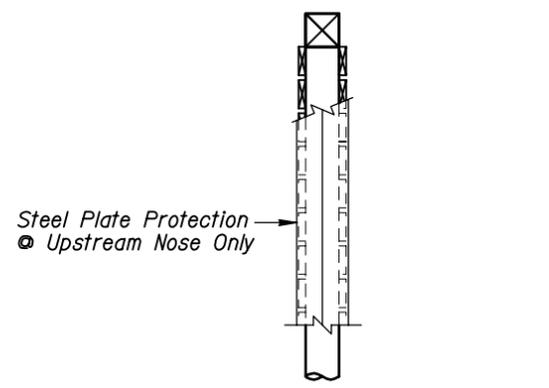
**SOUNDING PLAN**

- 5 A minor accumulation of 6-inch-diameter and smaller timber debris was observed along the west face of Pier 1.
- 6 A 12-inch-diameter tree trunk with branchy debris was observed along the west face of the pier, and a timber log on the channel bottom was observed along the east face.

- 7 A moderate accumulation of timber debris was observed at the upstream end of Pier 3 with 3-foot-diameter logs that extended along each face of the pier.

At this point, the timber drift accumulations at the bridge are not excessive; however, they should be monitored, and if found to be progressing to an extent where excessive lateral loads may be exerted on the pier or scour is influenced, the drift may need to be removed at that time.
