UNDERWATER BRIDGE INSPECTION REPORT

STRUCTURE NO. 36504

CR NO. 98

RAT ROOT RIVER

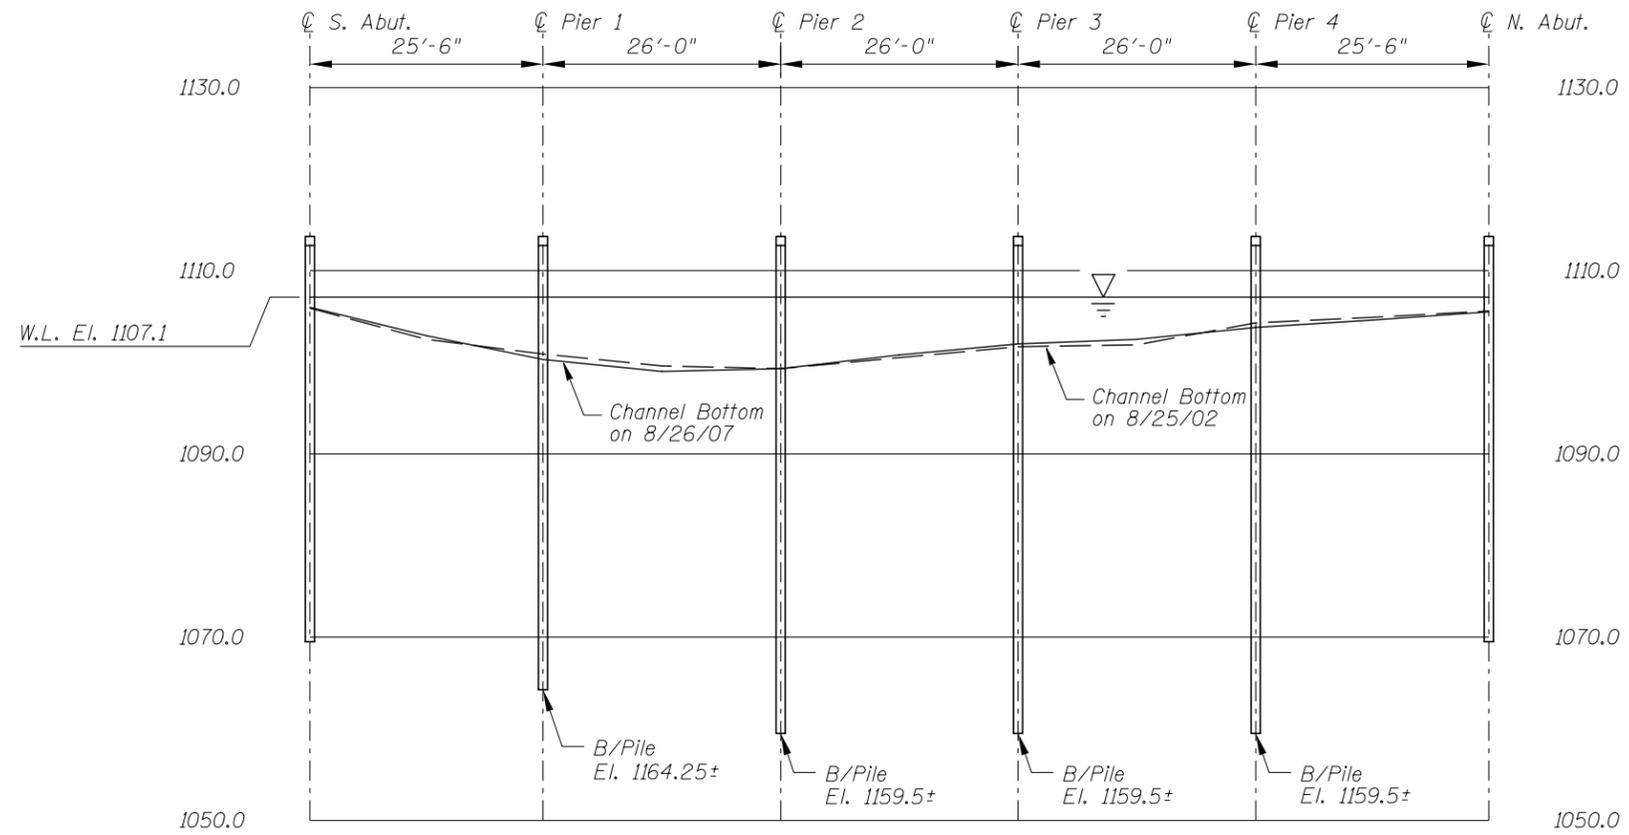
UPSTREAM FASCIA PROFILE

| <p>1 The channel bottom material around all of the piers typically consisted of silty clay with a maximum probe rod penetrations of 1 foot.</p> <p>2 Bracing split over length of 10 feet and separated through pile fastener.</p> <p>3 Outer layer of pile softer than typical with approximately 1 inch surface delamination from 3 feet above the waterline to the channel bottom. (ice related damage)</p> <p>4 End of cap at above the easternmost pile has a 50 percent loss of section, that has reduced the cap's bearing capacity on the pile by 50%. The pile seems to have shifted downstream.</p> <p>5 All of the timber piles around the waterline and below exhibited random 1/4 inch soft outer layer with checking and delamination due to normal weathering, age, and ice damage. Random 1/4 inch wide checking was also present at most piles.</p> <p>6 Heavier surface splintering and delamination, as noted in Note 5, typically extending between 1 foot below and 4 feet below the waterline with penetration/depth of 1/2 inch.</p> <p>7 Steel channel replacement cross bracing was used to replace the old timber cross bracing on the upstream south side and downstream north side of Pier 1, all of the timber cross bracing at Pier 2, and on the upstream north and south sides of Pier 3.</p> <p>8 Old abandoned timber piles that were protruding 2 to 4 feet above the mudline.</p> | <p>9 Light timber debris consisting of branches up to 6 inches in diameter. Most of the debris extended from the channel bottom to 1 to 3 feet above the channel bottom.</p> <p>10 The channel bottom at the South Abutment consisted of gravel and 1 foot diameter riprap.</p> <p>11 The steel channel was deformed between the 3rd and 4th pile in from the upstream fascia, and was not engaged to the 4th pile in from the upstream fascia.</p> <p>12 The steel channel was no longer engaged to the upstream pile and had been deformed by ice flow and drift.</p> <p>13 The timber pile exhibited a 3 inch diameter, with 1 inch penetration, area of abrasion that was caused by rubbing contact with the unconnected steel channel, and was located 1-1/2 feet below the waterline.</p> <p>14 Timber cross bracing was no longer in place.</p> <p>15 A 6 feet long by 2 inch wide split in timber bracing through the pile fastener.</p> |

Replace the damaged and disconnected timber cross bracing and repair the disconnected steel channel cross bracing.
