UNDERWATER BRIDGE INSPECTION REPORT

STRUCTURE NO. 36514

RAPID RIVER

DISTRICT 1 - KOOCHICHING COUNTY

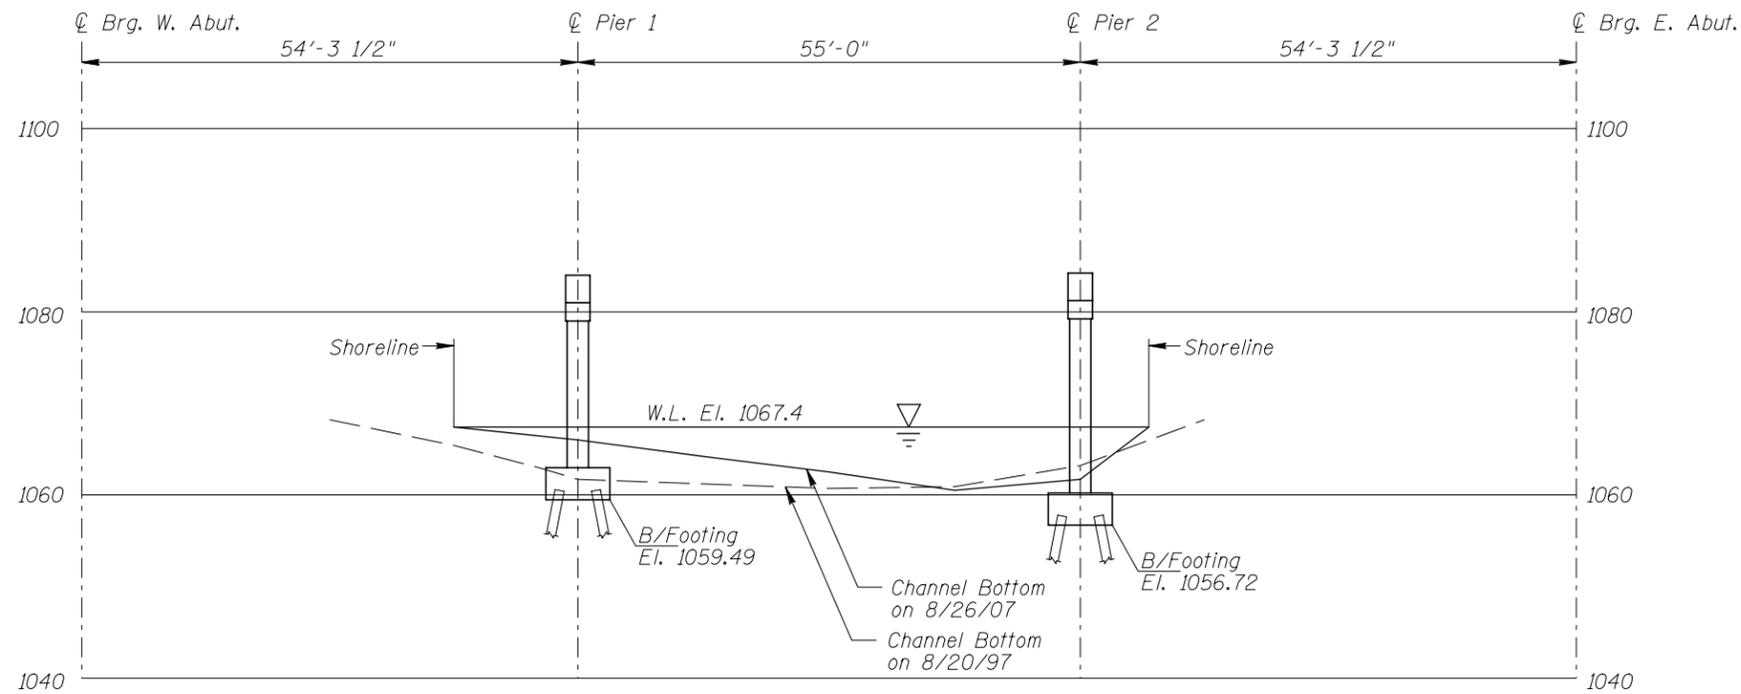
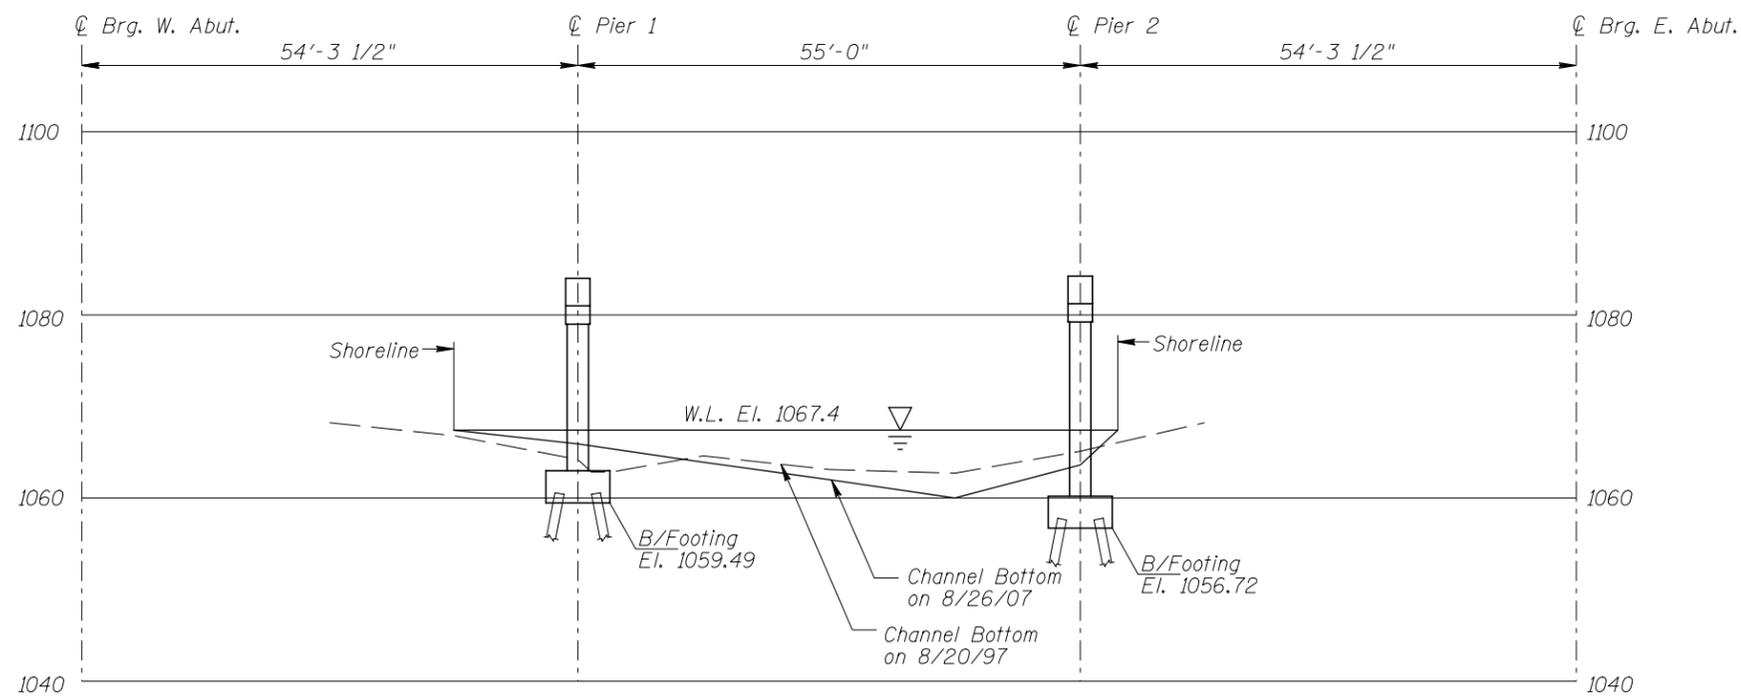
- 1 The channel material consisted of sand and gravel with some silt and up to 6 inches of probe rod penetration.
- 2 A minor accumulation of timber debris was observed at Pier 1, consisting of a few branches, each measuring up to 2 inches in diameter. The debris extended 1 foot up from channel bottom.

- 3 A moderate accumulation of timber debris was observed, consisting of numerous logs and tree trunks measuring up to 1 foot in diameter lying across the upstream nose and extending to the easterly shoreline. Debris extended from channel bottom to waterline at Pier 2.

- 4 The shoreline consisted of up to 2 feet diameter riprap, which was also present around the upstream and downstream noses of Pier 2.
- 5 Light scaling from 3 feet above the waterline to 2 feet below water level with 1/8 inch typical to 1/4 inch maximum penetrations was observed along the entire perimeter of Pier 1 and Pier 2.

- (A) Monitor the accumulations of timber debris at the upstream nose of Piers 1 and 2, and if found to be increasing, removal may be warranted as part of future maintenance to alleviate scour influence at the pier and any further accumulation.
