UNDERWATER BRIDGE INSPECTION REPORT

STRUCTURE NO. 36523
CSAH NO. 18
OVER THE
EAST FORK OF THE RAPID RIVER
DISTRICT 1 - KOOCHICHING COUNTY

PREPARED FOR THE
MINNESOTA DEPARTMENT OF TRANSPORTATION
BY
COLLINS ENGINEERS, INC.

JOB NO. 5221

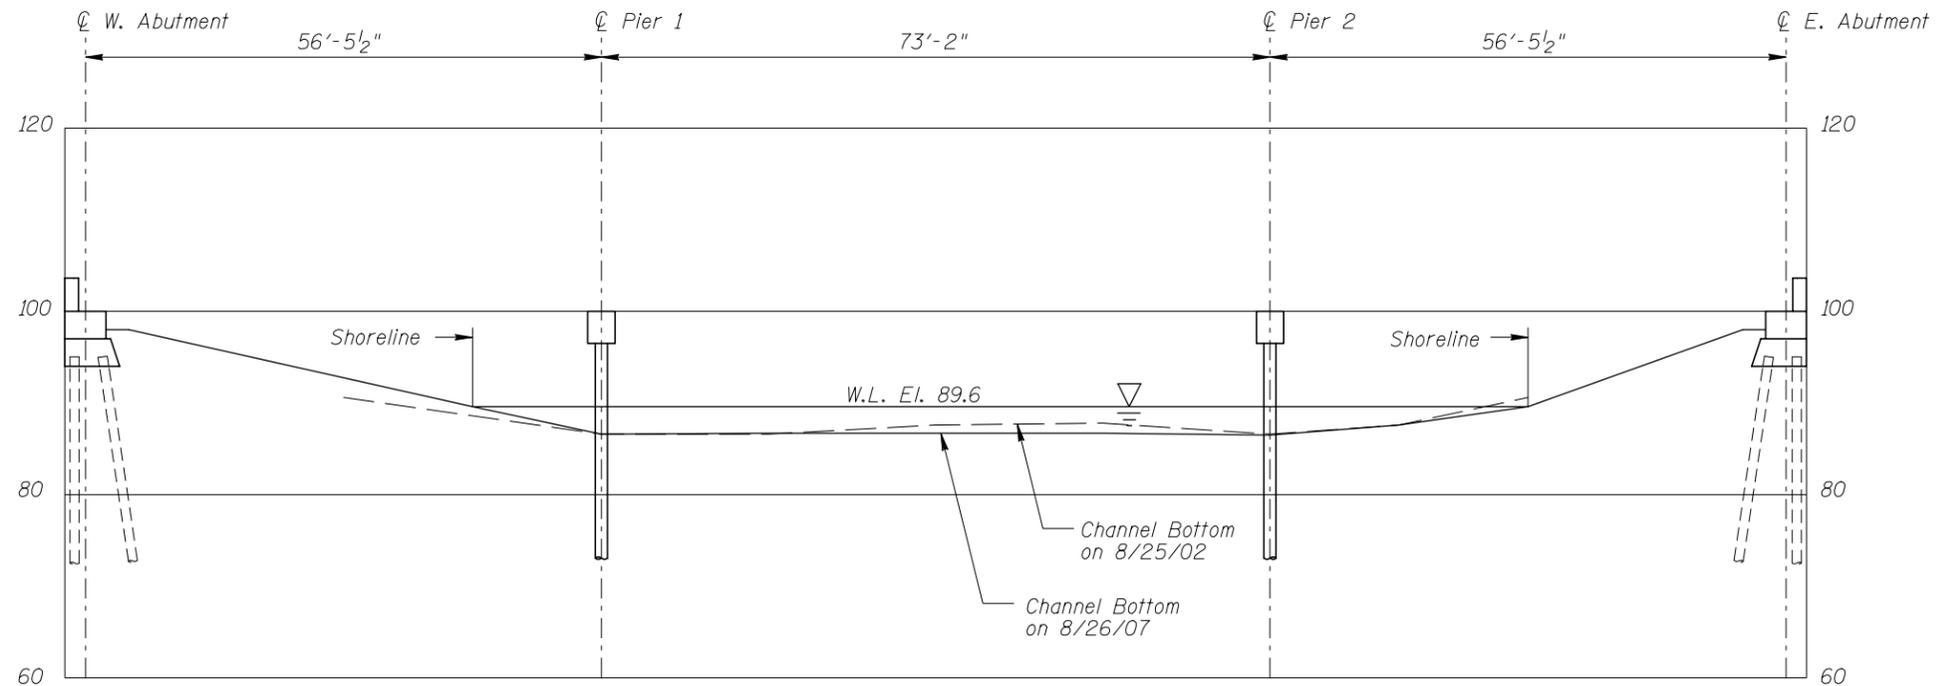
UPSTREAM FASCIA PROFILE

- 1 The coating on the steel encased concrete piles (concrete filled pipe piles) exhibited signs of breakdown and surface corrosion 6 inches above waterline to channel bottom. Nodules were observed 1/4 inch maximum size. No appreciable section loss was observed and the coverage was 10-20%.
- 2 The channel bottom at Pier 1 consisted of soft silt with a maximum probe rod penetration of 1 foot and occasional riprap.
- 3 The channel bottom at Pier 2 consisted of soft silt with a maximum probe rod penetration of 6 inches.
- 4 Two 1.5-foot-diameter tree trunks were observed along the west side of Pier 1 and a moderate accumulation of 6-inch-diameter timber debris was observed scattered throughout the piles from the channel bottom to the waterline.
- 5 A light accumulation of 6-inch-diameter timber debris was observed scattered throughout the piles.

Monitor accumulations of timber debris around piers during future inspection of the bridge, and if found to be increasing, removal operations may be warranted at that time.
