UNDERWATER BRIDGE INSPECTION REPORT

STRUCTURE NO. 69505
CSAH NO. 8
OVER THE
ST. LOUIS RIVER
DISTRICT 1 – ST. LOUIS COUNTY

PREPARED FOR THE
MINNESOTA DEPARTMENT OF TRANSPORTATION
BY
COLLINS ENGINEERS, INC.
JOB NO. 5221 (CEI 2)

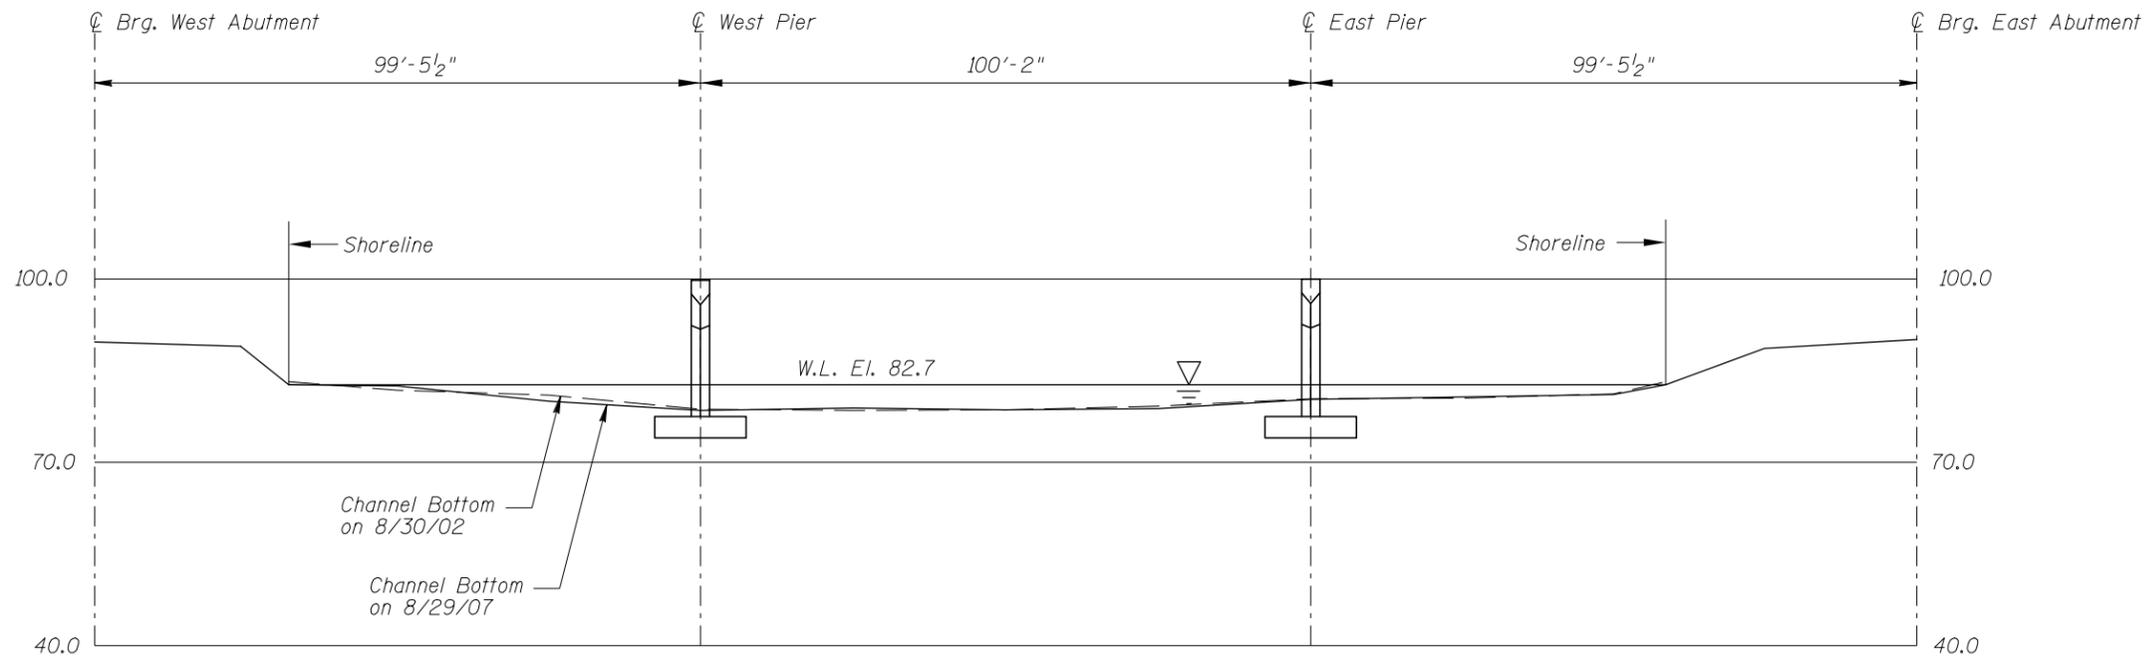
UPSTREAM FASCIA PROFILE

1. The channel bottom consisted of 1- to 2-foot-diameter riprap and cobbles.
2. The channel bottom consisted of 1 to 2 inches of soft silt over a firm mix of 1-to 2-foot-diameter riprap and cobbles.
3. The concrete exhibited light scaling from 4 feet above the waterline to the channel bottom with exposed aggregate and typical penetrations of 1/8 inch and maximum penetrations ranging from 1/4 inch to 1/2 inch.
4. A moderate accumulation of 1-foot-diameter and smaller timber debris was observed at the upstream end and along the shore side of the West Pier extending from the channel bottom to 1 foot above the waterline. The drift extended 5 feet upstream of the pier and 4 feet into the adjoining spans.
5. 1- to 2-foot-diameter riprap and cobbles were observed at the embankments.
