UNDERWATER BRIDGE INSPECTION REPORT

STRUCTURE NO. 69J13

RAILROAD STREET

COLLINS ENGINEERS, INC.

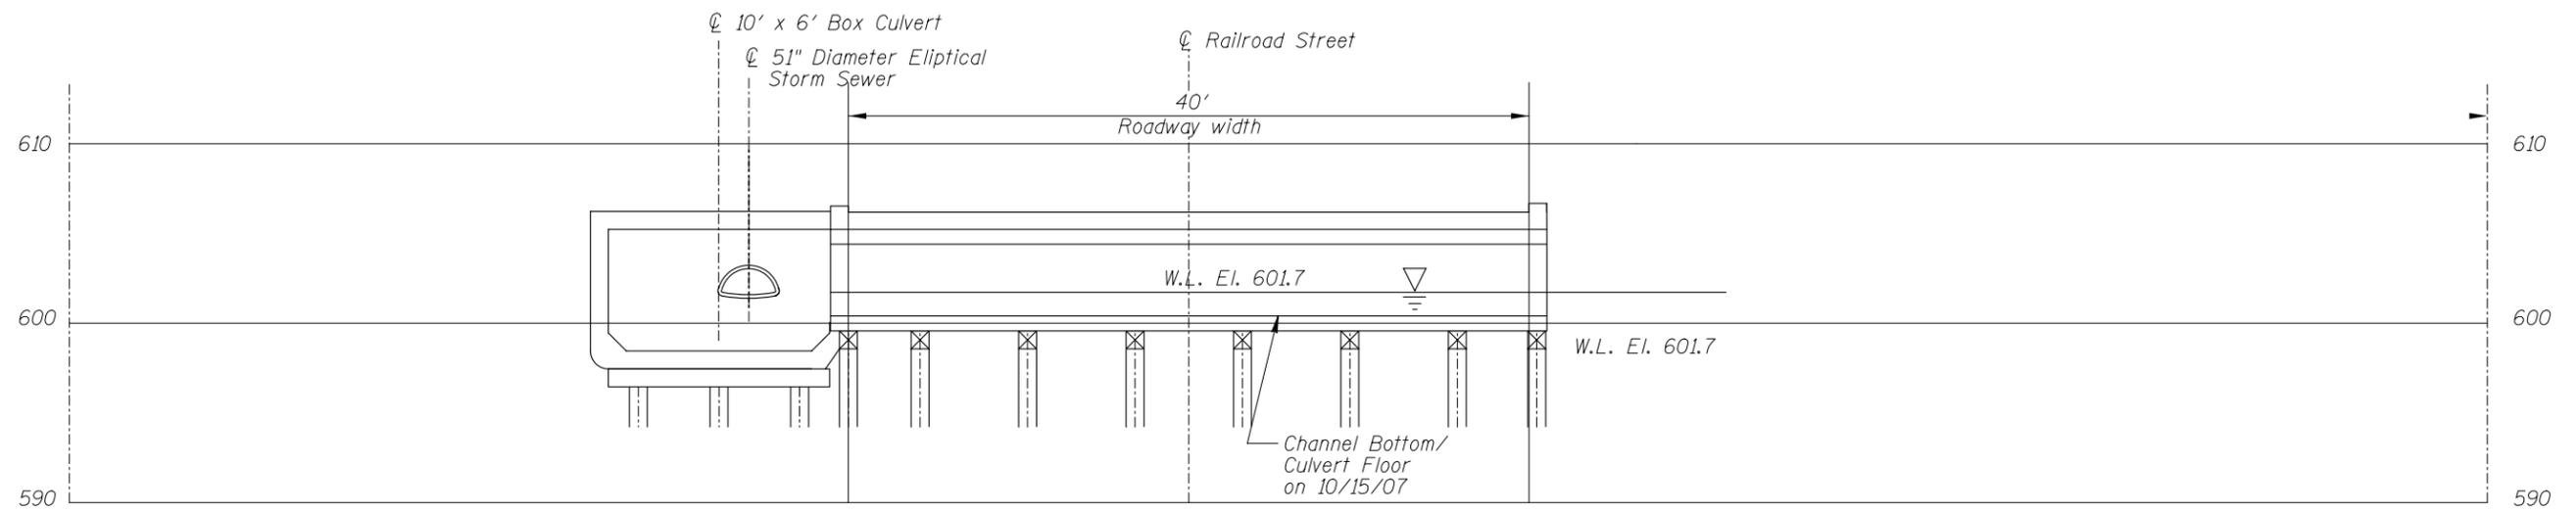
- ① The concrete was in smooth and sound condition with no notable deterioration. The joints between culvert segments exhibited 1/4- to 1-inch-wide gaps (at tongue and groove arrangement with no complete separations of joints) and up to 1/2 inch differentials between faces across joints.
- ② A 6-inch-thick layer of soft silt covered most of the concrete floor of the culvert.

-0.4 Sounding Depth (10/15/07)
