UNDERWATER BRIDGE INSPECTION REPORT

STRUCTURE NO. 31510

MISSISSIPPI RIVER

OCTOBER 1, 2012

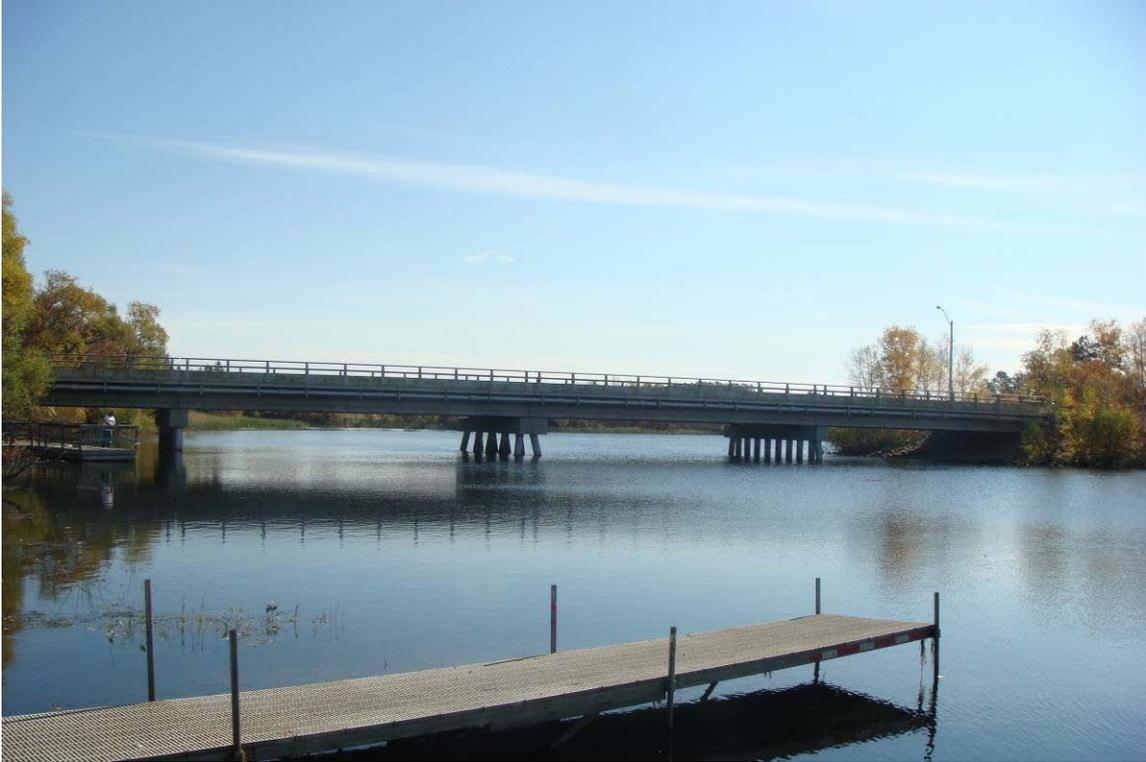
Photograph 1. Overall View of the Structure, Looking Southeast.

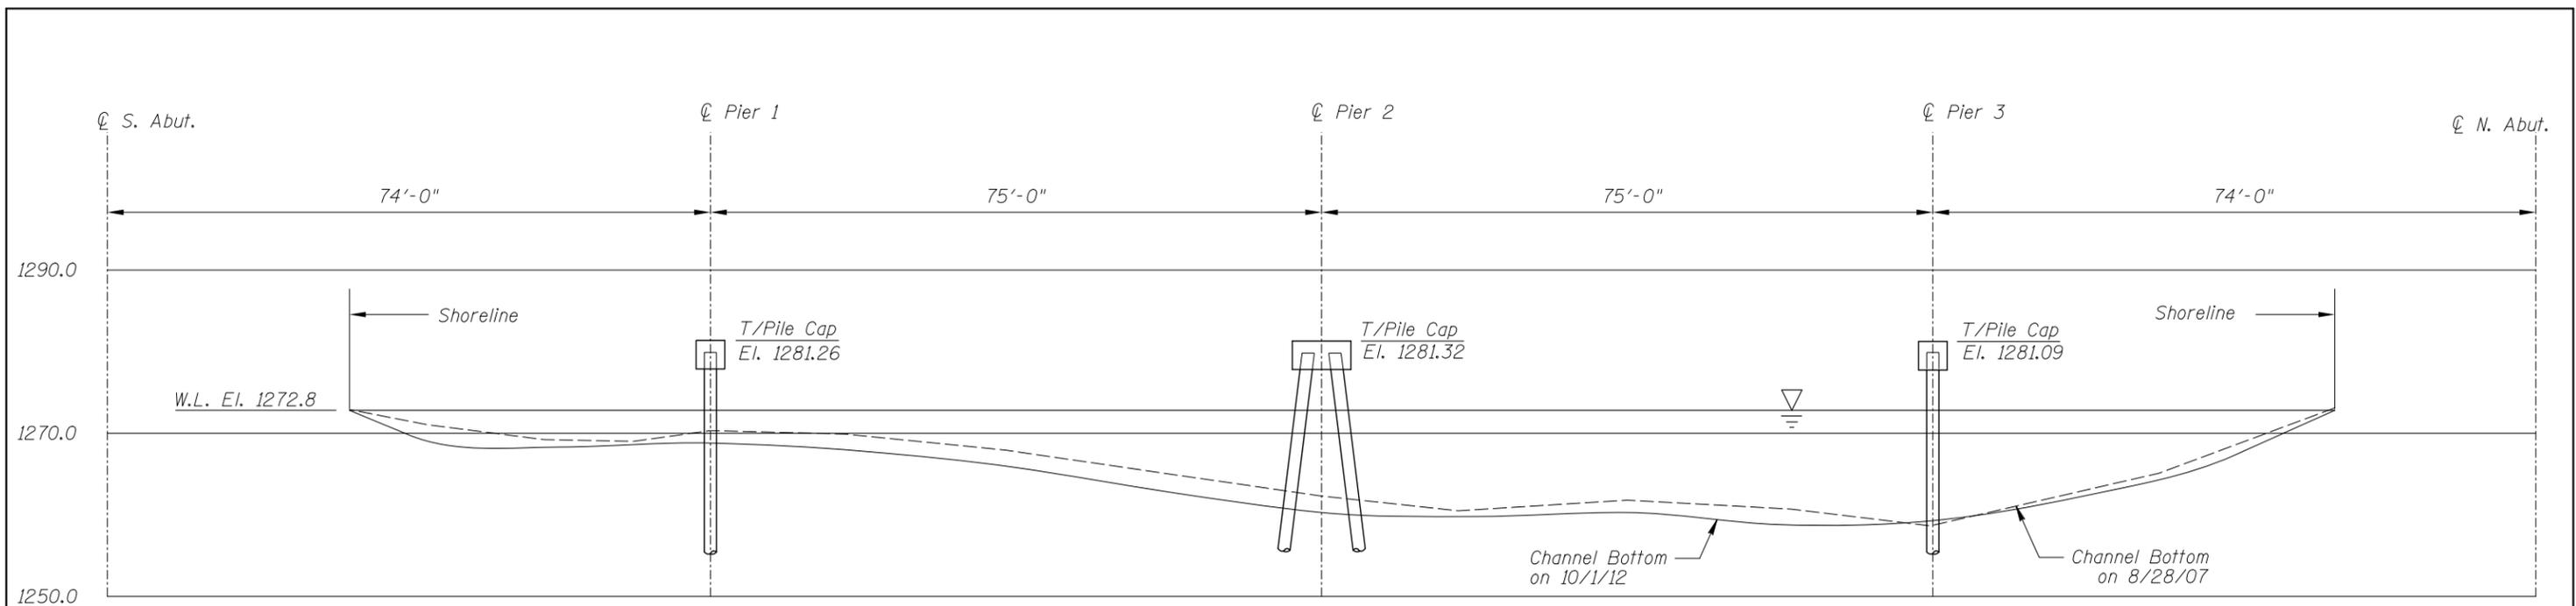
UPSTREAM FASCIA PROFILE

- 1 The channel bottom material consisted of soft silty sand allowing maximum probe rod penetrations of 1 to 1.5 feet.
- 2 Moderate corrosion covered 75 to 100 percent of the pile surfaces from the waterline to the channel bottom. Minimal section loss was observed with typical pitting up to 1/32 inches deep and maximum pitting in random instances up to 1/16 inches deep near the waterline.

- 3 Vertical crack along welded joint noted in previous inspection, August 27, 1997, has been repaired with a bolted steel collar extending from the underside of the pile cap to 3 feet below the waterline. The repair was in good and sound condition.

- 4 The channel bottom material consisted of firm sandy gravel with 6 inch to 2 foot diameter rocks and probe rod penetrations of 2 to 4 inches.
- 5 Minor scour depressions, up to 2 feet deep with up to 2 feet radius, were observed around the upstream piles of Pier 2.

- 6 Moderate accumulation of organics/vegetation was observed at the upstream nose and along the entire bank side of Pier 3 with occasional 1 foot diameter timber debris extending from the mudline to 2 feet above the channel bottom.

- 7 One approximately 8 inch diameter piece of timber debris was observed on the channel bottom along the midpoint of the pier.
- 8 The downstream battered pile at Pier 3 exhibited a 15 degree bend 5 feet below the waterline where the pile then extends vertically into the channel bottom. (appears to be related to driving the pile during original bridge construction)
