UNDERWATER BRIDGE INSPECTION REPORT

STRUCTURE NO. 31514

MSAS 119

MINNESOTA DEPARTMENT OF TRANSPORTATION
UNDERWATER BRIDGE INSPECTION

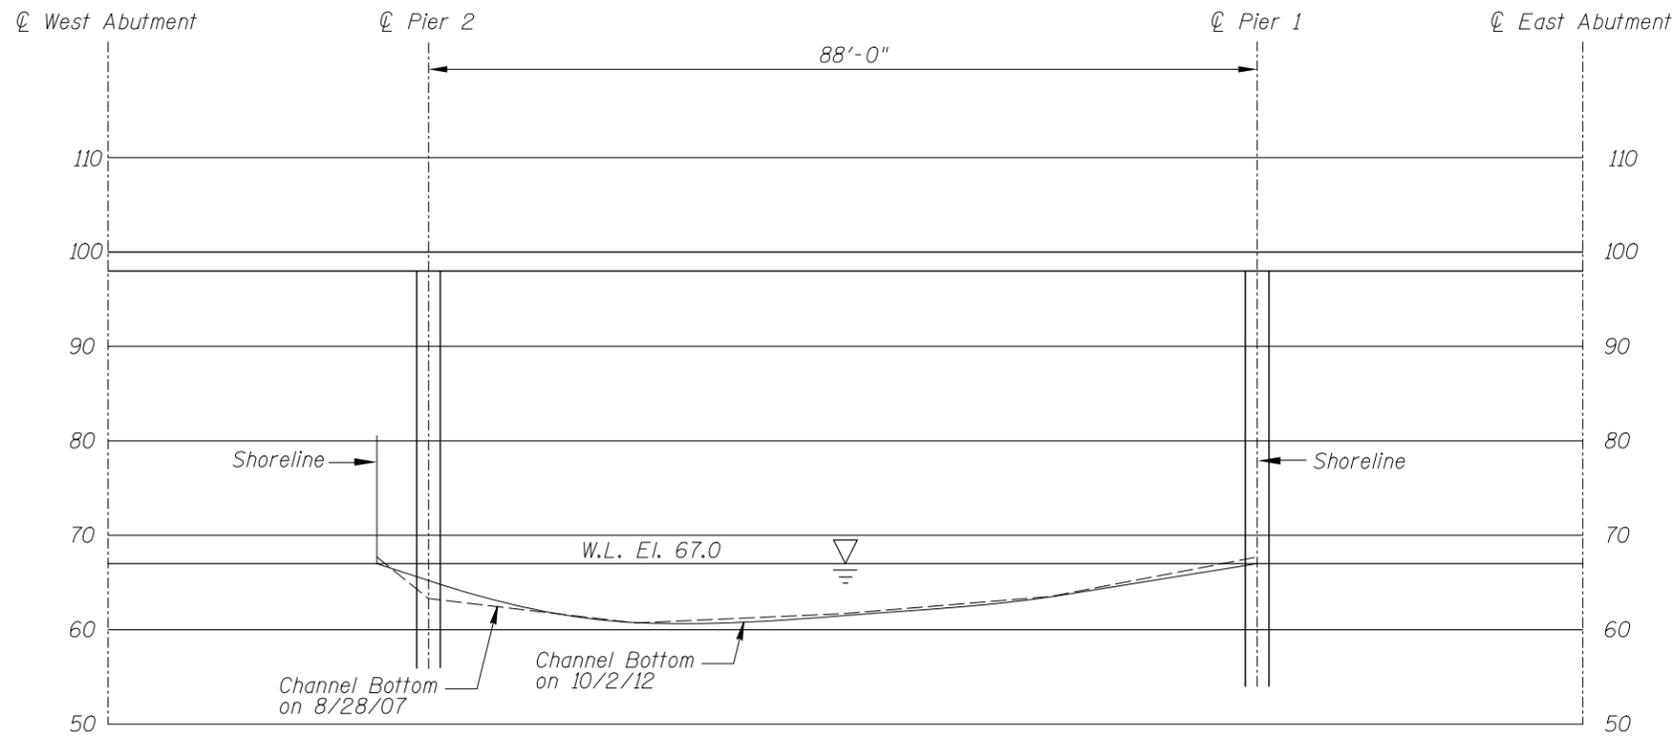
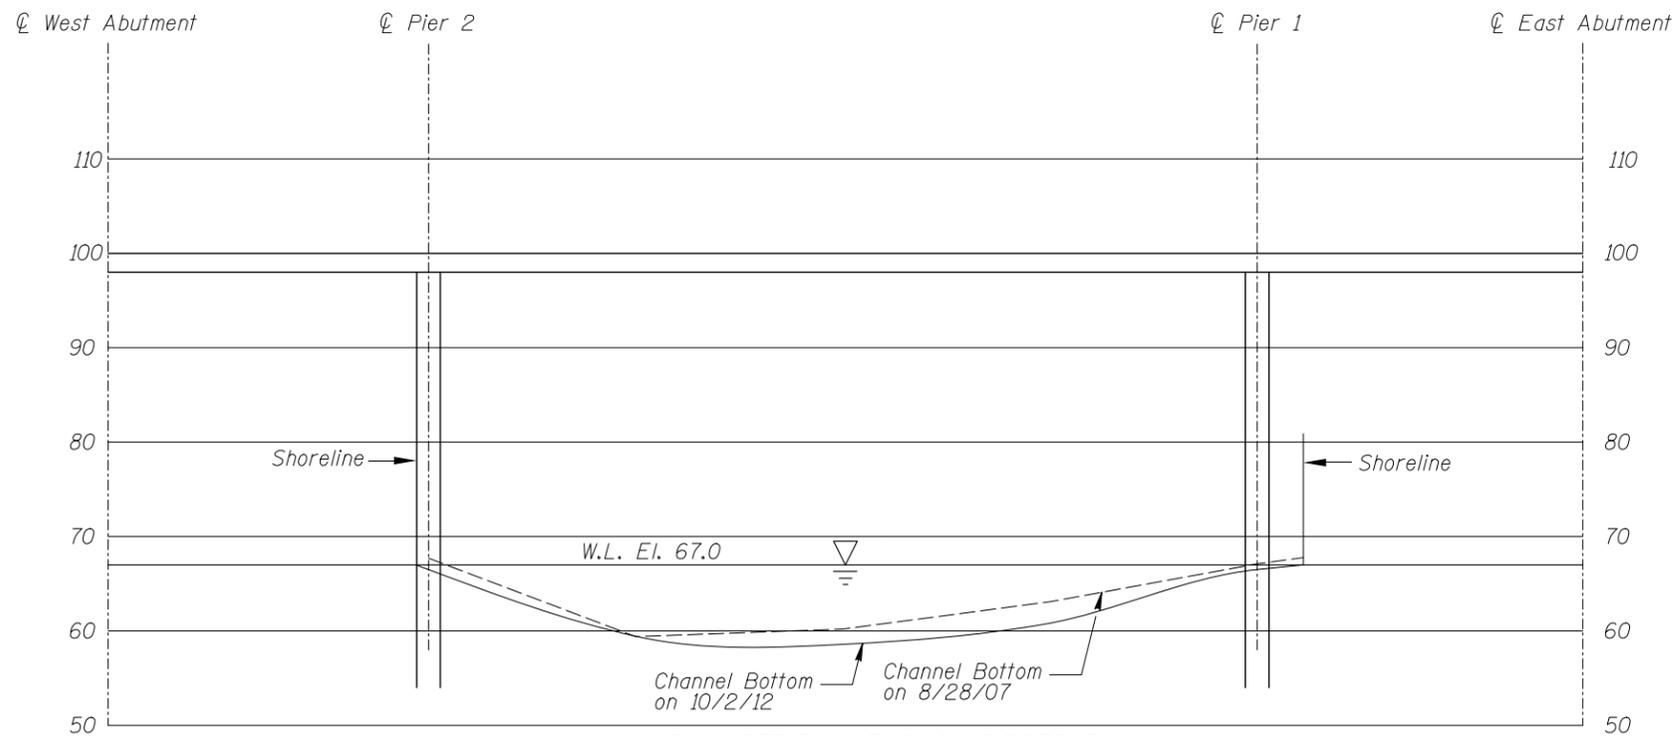
UPSTREAM FASCIA PROFILE

- 2 Overall the concrete was relatively smooth and sound with no significant deterioration.
- 3 Light scaling was observed from 4 feet above the waterline to the channel bottom with a typical penetration of 1/8 inch.

- 5 Footing and formwork was observed 6 feet out from the entire east face of Pier 1. The maximum vertical exposure was 3 feet and was located at the middle of the pier. The footing (and formwork) was observed for a short distance also at the upstream nose of Pier 1. The top of the footing was at 3.8 feet below the waterline and was covered by a layer of sand, from the upstream nose to the downstream 1/4-point of Pier 1.
