UNDERWATER BRIDGE INSPECTION REPORT

STRUCTURE NO. 38505

SILVER RAPIDS

JUNE 19, 2012

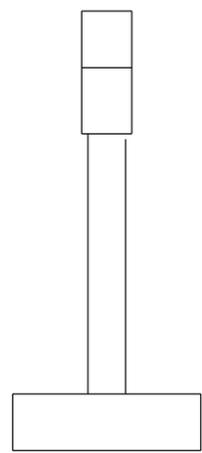
TYPICAL END VIEW OF PIERS

- ③ A band of scaling was observed around Piers 1 and 2, extending from 1.5 feet above to 3 feet below the waterline, with typical penetrations of 1/8 to 1/4 inch and maximum penetrations of 1/2 inch at the upstream ends of the piers.

- ④ A minor scour depression with a width of 4 feet and a depth of 6 inches was observed along the easterly side of Pier 1.
- ⑤ Random light scaling and exposed aggregate was observed at Pier 3 near the waterline.
