UNDERWATER BRIDGE INSPECTION REPORT

STRUCTURE NO. 58506
CSAH NO. 7
OVER THE
SNAKE RIVER
DISTRICT 1 - PINE COUNTY

JUNE 7, 2012
PREPARED FOR THE
MINNESOTA DEPARTMENT OF TRANSPORTATION
BY
COLLINS ENGINEERS, INC.
AND
WSB & ASSOCIATES, INC.
JOB NO. 2107

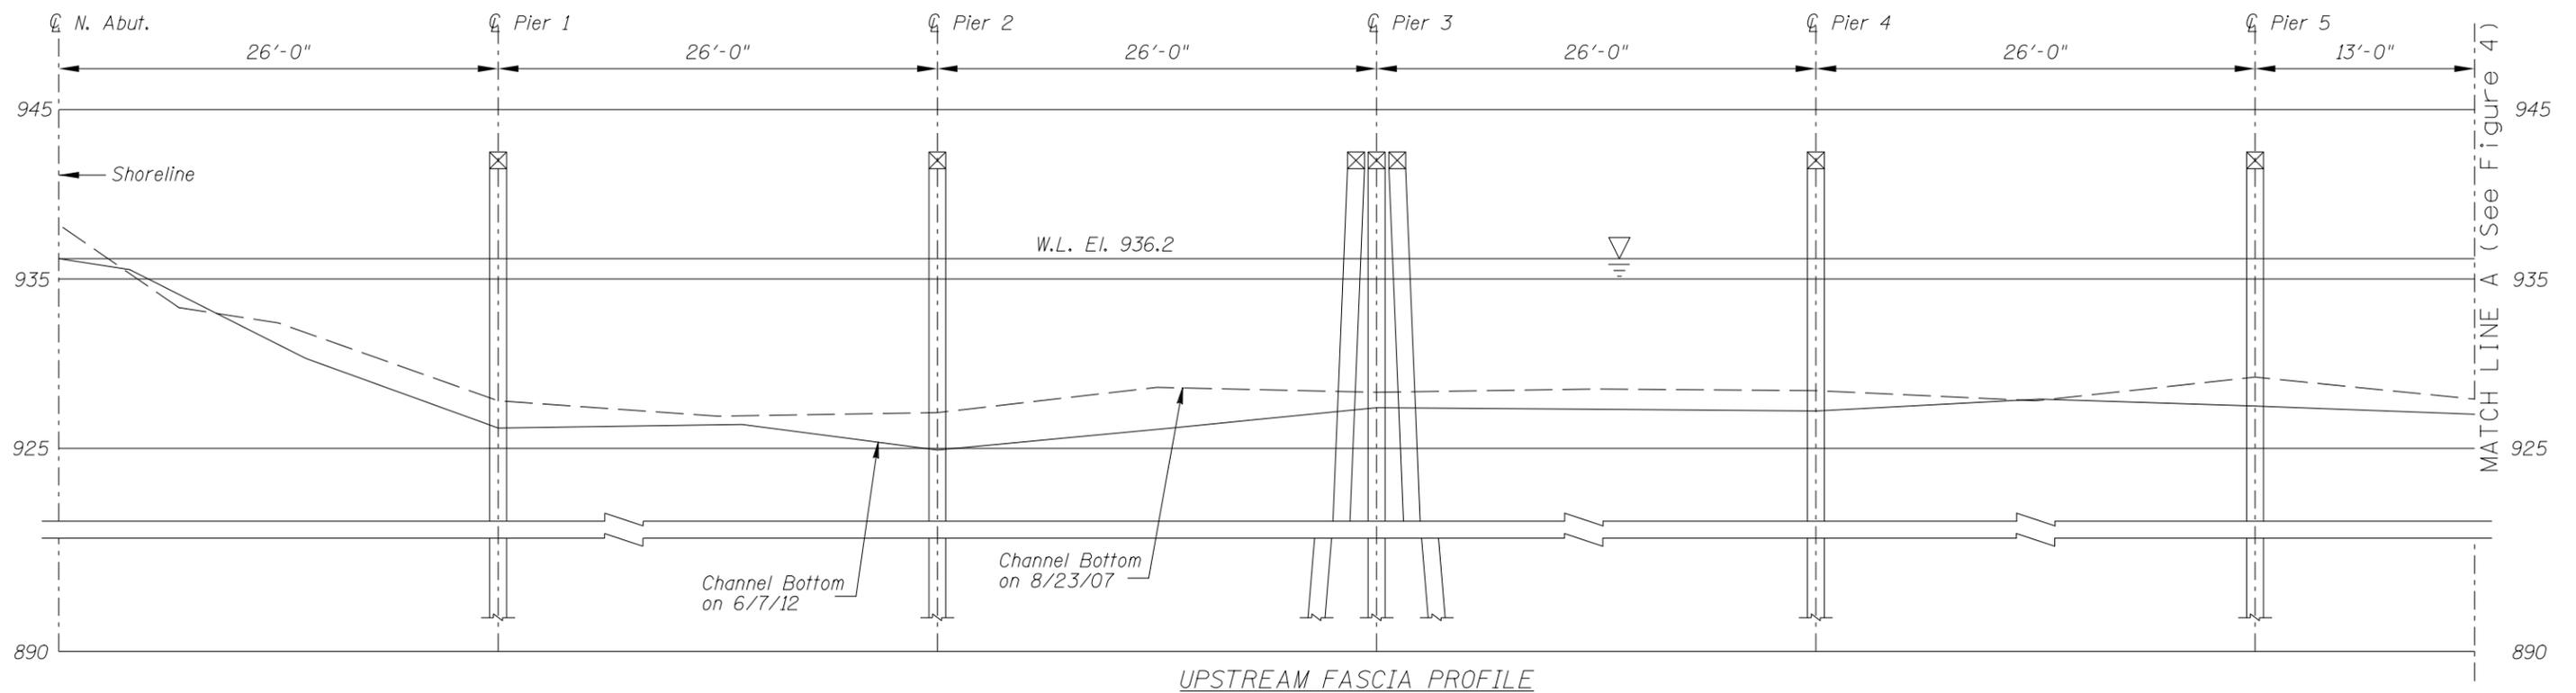
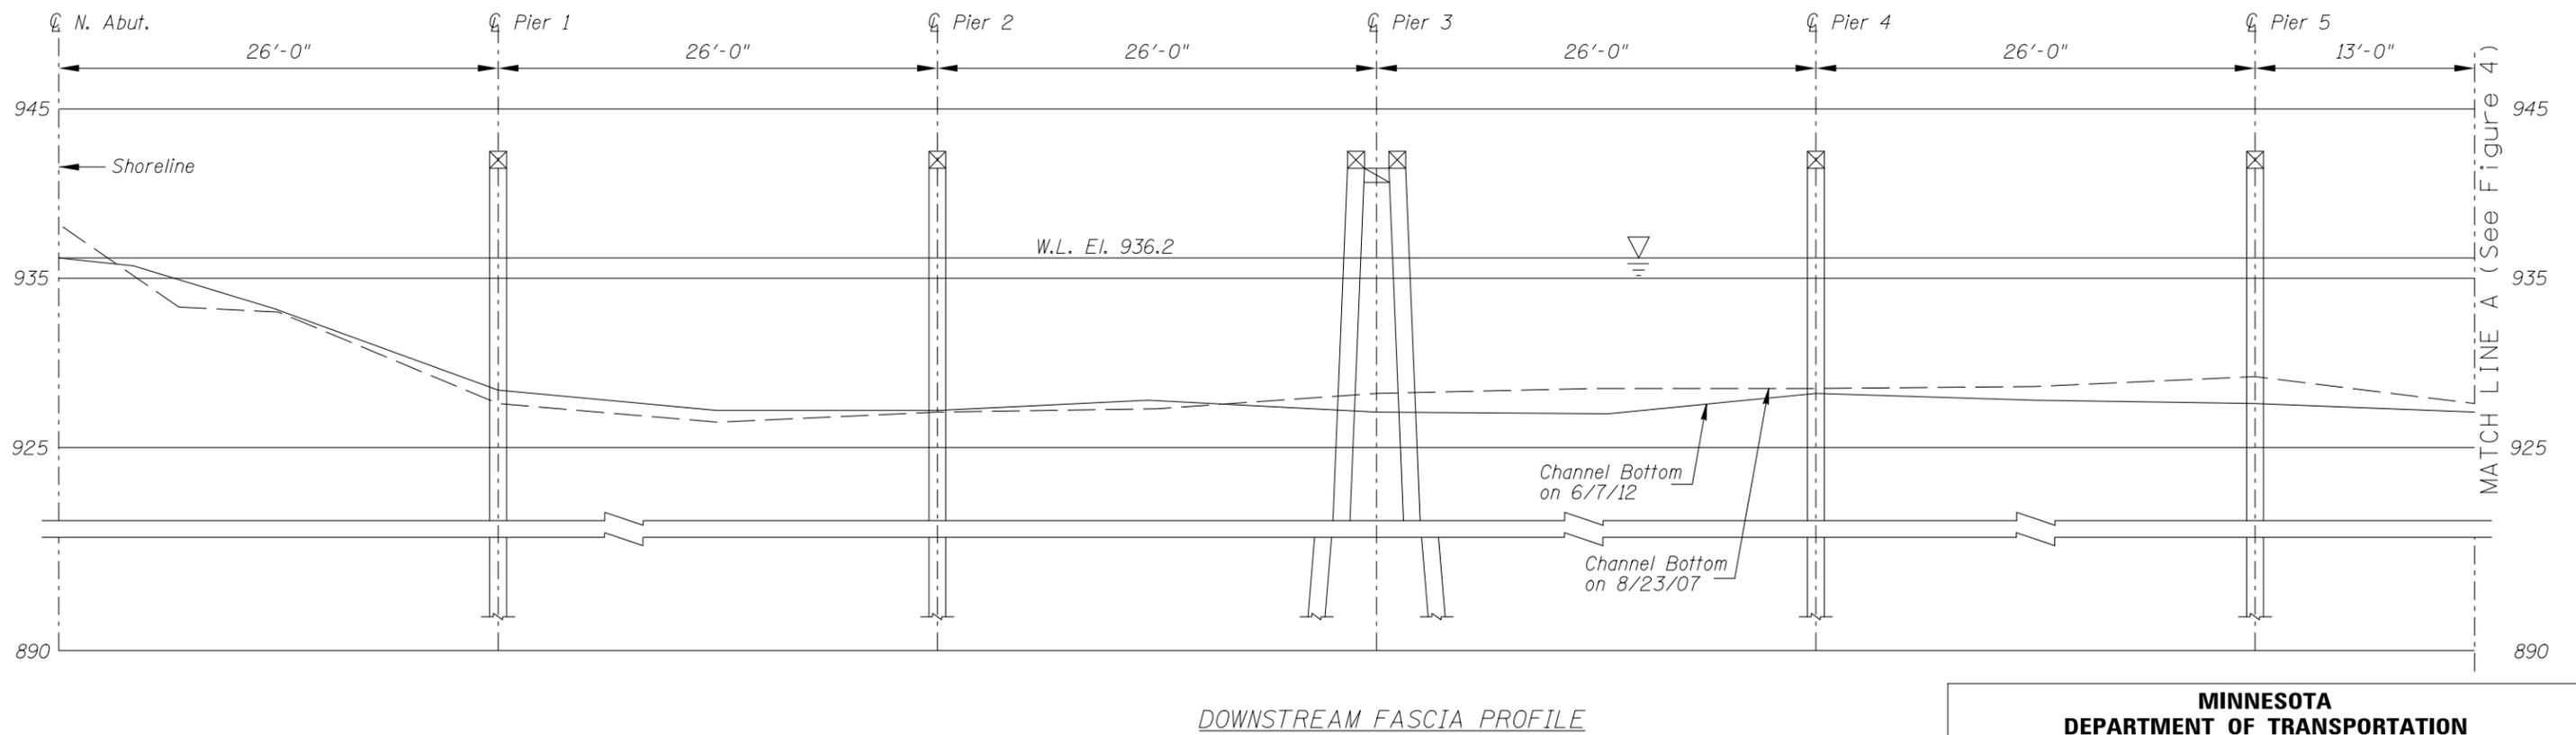
MINNESOTA DEPARTMENT OF TRANSPORTATION UNDERWATER BRIDGE INSPECTION		
STRUCTURE NO. 58506 OVER THE SNAKE RIVER DISTRICT 1, PINE COUNTY		
INSPECTION AND SOUNDING PLAN II		
Drawn By: BJR	COLLINS ENGINEERS	Date: JUNE 2012
Checked By: BRL		Scale: NTS
Code: 52210073		Figure No.: 2

- 1 The channel bottom consisted of silty sand with random scattered riprap and up to 6 inches of probe rod penetration.
- 2 The outer shell of the fourth pile from the west end of pier was cracked, splintered, soft, and delaminated. This condition was present from the channel bottom to 1 foot above the waterline. Probing revealed the wood beneath the outer shell to be sound.

- 3 The channel bottom at Piers 2 and 3 consisted of sand and riprap up to 6 inches in diameter with no appreciable probe rod penetration.
- 4 A 12 inch high by 6 inch wide and 3/4 inch deep portion of the outer shell of this pile has splintered outward. The wood beneath this area was soft to a depth of 1/4 inch. The estimated loss in cross sectional area was 10 to 20 percent. This condition occurred at 2 feet below the waterline.

- 7 All of the piles exhibited random checking up to 1/4 inch wide, and a softer out pile shell up to 1/4 inch thick with 1/4 inch wide splits.
- 8 Light accumulation of timber debris, consisting of 6 inch diameter and smaller logs and branches, was observed at the upstream noses of Piers 2, 3, and 7.

- 9 The outer 1 1/2 inch shell of end pile at west end of Pier 3 was cracked and splintered. This condition was present from 6 inches below the waterline to 1 1/2 feet above the waterline.

- 10 The outer 2 inch shell was cracked, splintered, soft and delaminated at the second pile from the west of Pier 4. The defect extended from channel bottom to 1.5 feet above the waterline.

- 11 Moderate to heavy accumulation of timber debris, consisting of up to 1.5 foot diameter drift pieces, was observed around the upstream end of Piers 4 and 5 extending from channel bottom to waterline.

- 12 A moderate accumulation of timber debris, consisting of 6 inch diameter and smaller limbs and branches, was observed along the south face of Pier 8. It extended from channel bottom to waterline.
