UNDERWATER BRIDGE INSPECTION REPORT

STRUCTURE NO. 6413

CSAH NO. 6

CALDWELL BROOK

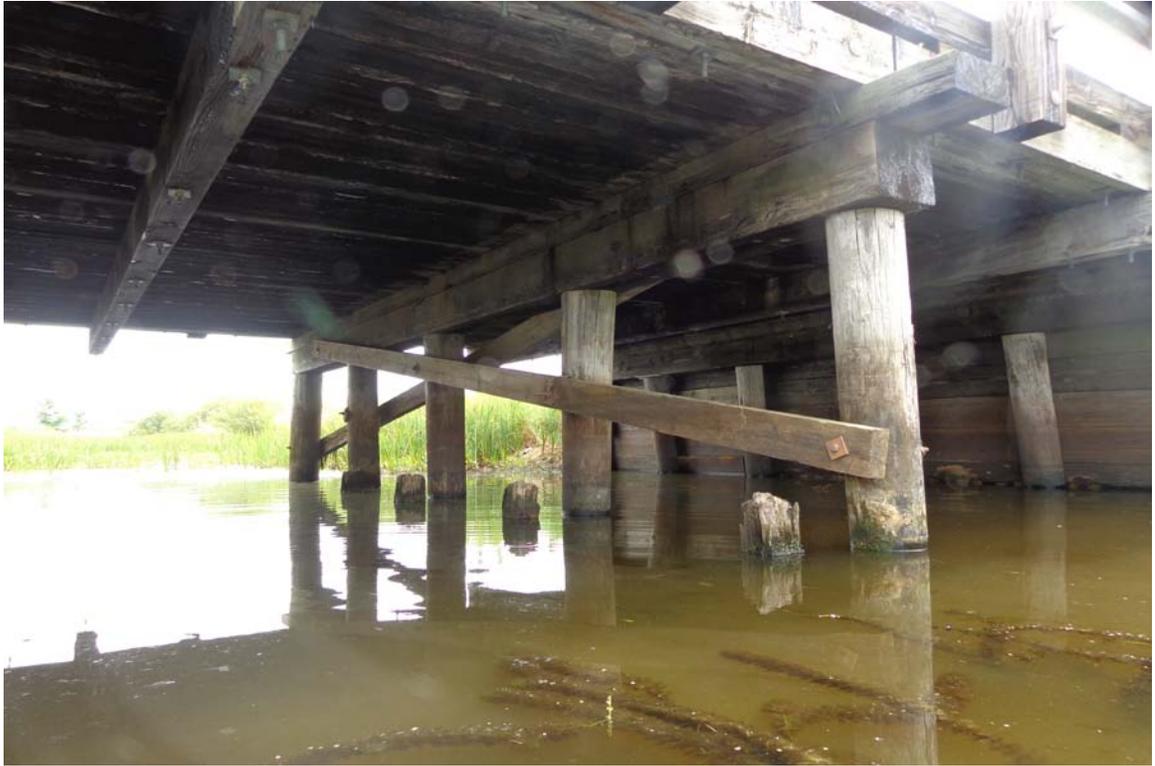
Photograph 3. View of Bent 1, Looking Southeast.

- (G) The south brace exhibited a 5-foot-long split with a failed connection to the easternmost pile at Bent 1.

- 7 The south brace exhibited a 5-foot-long split with a failed connection to the easternmost pile at Bent 1.
- 8 Channel bottom consisted of soft silt with up to 8 inches of probe rod penetration and random 12 inch riprap.

Replace timber cross bracing members with splits and failed connections.

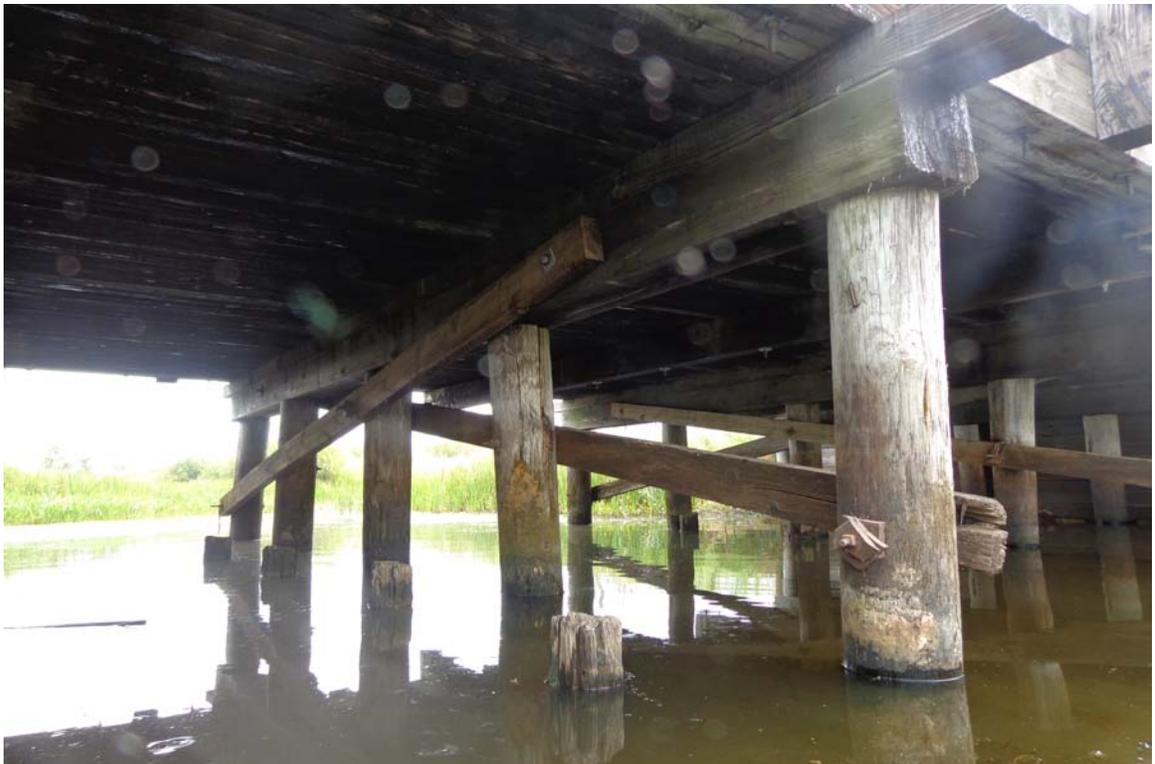
Photograph 4. View of Bent 2, Looking Southeast.

- (E) The top of the northeast wingwall exhibited up to 12 inches of displacement to the South with no active loss of backfill noted.
- (F) The south brace exhibited a 3-foot-long split with a failed connection to the westernmost pile at Bent 2.

- 9 The connection hardware typically exhibited corrosion with no appreciable loss of section noted.
- 10 The easternmost pile of Bent 2 was delaminated from the top of the pile down to waterline with up to 3 inches of awl penetration.
