UNDERWATER BRIDGE INSPECTION REPORT

STRUCTURE NO. 69505
CSAH NO. 8
OVER THE
ST. LOUIS RIVER
DISTRICT 1 – ST. LOUIS COUNTY

JULY 25, 2012

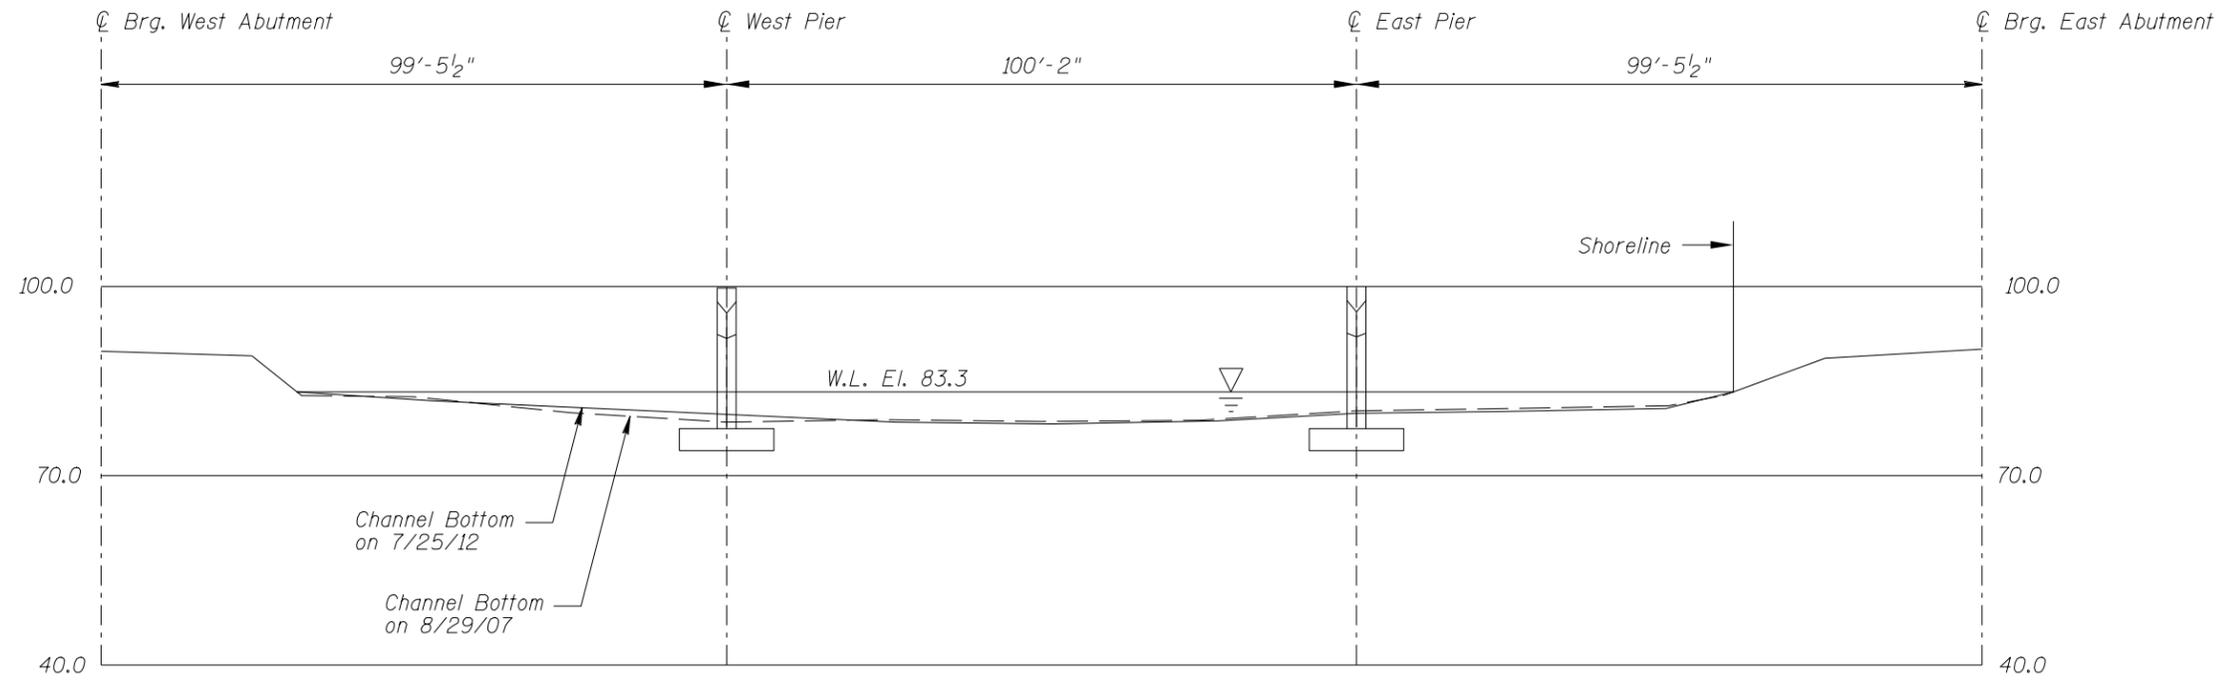
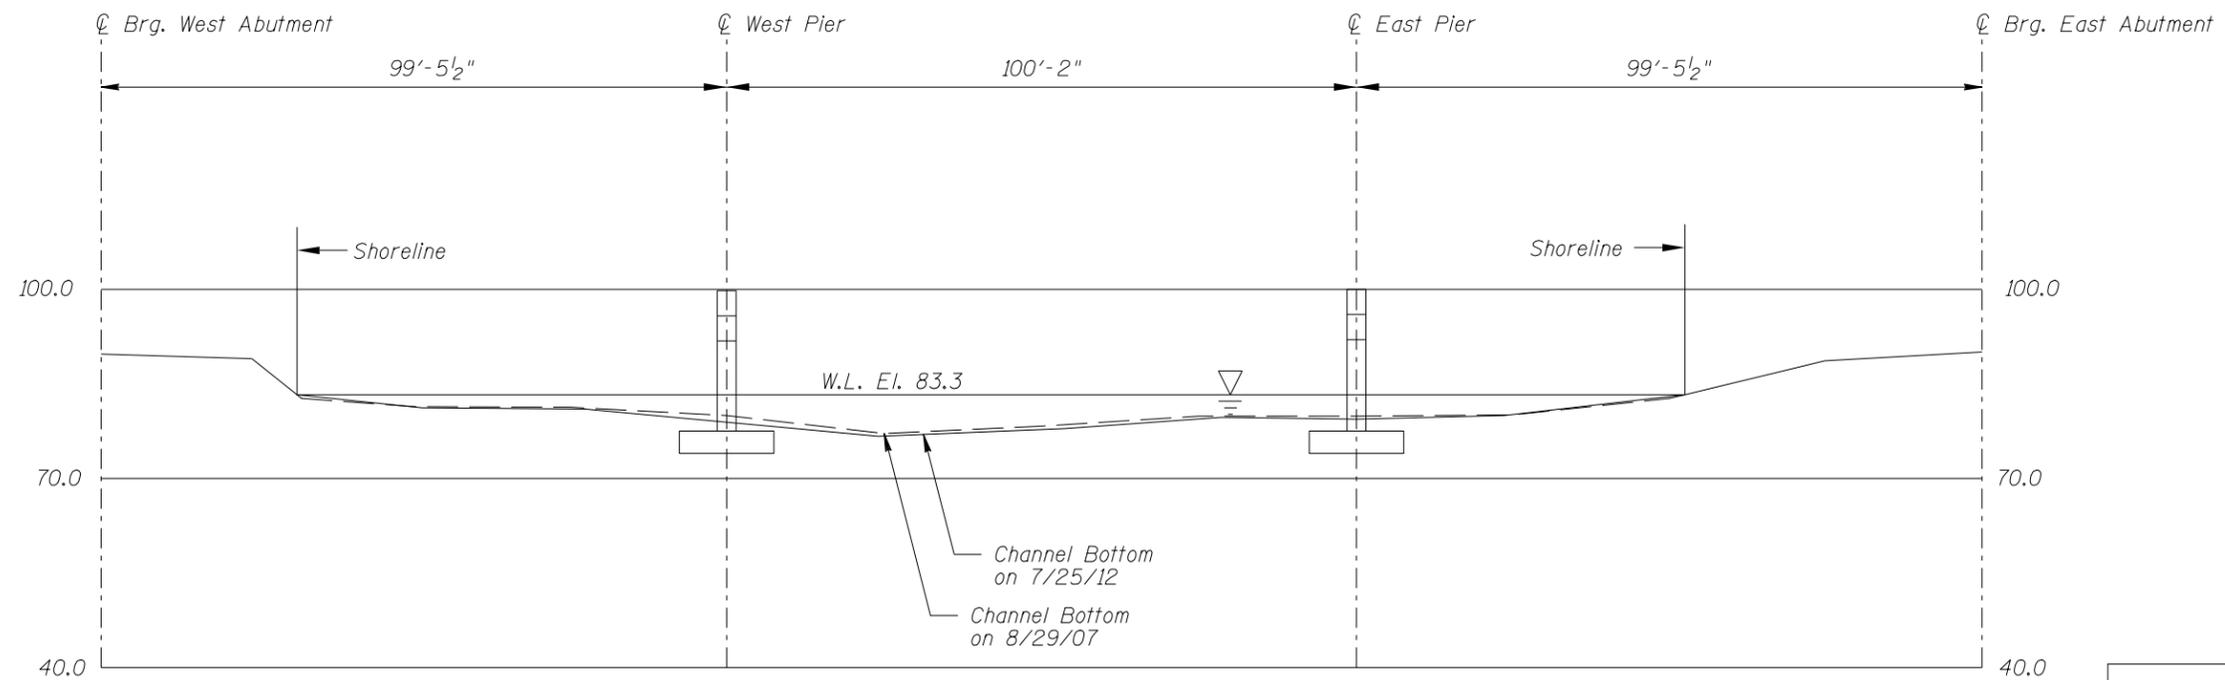
- 1 The channel bottom consisted of 1- to 2-foot-diameter riprap and cobbles.
- 2 The concrete exhibited light scaling from 3 feet above the waterline to the channel bottom with exposed aggregate and typical penetrations of 1/8 inch and maximum penetrations ranging from 1/4 inch to 1/2 inch.
- 3 A heavy accumulation of 3-foot-diameter and smaller timber debris was observed around the entire pier extending 50 feet upstream and 25 feet downstream off the noses, 20 feet off the faces of Pier 1, from the channel bottom to 8 foot above the waterline.
- 4 1- to 2-foot-diameter riprap and cobbles were observed along the embankments.
