UNDERWATER BRIDGE INSPECTION REPORT

STRUCTURE NO. 69506

CSAH 133

JULY 25, 2012

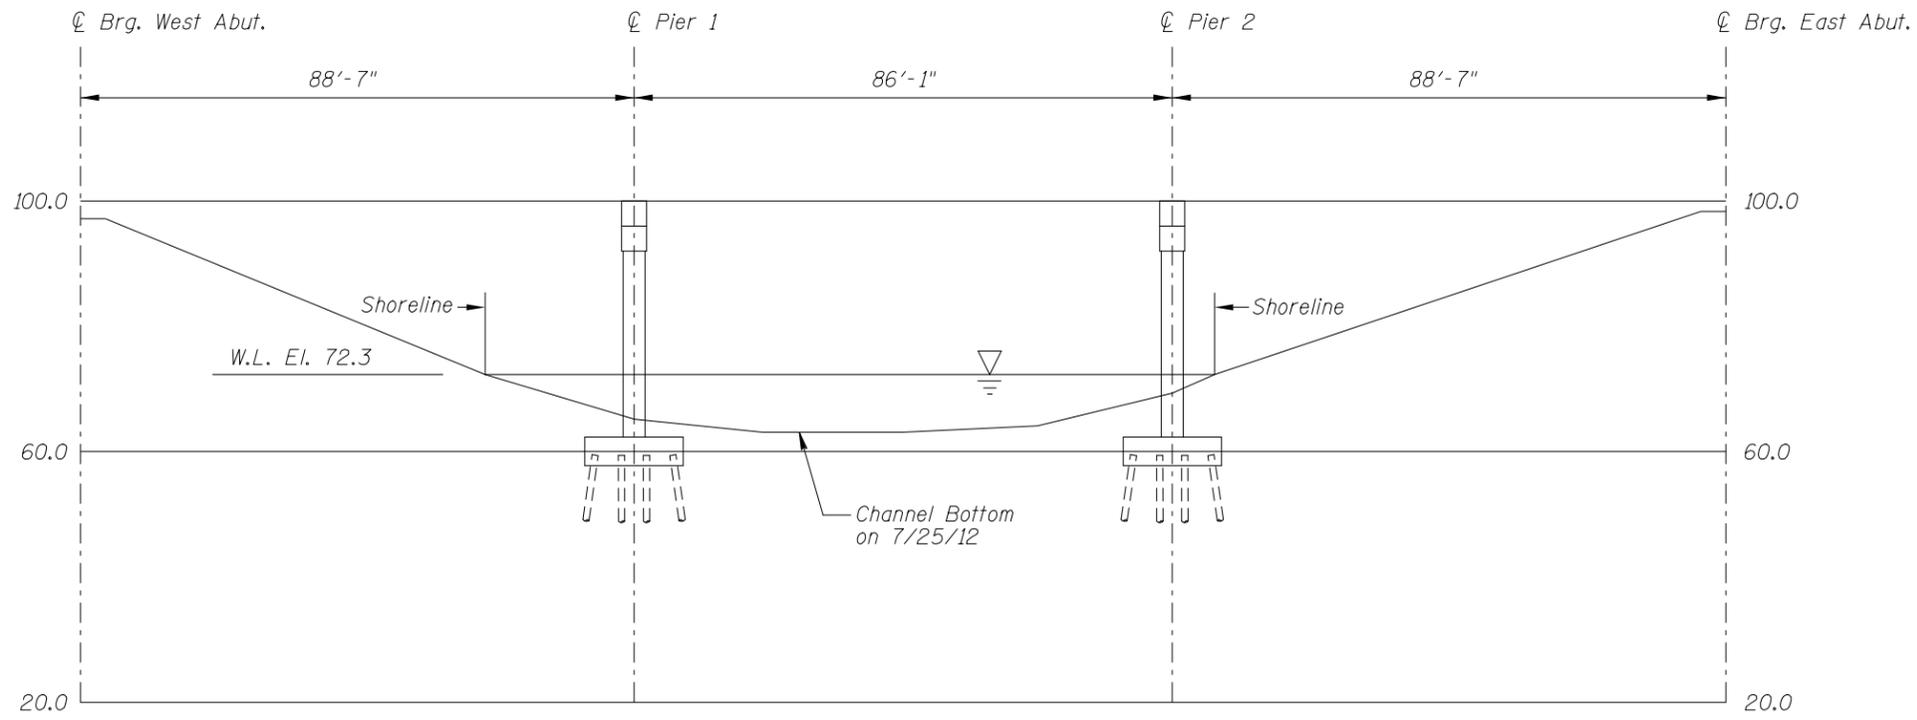
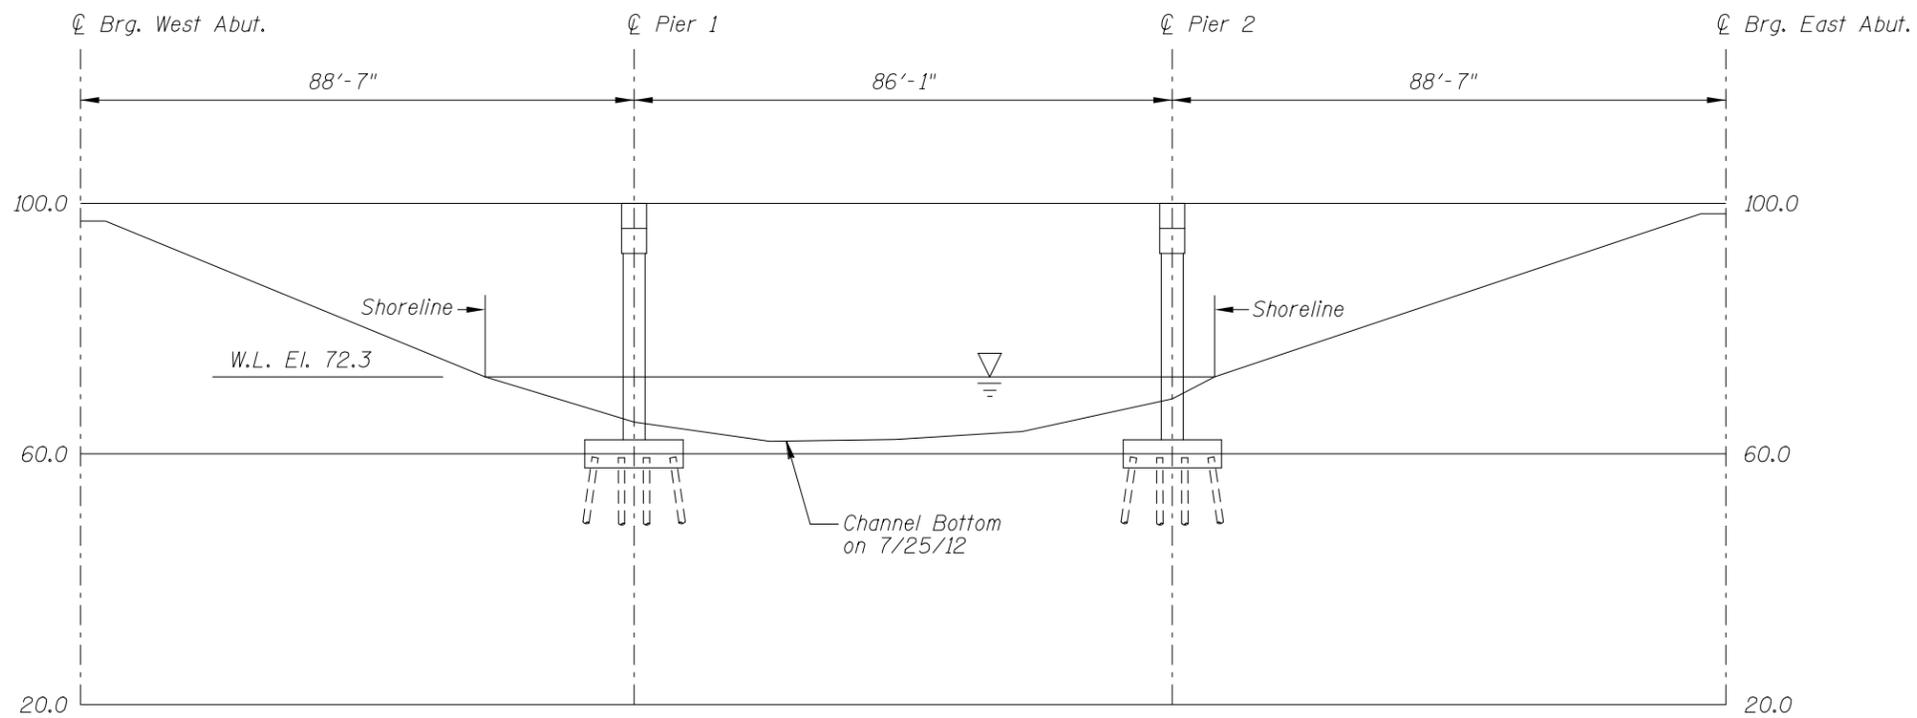
- ① The channel bottom consisted of riprap 2 feet dia. and smaller allowing no probe rod penetration.
- ② The outer (approximately 1/4 inch thick) layer of concrete from the channel bottom up 4 feet was unsound and easily degradable by the use of hand tools.

REMARKS: Overall, Pier 1 and Pier 2 were in satisfactory condition with no defects of structural significance. There was concrete deterioration of Pier 1 with easily degradable and unsound concrete surfaces from the channel bottom up four feet.

Monitor the extent of concrete deterioration during future underwater inspections.

Reinspect the submerged substructure units at the normal maximum recommended (NBIS) interval of sixty (60) months.
