UNDERWATER BRIDGE INSPECTION REPORT

STRUCTURE NO. 69511

CSAH 15

CLOQUET RIVER

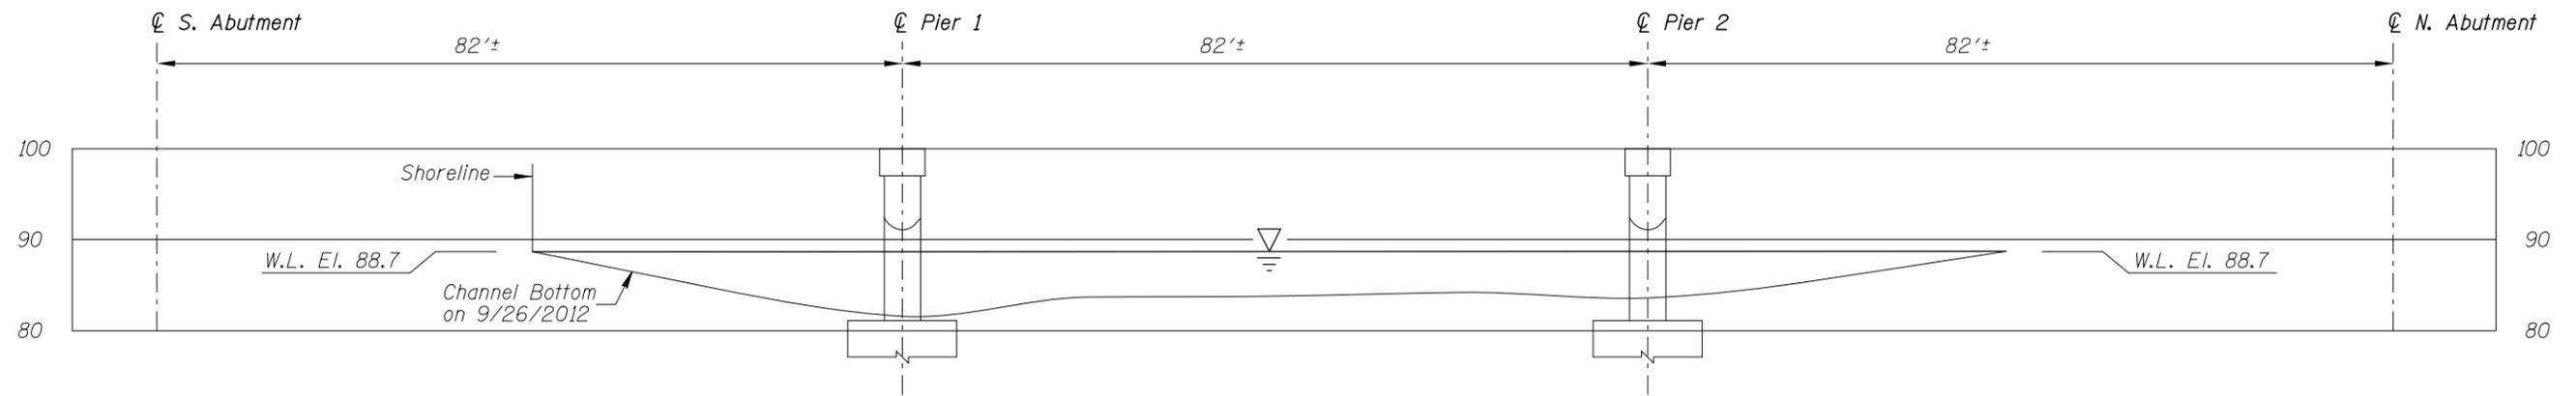
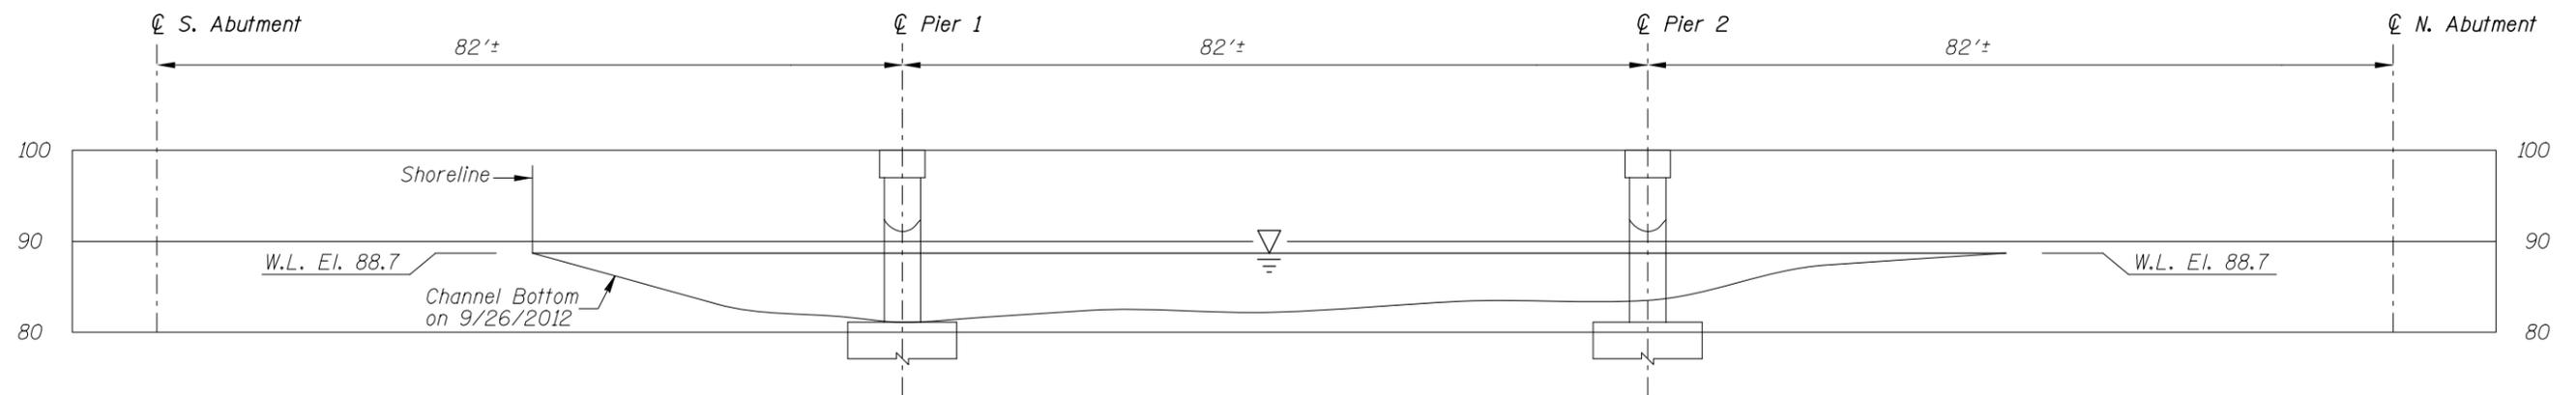
- ③ The top of the footing of Pier 1 was exposed from the north face midpoint to the upstream nose and extending up to 2 feet off the face of the pier. No vertical exposure or edge of footing was observed.

- ④ A 8 inch diameter tree was observed along the upstream nose of Pier 1 that extended 10 feet off the north and south faces and from the channel bottom to the waterline.

- ⑤ A heavy accumulation of timber debris consisting of 1 foot diameter and smaller trees and branches was observed around Pier 2 extending from the channel bottom to 2 feet above the waterline, 10 feet off the north and south faces, and 15 feet upstream of the upstream nose.
