UNDERWATER BRIDGE INSPECTION REPORT

STRUCTURE NO. 69533

WHITEFACE RIVER

MINNESOTA DEPARTMENT OF TRANSPORTATION
UNDERWATER BRIDGE INSPECTION

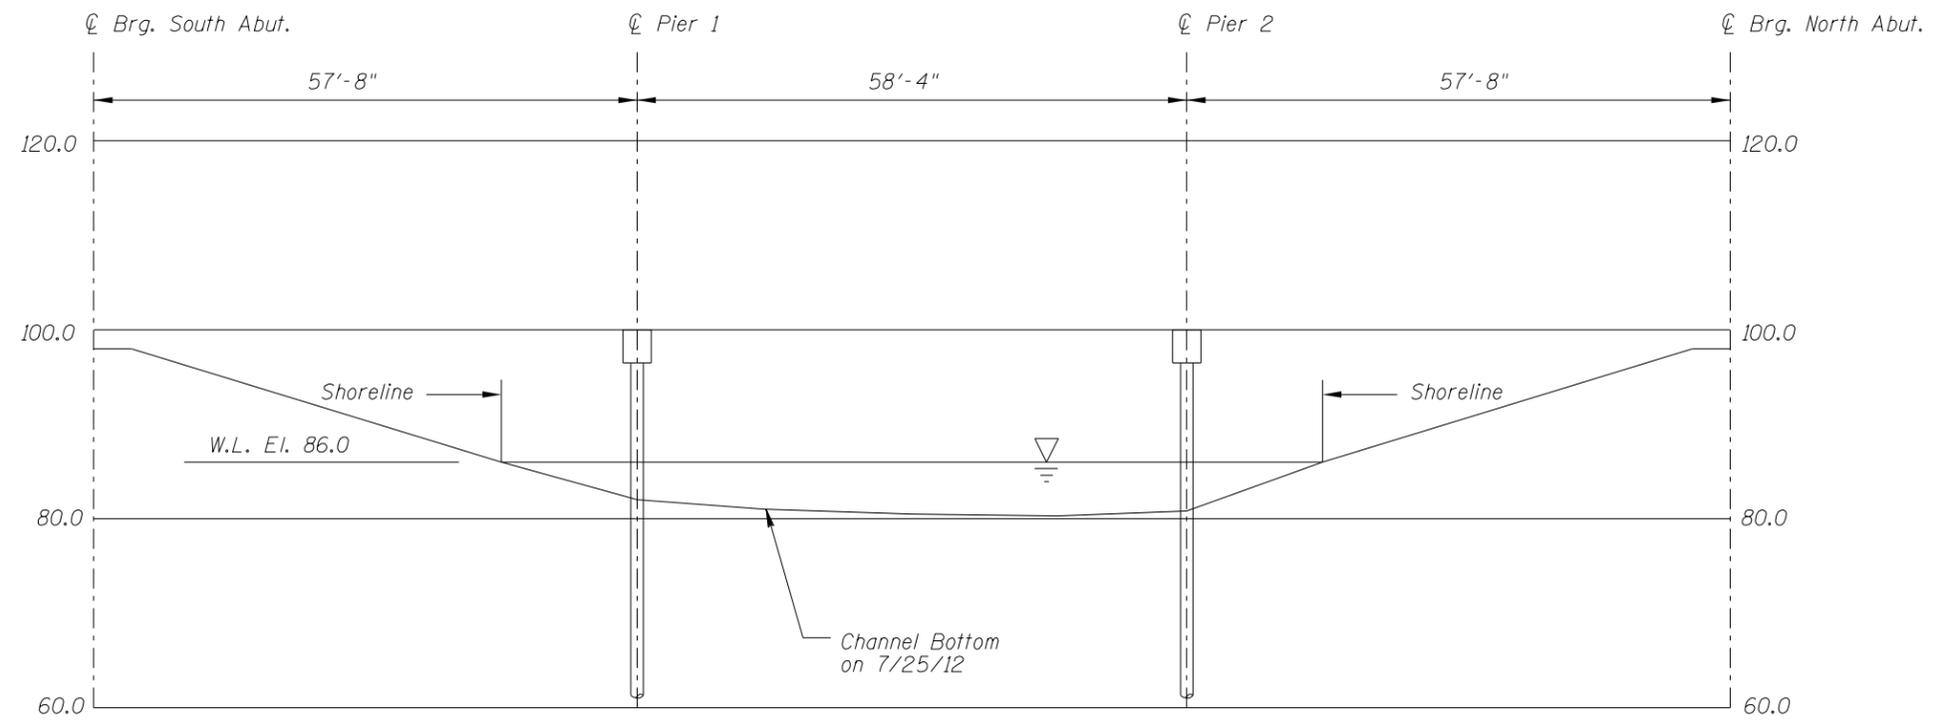
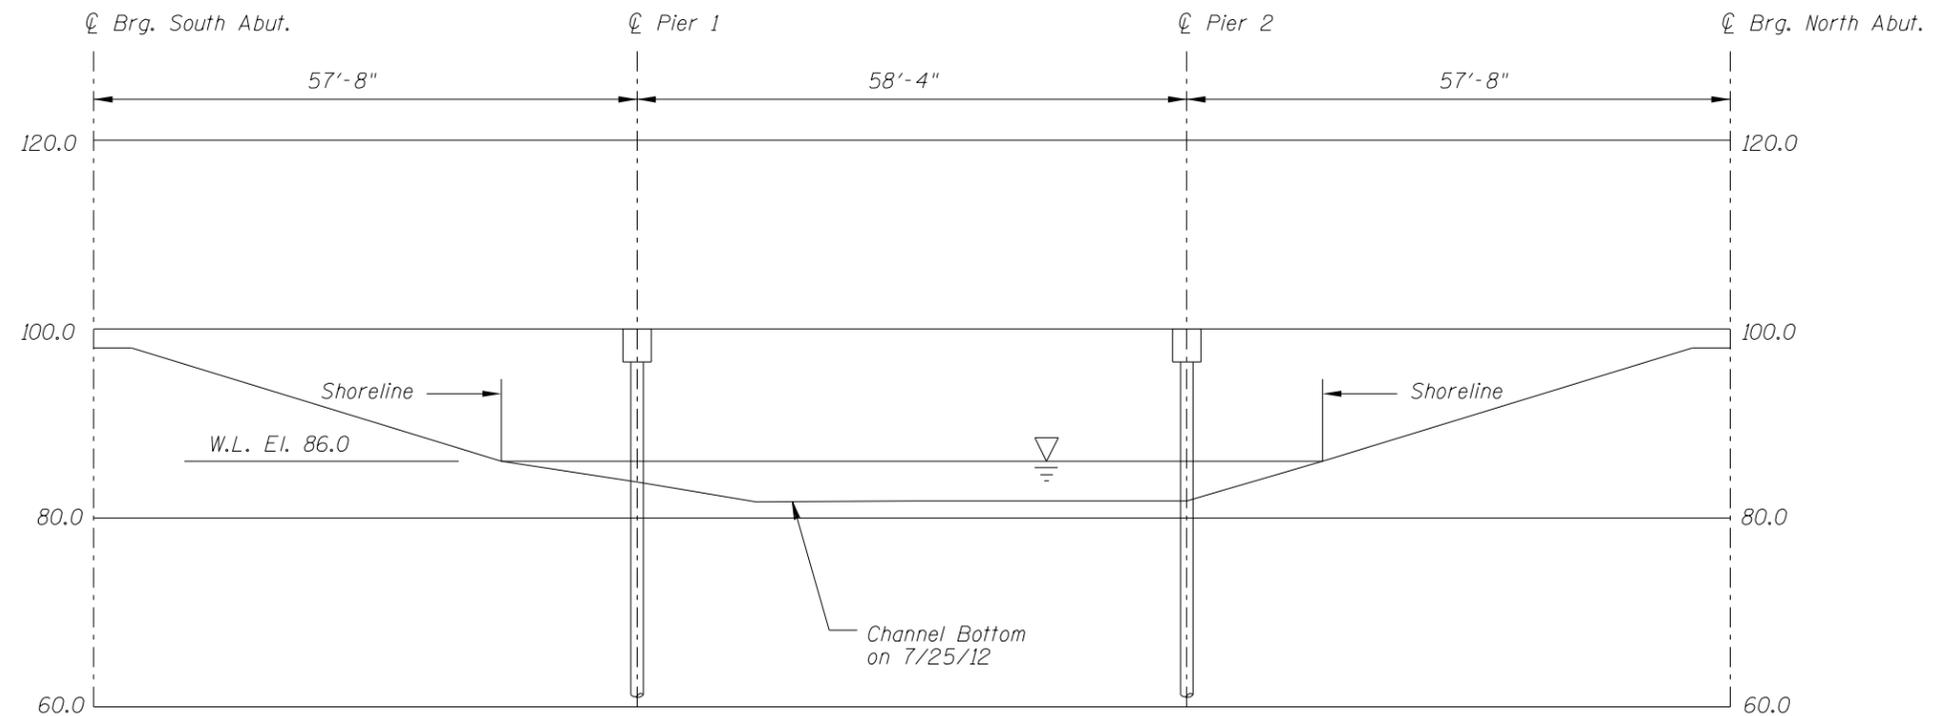
Date: JULY 2012
 Scale: NTS
 Figure No.: 1

- ① The channel bottom material consisted of sandy silt allowing up to 6 inches of probe rod penetration.
- ② A light accumulation of timber debris, consisting of branches 3" inch dia. and smaller, was observed around the perimeter of Pier 1 extending 5 feet off all faces and from the channel bottom to the waterline.
- ③ A moderate accumulation of timber debris, consisting of logs and branches 12" inch dia. and smaller, was observed around the upstream nose of Pier 2 extending from the channel bottom to 2 feet above the waterline.
- ④ The steel piles typically exhibited pitting 1/4 inch dia. with up to 1/8 inch penetration observed from 1 foot above to 2 feet below the waterline.
- ⑤ The steel piles from 1 foot above the waterline to the cap exhibited coating failure on approximately 25% of the surface area. Surface corrosion was present with no appreciable loss of section.
