UNDERWATER BRIDGE INSPECTION REPORT

STRUCTURE NO. 69539
CR NO. 156
OVER THE
ST. LOUIS RIVER
DISTRICT 1 - ST. LOUIS COUNTY

JULY 25, 2012

MINNESOTA DEPARTMENT OF TRANSPORTATION
UNDERWATER BRIDGE INSPECTION

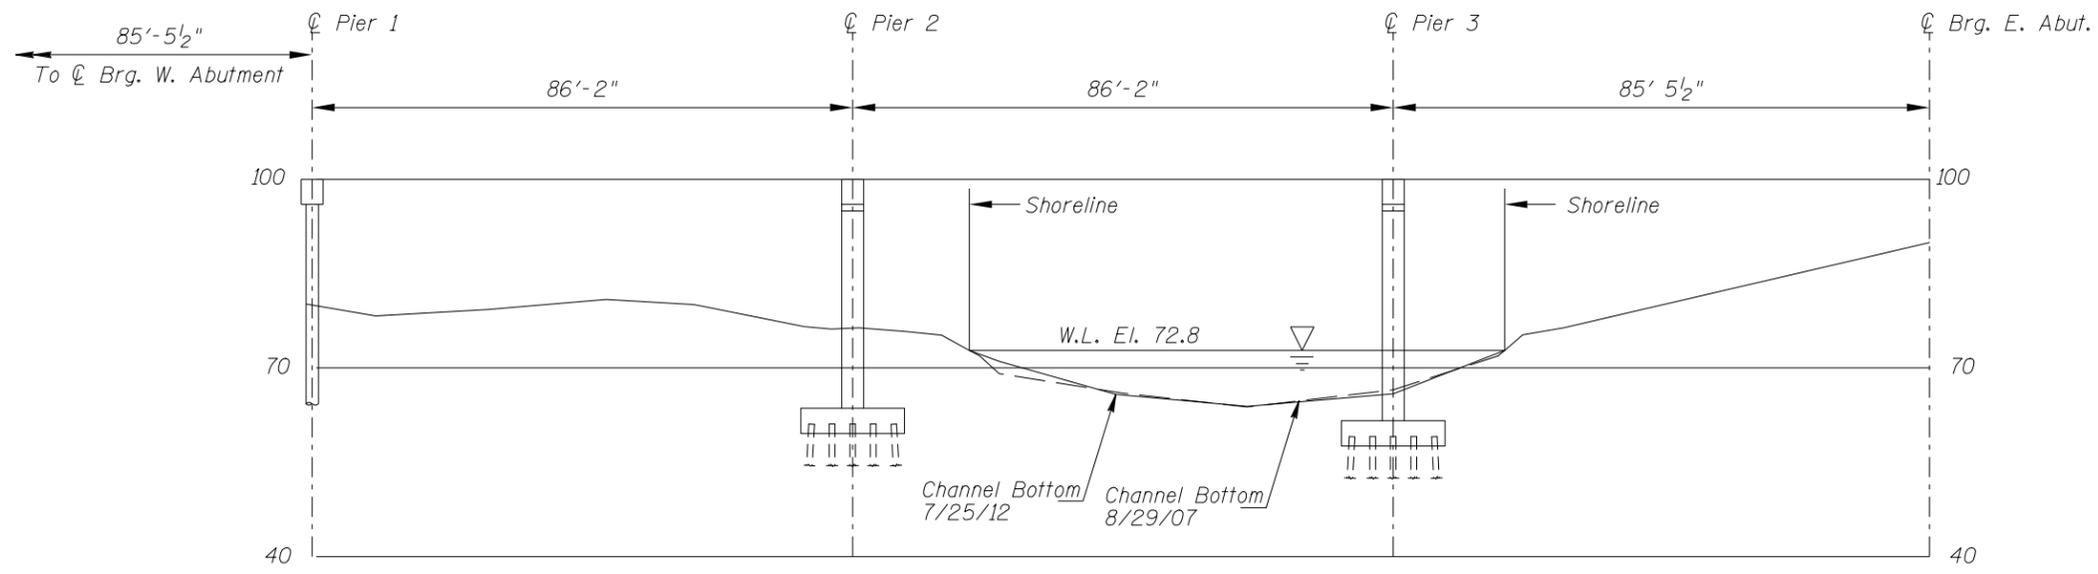
UPSTREAM FASCIA PROFILE

- 1 The channel bottom consisted of 1-foot-diameter riprap with no probe rod penetration around Pier 3.
- 2 Light scaling was observed from 1 foot below the waterline to 2 feet above the waterline with typical penetrations of 1/8 inch and up to 1/4 inch maximum penetrations.
