UNDERWATER BRIDGE INSPECTION REPORT

STRUCTURE NO. 69559

CR 927

WEST SWAN RIVER

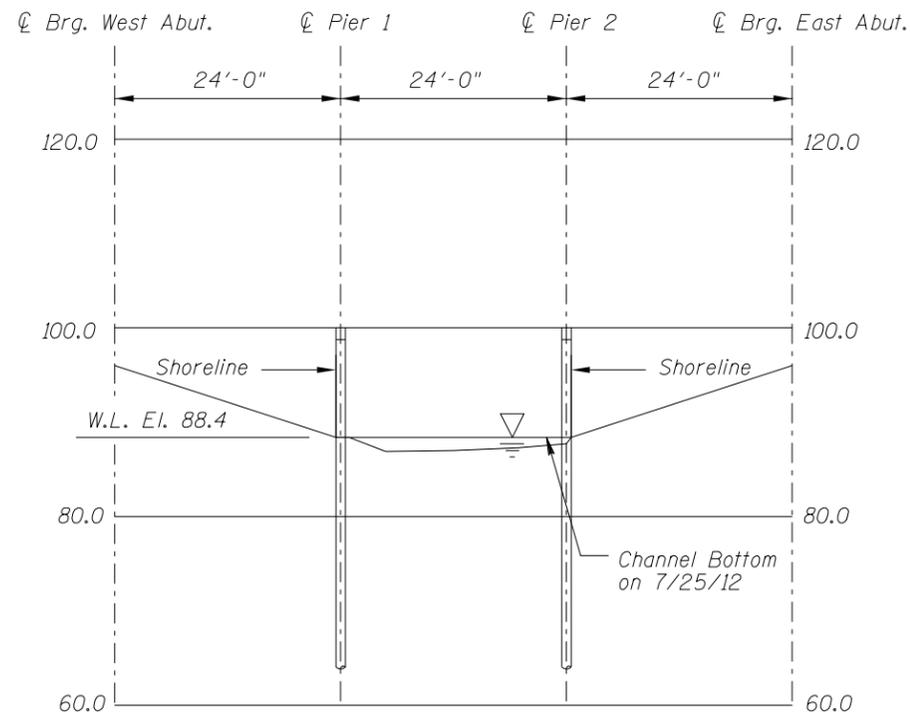
UPSTREAM FASCIA PROFILE

- ① The channel bottom material consisted of silty clay allowing up to 2 feet of probe rod penetration.
- ② Steel pipe piles were in good condition with no notable corrosion or section loss noted.
