UNDERWATER BRIDGE INSPECTION REPORT

STRUCTURE NO. 69594

CSAH 48

FISH LAKE

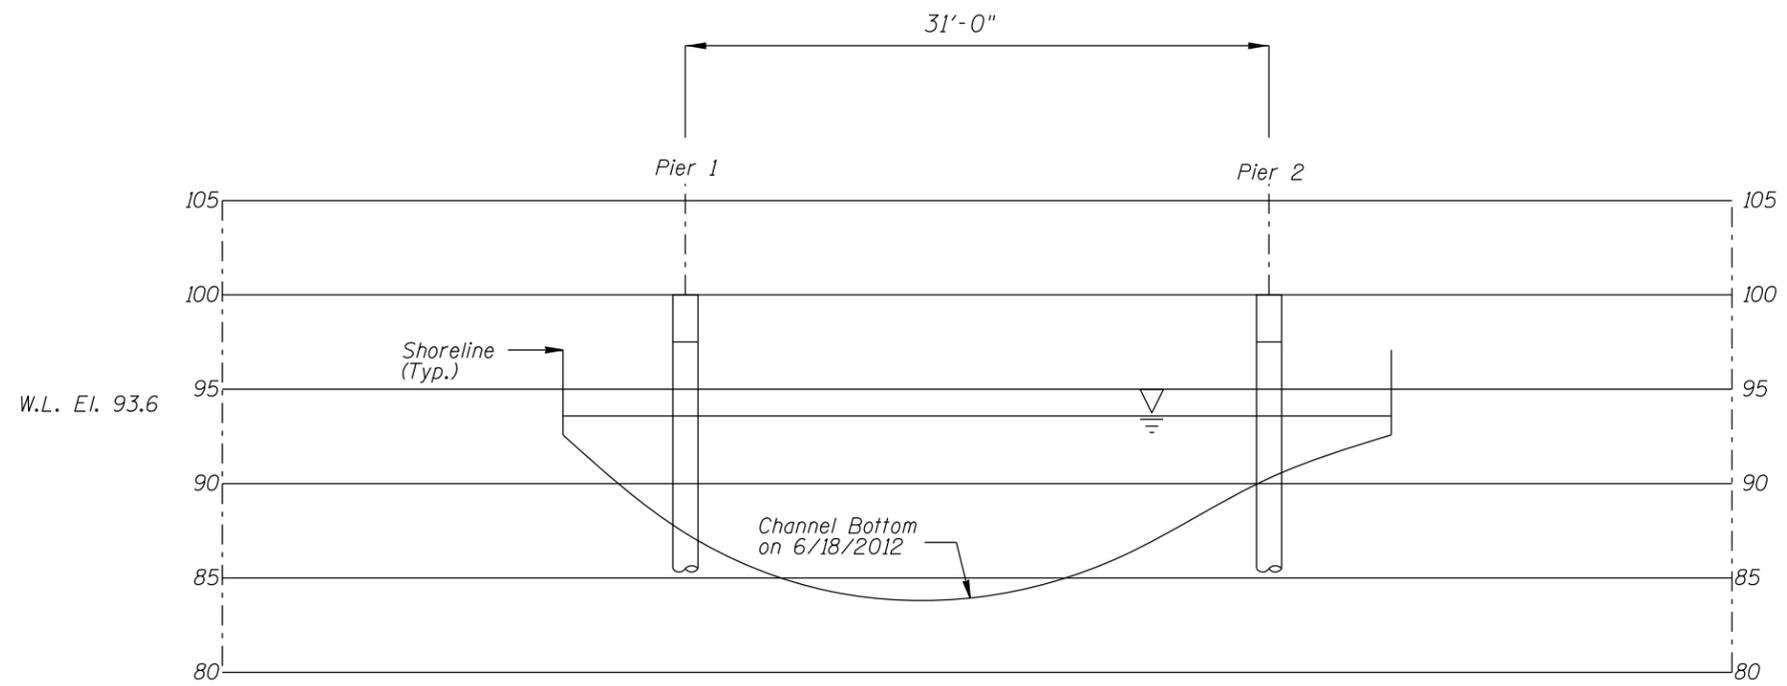
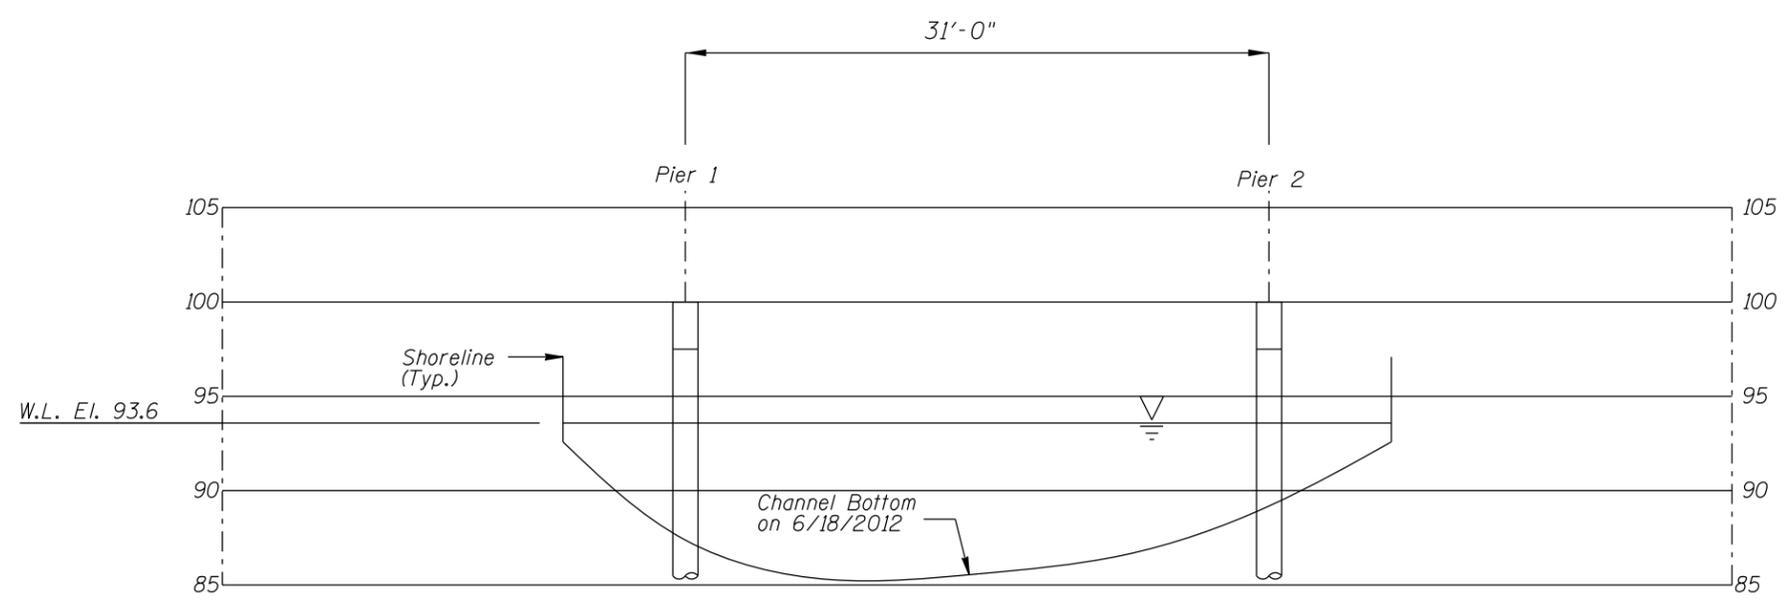
- ① Channel material as well as the shorelines consisted of up to 2 foot diameter riprap.
- ② All piles typically exhibited minor corrosion, consisting of 1/4 inch diameter rust nodules with minimal pitting, extending from 1 to 3 feet below the waterline. Nodular corrosion was present on approximately 20 percent of the surface within the specified location.
- ③ Coating loss was observed on approximately 50 percent of the surface area from 1 foot below the waterline to the channel bottom.
