UNDERWATER BRIDGE INSPECTION REPORT

STRUCTURE NO. 69602

CR 694

CLOQUET RIVER

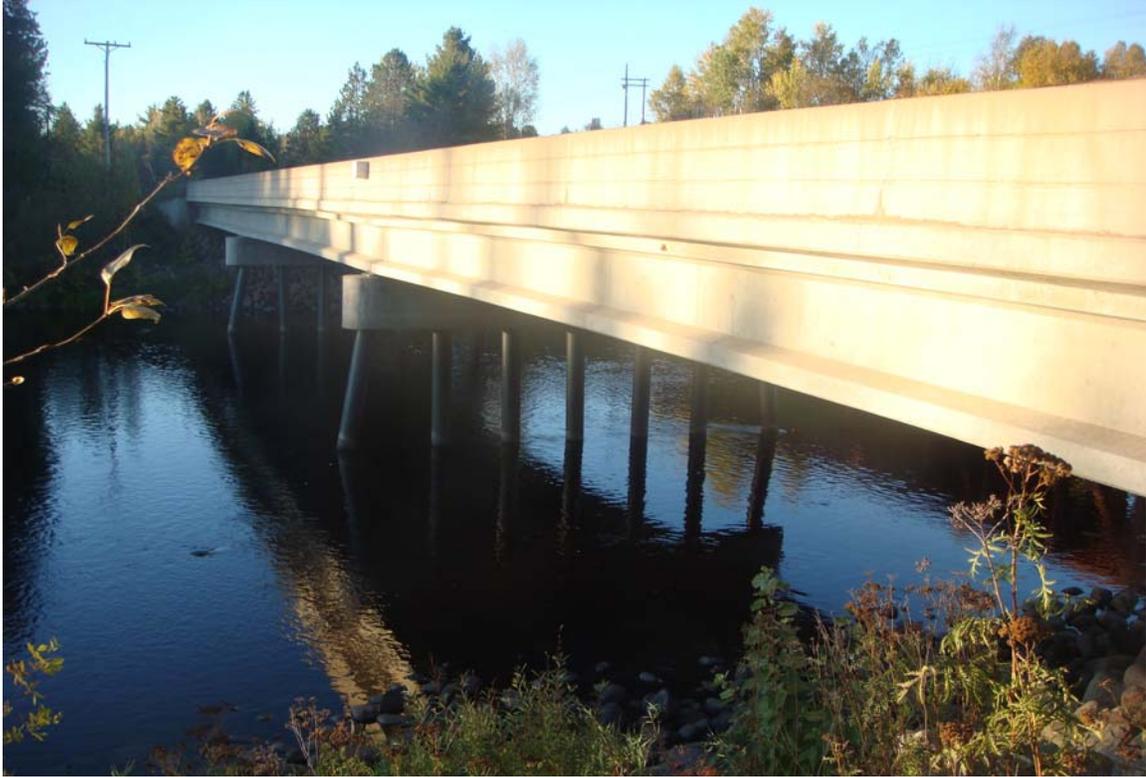
Photograph 1. Overall View of Structure, Looking Northeast

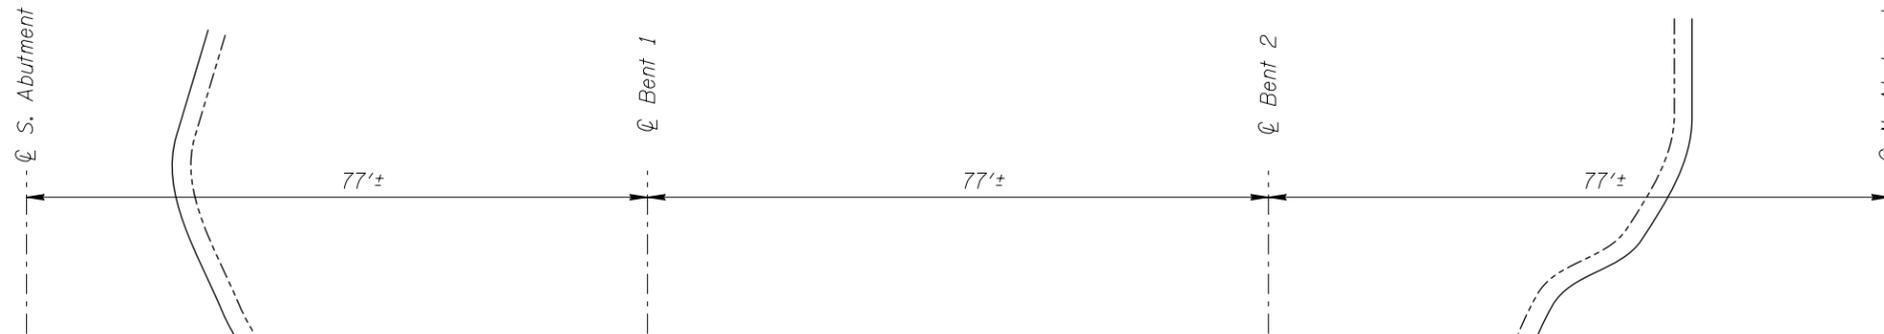
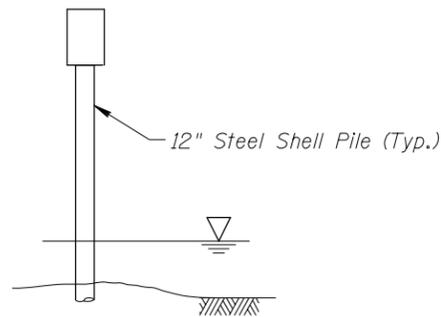
TYPICAL END VIEW OF BENT

- ① The channel bottom material typically consisted of 8 inch diameter and smaller stones and cobbles allowing no probe rod penetration.
- ② The piles of Bents 1 and 2 exhibited coating loss on approximately 90 percent of their surface area extending from the channel bottom to 2 feet above the waterline with light corrosion extending from the waterline to 1 foot above the waterline.
- ③ The piles of Bent 1 exhibited rust nodules, up to 1/4 inch in diameter, covering approximately 20 percent of the pile surface area extending from the channel bottom to 1 foot below the waterline. The nodules typically have negligible pitting of the steel associated with them.
- ④ A light accumulation of 2 inch diameter and smaller timber debris was observed around the upstream three piles of Bent 2.
