UNDERWATER BRIDGE INSPECTION REPORT

STRUCTURE NO. 69623

ST. LOUIS RIVER

JOB NO. 2107

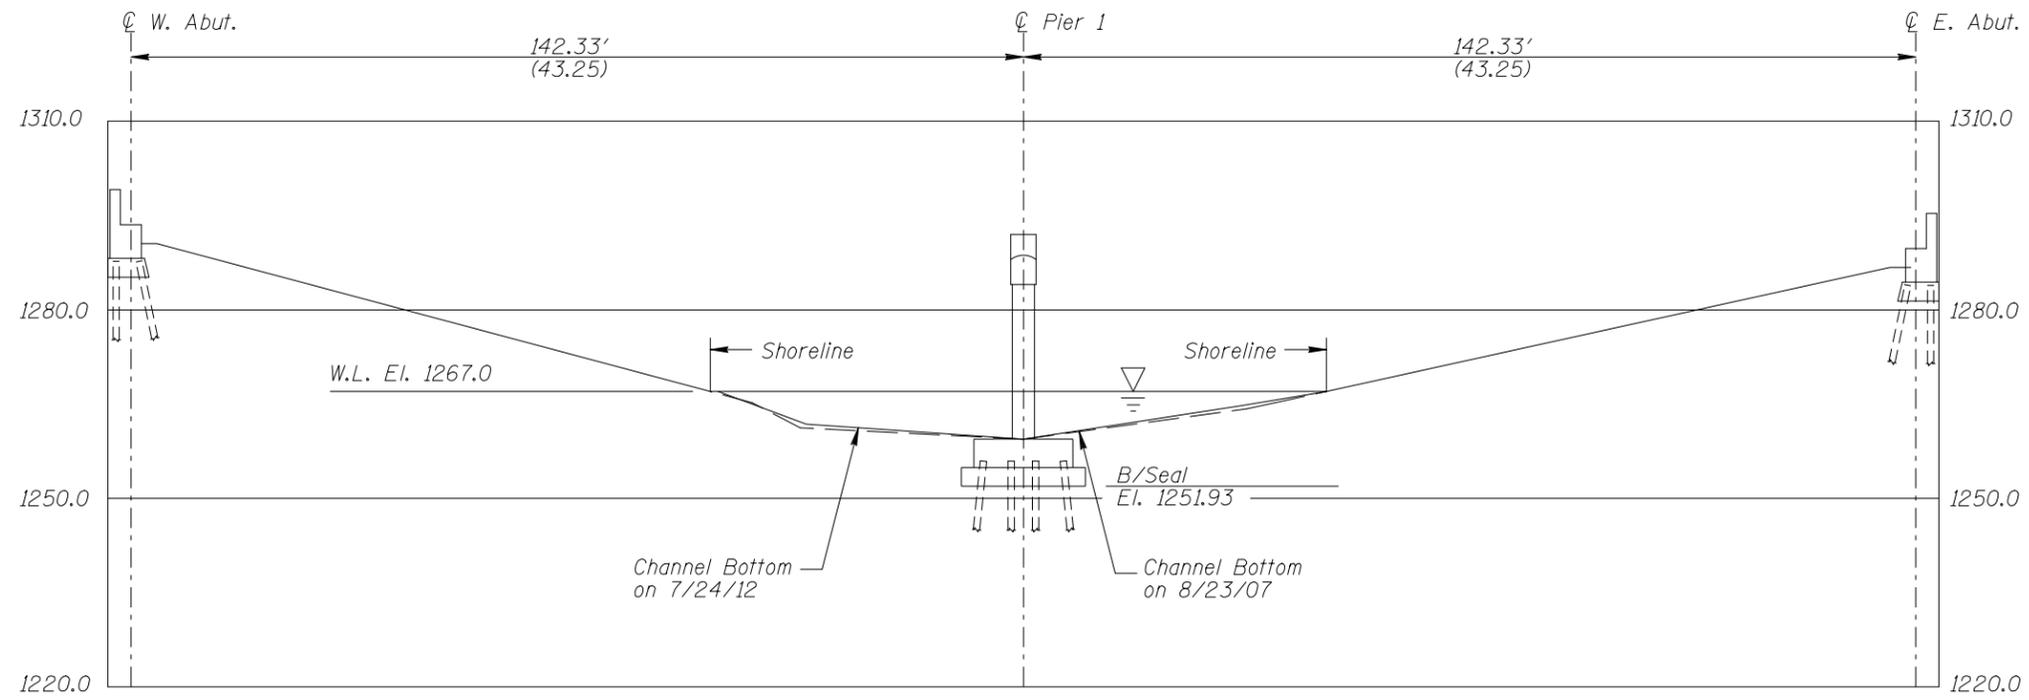
UPSTREAM FASCIA PROFILE

1. The channel bottom consisted of soft silt with 1.5 to 2 feet of probe rod penetration and riprap at the upstream nose of Pier 1.
2. The concrete of Pier 1 was smooth and sound.
3. A heavy accumulation of timber debris consisting of logs and branches up to 12 inch in diameter was observed around the upstream half of Pier 1 extending from the channel bottom to 4 feet above the waterline. The accumulation extended approximately 20 feet off the pier nose and faces.
4. Light scaling was observed around entire pier from 0.5 foot below to 2 feet below the waterline with 1/8 inch maximum penetration.

- (A) Remove the heavy accumulation of timber debris at the upstream nose and along the faces of Pier 1 to alleviate scour influence at the pier and to minimize any further accumulation.
