UNDERWATER BRIDGE INSPECTION REPORT

STRUCTURE NO. 7065

GARDEN LAKE

MINNESOTA DEPARTMENT OF TRANSPORTATION
UNDERWATER BRIDGE INSPECTION

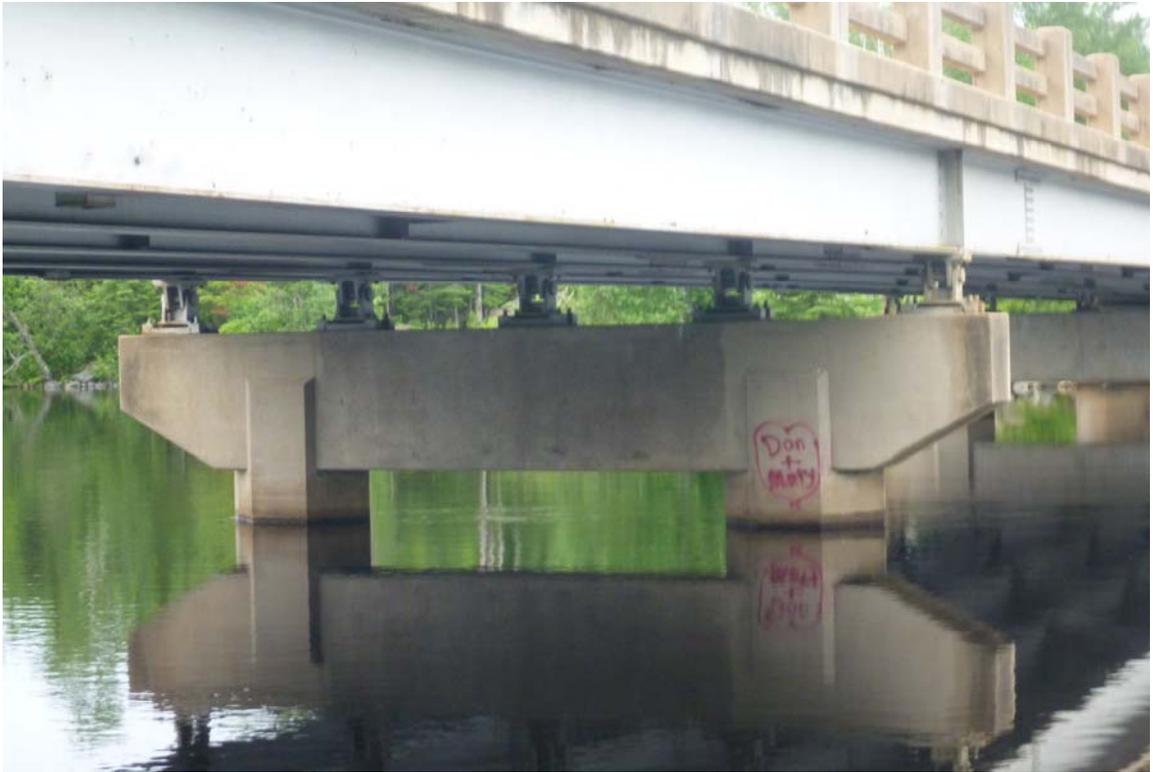
Photograph 5. View of Pier 2, Looking Southwest.

- (G) A heavy concentration of up to 4 foot diameter riprap was observed along the east side of the upstream column of Pier 2. On the west side, there was smaller riprap and a slight 1 foot deep scour depression.
- (H) The channel bottom material consisted of sandy gravel typically allowing 2 inches of probe rod penetration with scattered 1 to 3 foot diameter riprap and 6 inch diameter cobbles.
