UNDERWATER BRIDGE INSPECTION REPORT

STRUCTURE NO. 7183

CSAH 100

ST. LOUIS RIVER

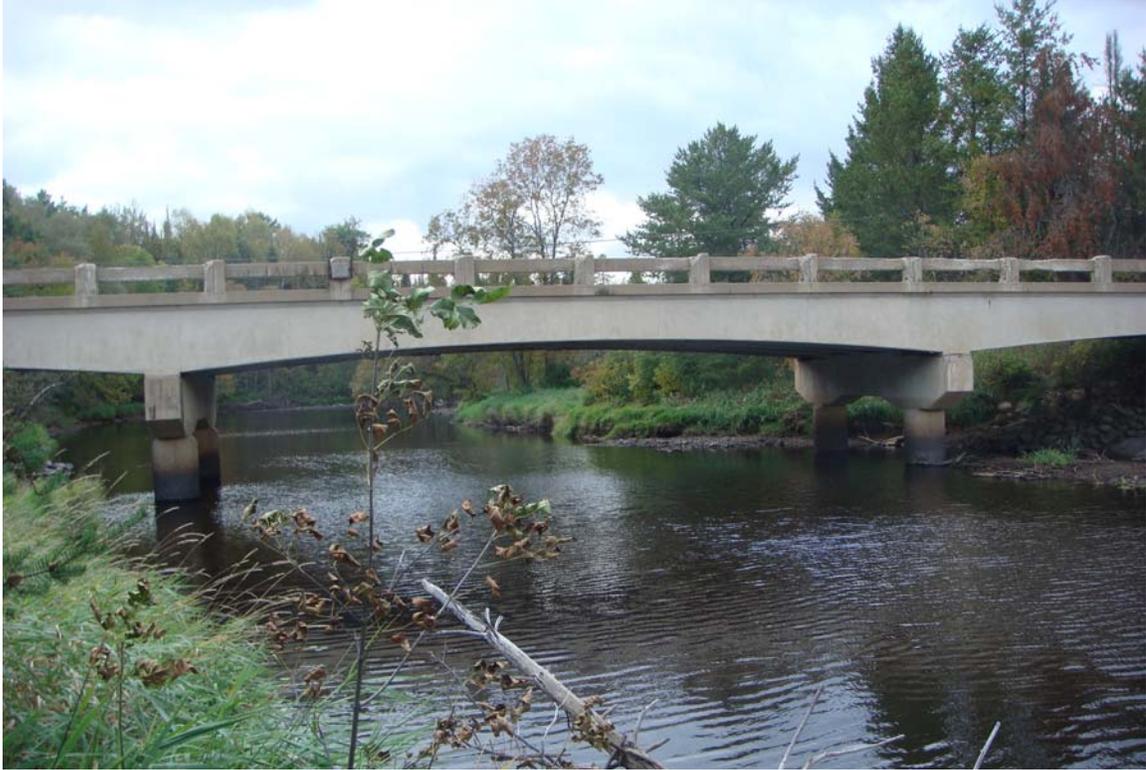
Photograph 1. Overall View of the Structure, Looking West.

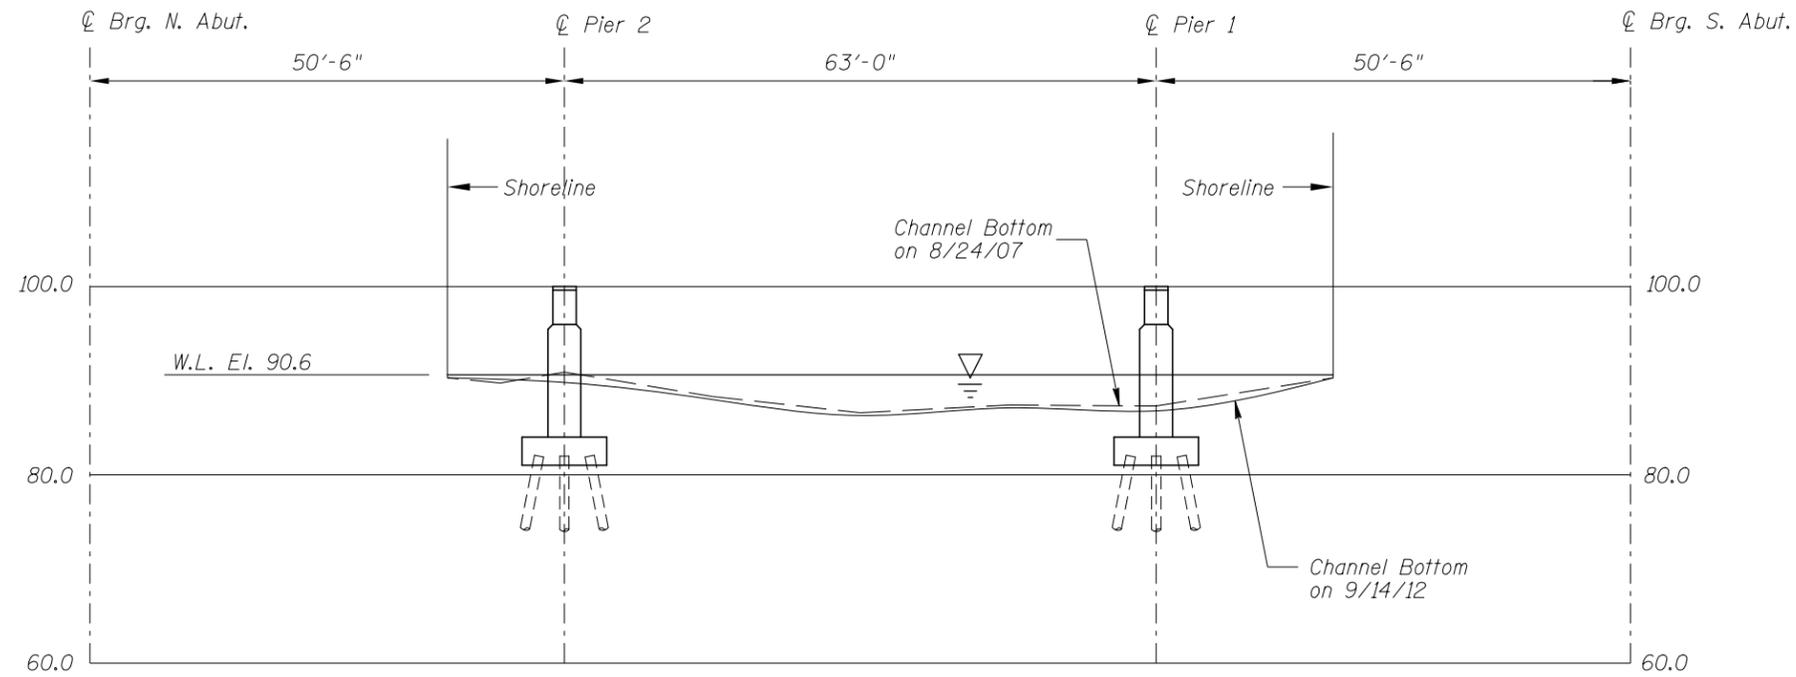
UPSTREAM FASCIA PROFILE

- 2 The channel bottom consisted of soft silt and organic material with typical 1.5 feet of probe rod penetration at the upstream column of Pier 2.
- 3 Moderate scaling with some aggregate exposure from 4 feet above the waterline to 1.5 feet below the waterline with typical penetrations of 1/8 to 1/4 inch and up to 1 inch maximum was observed around all columns of both piers.

- 4 An area of heavy scaling/section loss was observed around the downstream column of Pier 1, 2-foot-high by 2.5-foot-wide at 0.5 feet below to 1.5 feet above the waterline with a maximum penetration of 2.5 inches. The concrete within the heavy scaling was flakey and unsound.

- 5 A scour depression, 5 feet in radius with a depth of 2 feet, was observed at the upstream and downstream column of Pier 2. The accumulation of timber debris was observed within the depression.

- 6 6-to 12-inch-diameter log was observed from the channel bottom to the waterline along Pier 1 as shown.
- 7 A light to moderate accumulation of 6-inch-diameter and smaller timber debris was at the upstream end of Pier 2. Accumulations extended from the channel bottom up 3 feet.
