UNDERWATER BRIDGE INSPECTION REPORT

STRUCTURE NO. 7685

CSAH 24

HAWKINSON CREEK

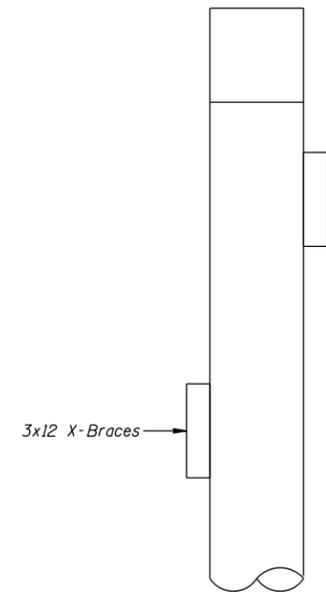
INSPECTION AND SOUNDING PLAN

- 1 The channel bottom material consisted of sandy silt typically allowing 6 inches of probe rod penetration.
- 2 All the timber piles were in good condition with only minor checking. There was no notable loss of section or indications of decay. The timber typically allowed a awl penetration of 1/8 inch.
- 3 Only half of the pile cap was bearing on Piles C, D, and E of the West Abutment. The pile cap was not properly seated on Piles C, D, and E of the West Abutment.
- 4 A split 5 feet long by 1 inch wide was observed on the cross-brace at Pile A of Bent 1. Due to the split, the Pile A to cross-brace connection was compromised.
- 5 A light accumulation of branchy debris and soft silty infill was observed on the west side along the downstream half of Bent 1. The channel bottom depth in this area ranged from 1 to 2 feet deep.
