UNDERWATER BRIDGE INSPECTION REPORT

STRUCTURE NO. 7773

CSAH 116

PICKET RIVER

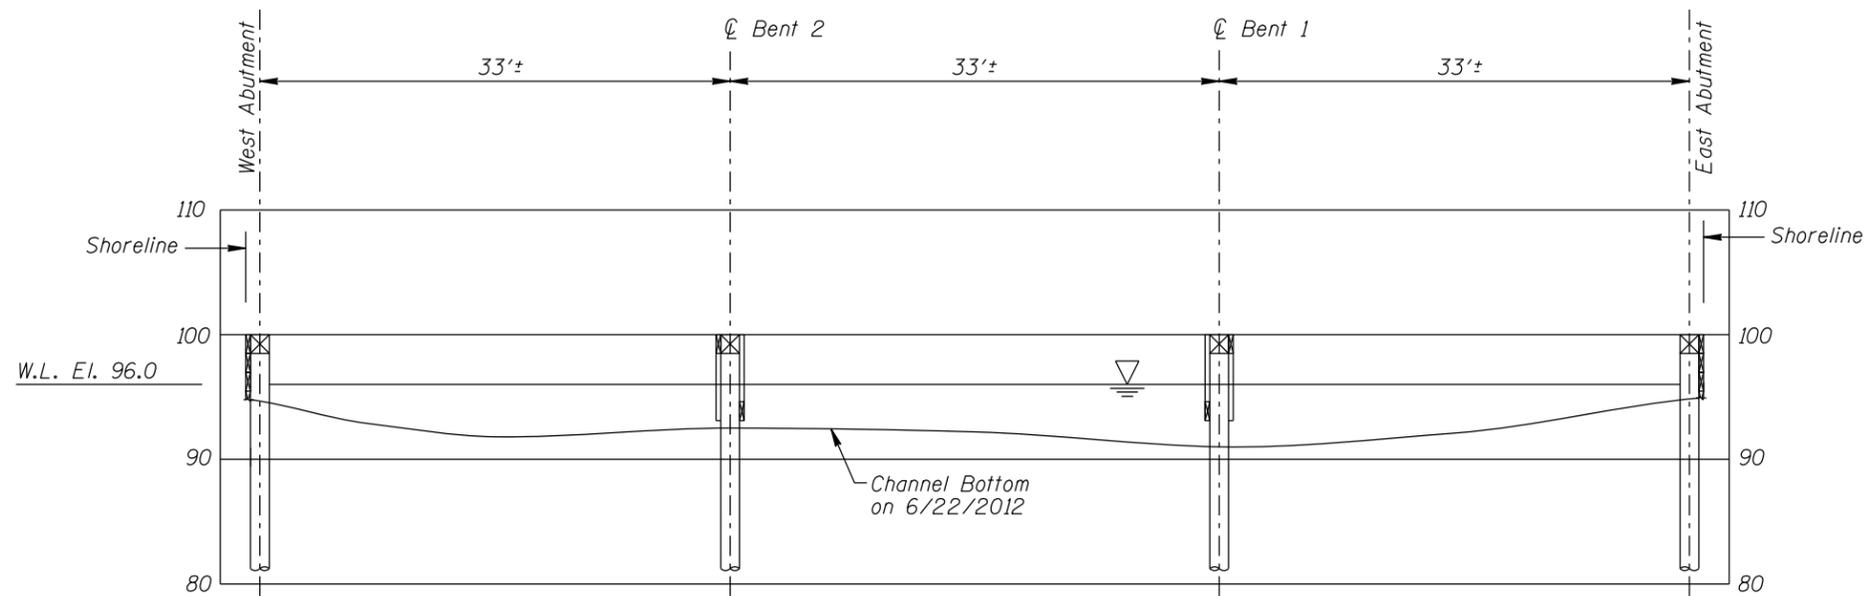
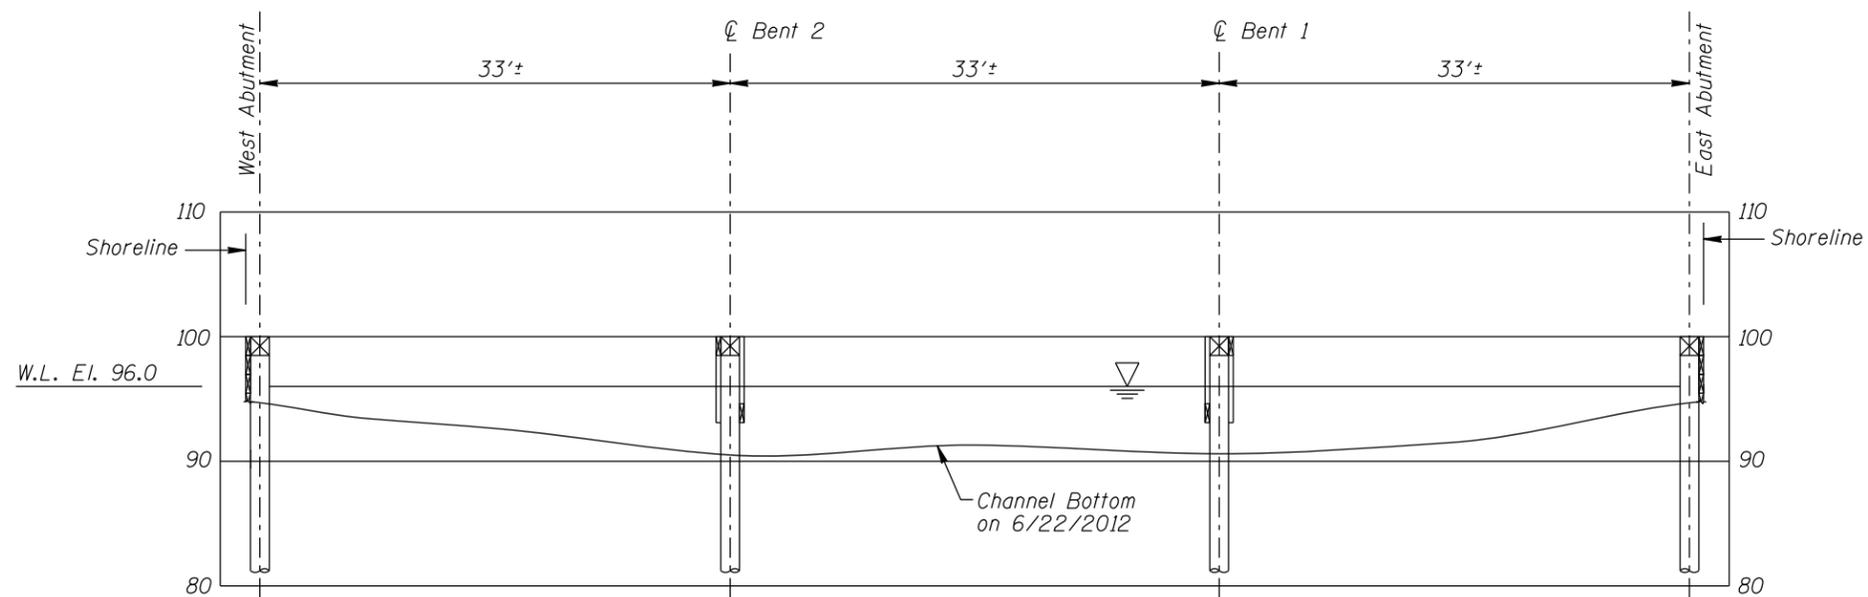
- 4 The timber pile cap at the East Abutment was bearing on shims at the top of Piles A, B, C, E, and F.
- 5 A timber cross-brace was missing on the west side of Piles D through F of Bent 1.

- 6 The timber cross-bracing on the east side of Piles C and D of Bent 1 exhibited heavy deterioration and splitting with up to 100 percent section loss.

- 7 A split in the cross-brace, measuring up to 4 inches wide, was observed on the west side of Bent 1 extending from Pile D to Pile A. The cross-brace to pile connection at Pile D was compromised.

- 8 A split in the cross-brace, measuring up to 2 inches wide, was observed on the west side of Bent 2 extending from Pile C to Pile E. The cross-brace to pile connection at Pile D was compromised.

- 9 A light accumulation of timber debris, consisting of 2 inch diameter and smaller branches, was observed around Pile A of Bent 1.

Repair or replace the deficient timber cross-bracing including all the bracing at Bent 1.
