UNDERWATER BRIDGE INSPECTION REPORT

STRUCTURE NO. 7787

CSAH 6

DUTCH SLOUGH

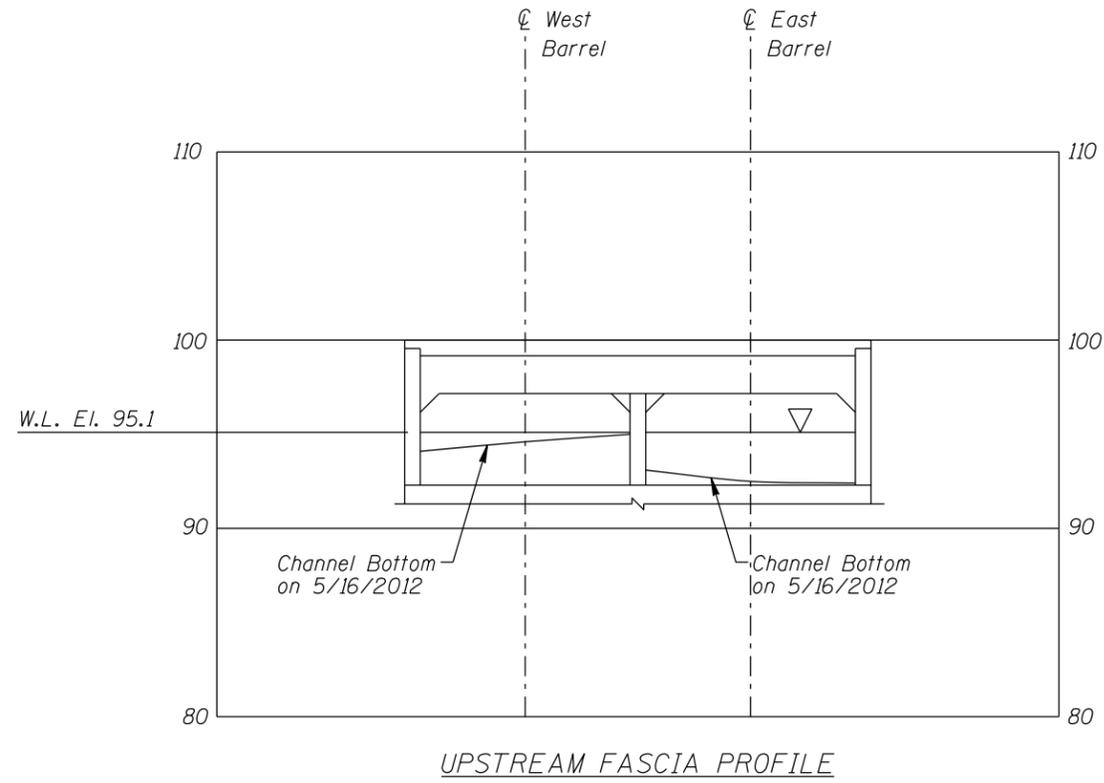
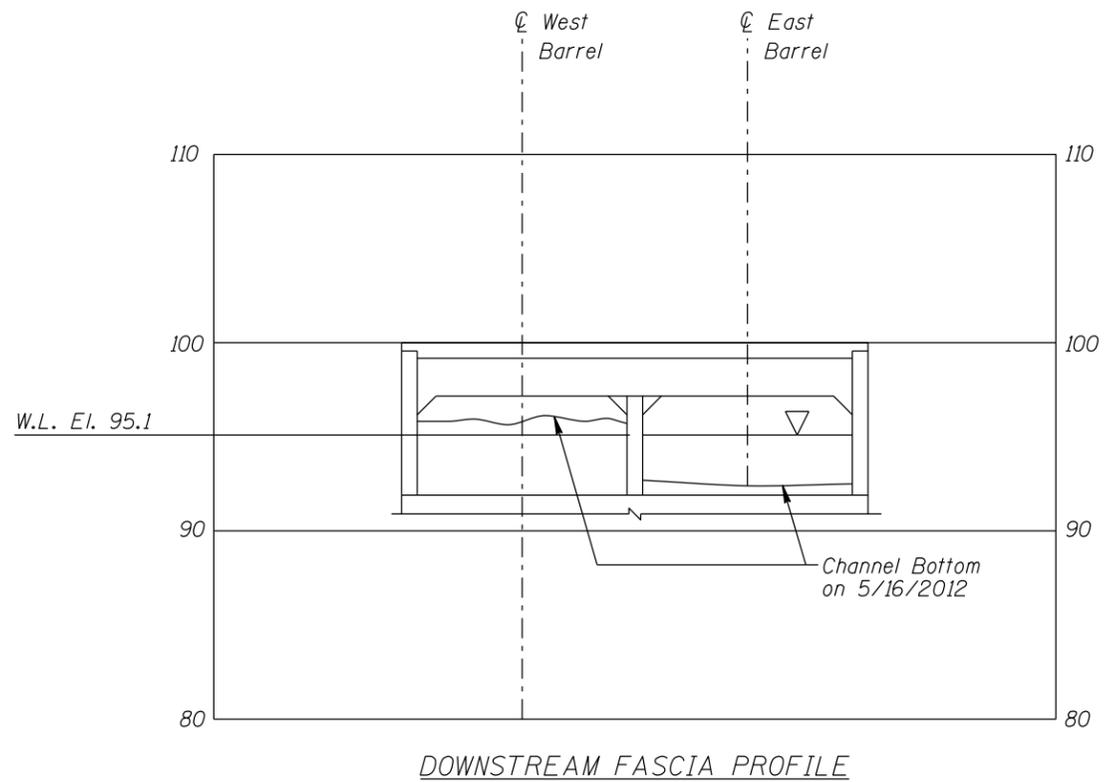
- 1 Channel bottom material consisted of gravel and riprap up to 8 inches in diameter.
- 2 Two areas of minor concrete section loss located at the upstream end of the northeast wingwall measured 8 inches in diameter with 2 inches of penetration. No exposed reinforcing steel was observed.

- 3 Spall with exposed reinforcing steel located on the entire length of the west wall of the East barrel from the upstream to the downstream fascia extended from 1 foot below to 6 inches above the waterline with up to 3 inches of penetration. Exposed reinforcing steel exhibited 10 percent loss of section.

The spalls and associated concrete section loss are not structural concerns at this time; however, they should be repaired to prevent further deterioration. The repairs should include removal of concrete to a minimum of 1 inch behind the reinforcing steel, cleaning and replacing reinforcing steel as required, and placing concrete designed to provide high durability with low permeability.
