UNDERWATER BRIDGE INSPECTION REPORT

STRUCTURE NO. 7877

COUNTY ROAD 367

PIKE RIVER

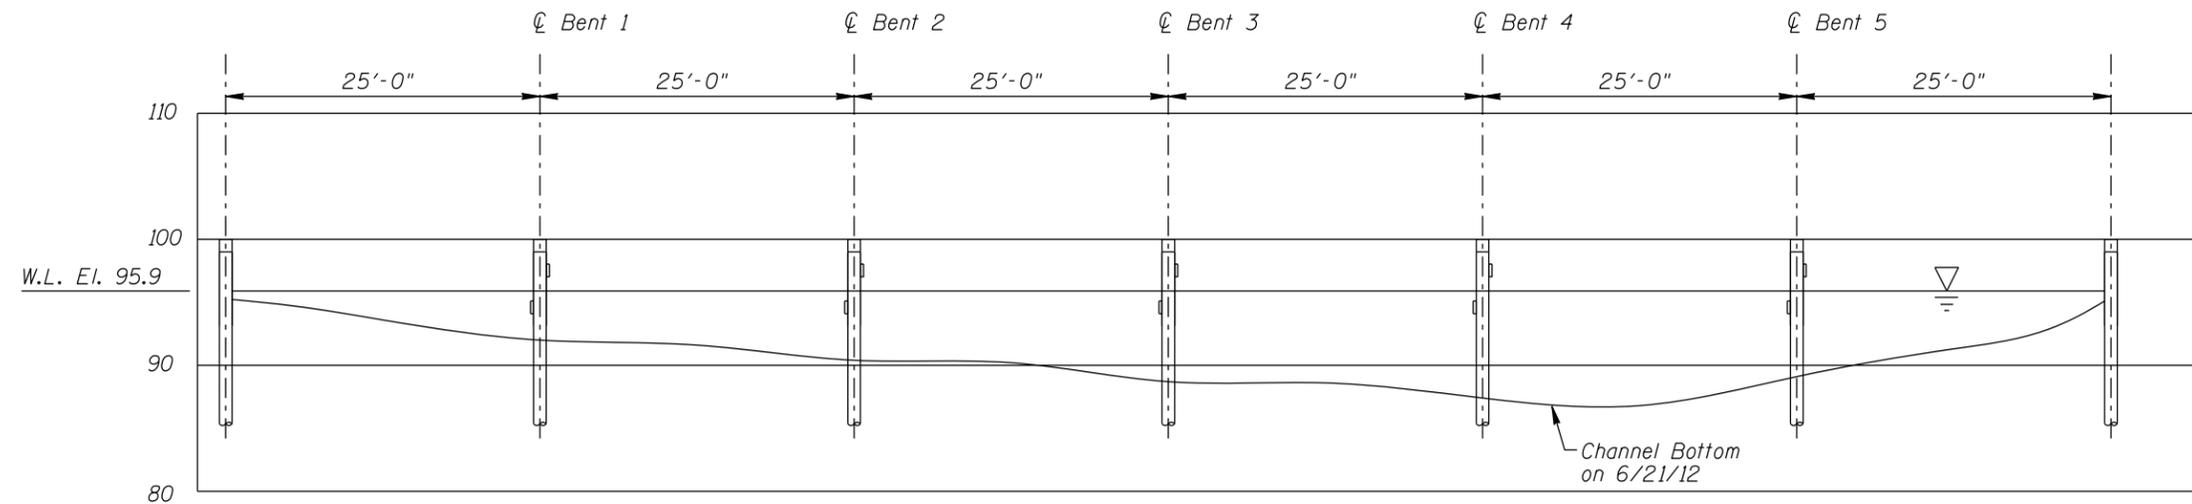
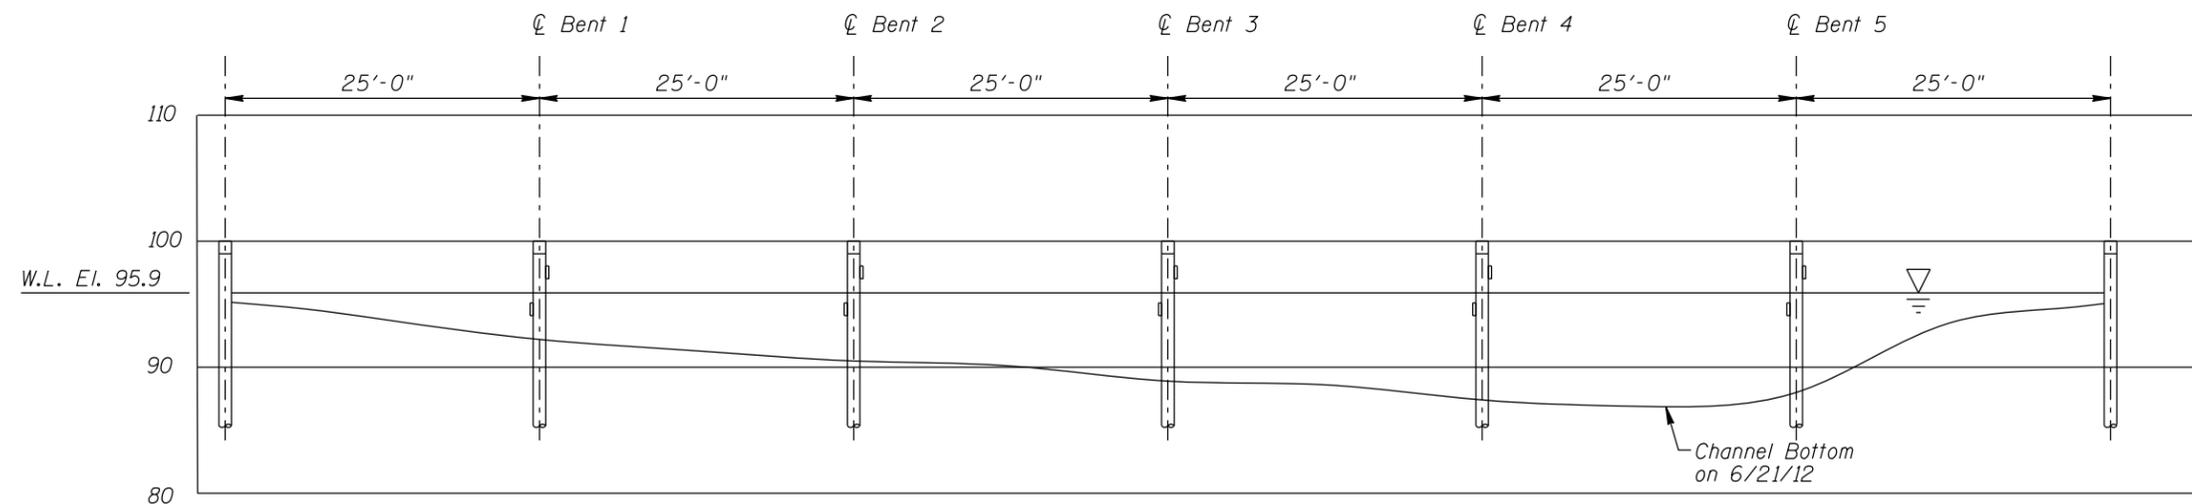
INSPECTION NOTES

- 2 All timber piles were generally firm and sound with no indication of decay or soft areas. The timber typically allowed awl penetrations of 1/8 inch or less.

- 5 A splice-in-pile repair of the upper pile portion was observed on several piles. The piles which were repaired are Piles C and E of Bent 1, Piles B, C, and E of Bent 2, Piles B and E of Bent 3, Piles A, D, and E of Bent 4, and Piles A, C and D of Bent 5. All spliced sections were generally in good condition with minor checking or splitting with the exception of a \*inch wide split observed on the east face of the spliced section at Pile C of Bent 2.
