UNDERWATER BRIDGE INSPECTION REPORT

STRUCTURE NO. 88798

CR 600

FLINT CREEK

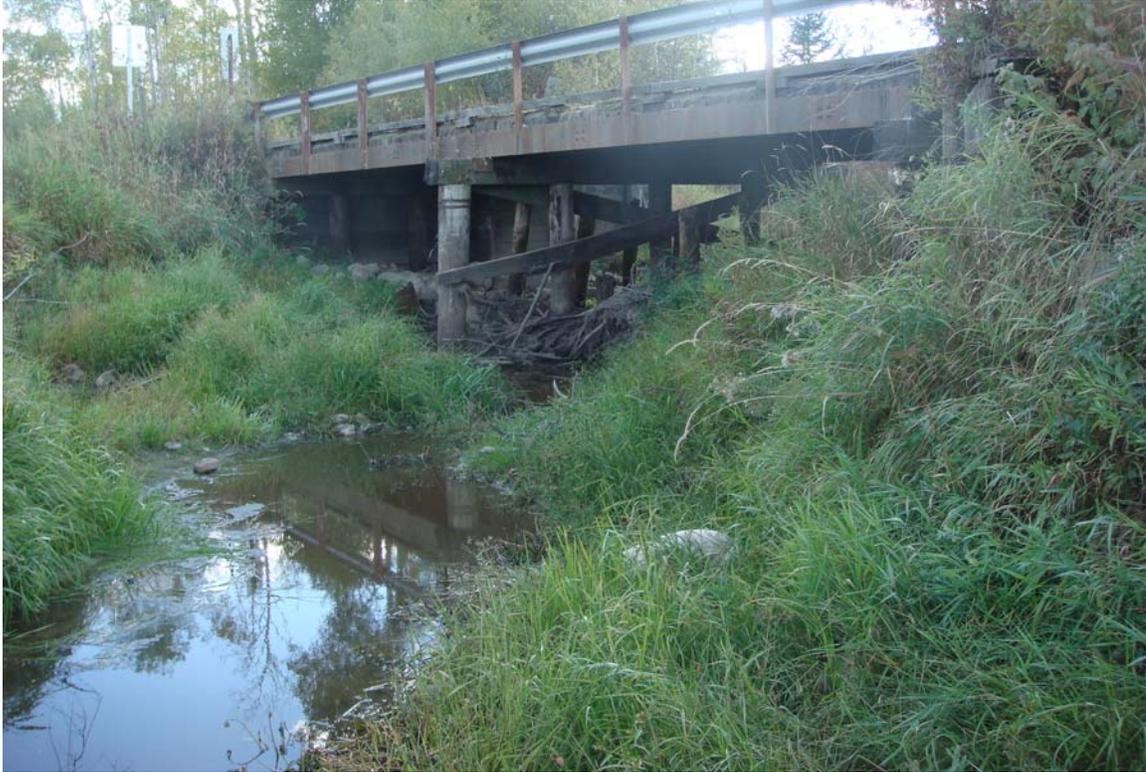
Photograph 1. Overall View of Structure, Looking Southeast.

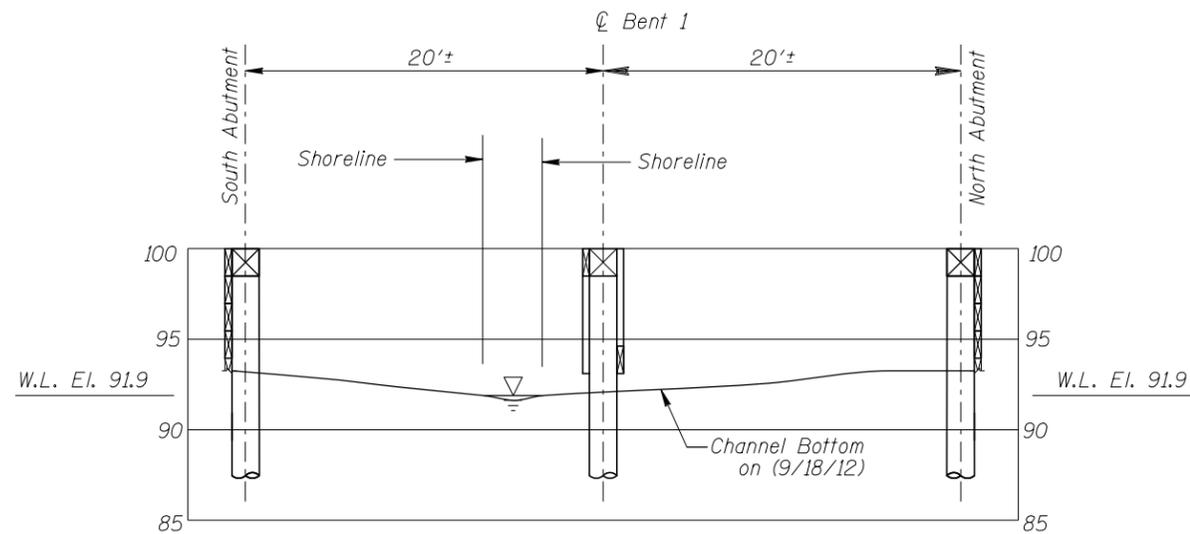
DOWNSTREAM FASCIA PROFILE

- 2 The timber piles were generally sound with random splitting or checking that was typically 1/4 inch wide and 1 inch deep.
- 3 The north cross-brace at Bent 1 was broken just east of Pile D. The brace was not connected to Pile E.

- 5 A heavy accumulation of timber debris, consisting of logs and branches up to 3 inches in diameter, was observed between Bent 1 and the North Abutment extending from the channel bottom to 5 feet above the waterline.

- 6 Random abandoned 12 inch diameter timber piles were observed in the channel.

- (A) The timber debris accumulation between Bent 1 and the North Abutment did not significantly affect the channel flow, and as a result, does not require removal at this time. If the debris accumulation increases in size or density, it may be necessary to remove the debris to reduce excessive lateral loads on the structure, limit further debris accumulation, and reduce the likelihood of channel bottom degradation resulting from obstructed channel flow.
