UNDERWATER BRIDGE INSPECTION REPORT

STRUCTURE NO. 92628

COOLIDGE CREEK

MINNESOTA DEPARTMENT OF TRANSPORTATION
UNDERWATER BRIDGE INSPECTION

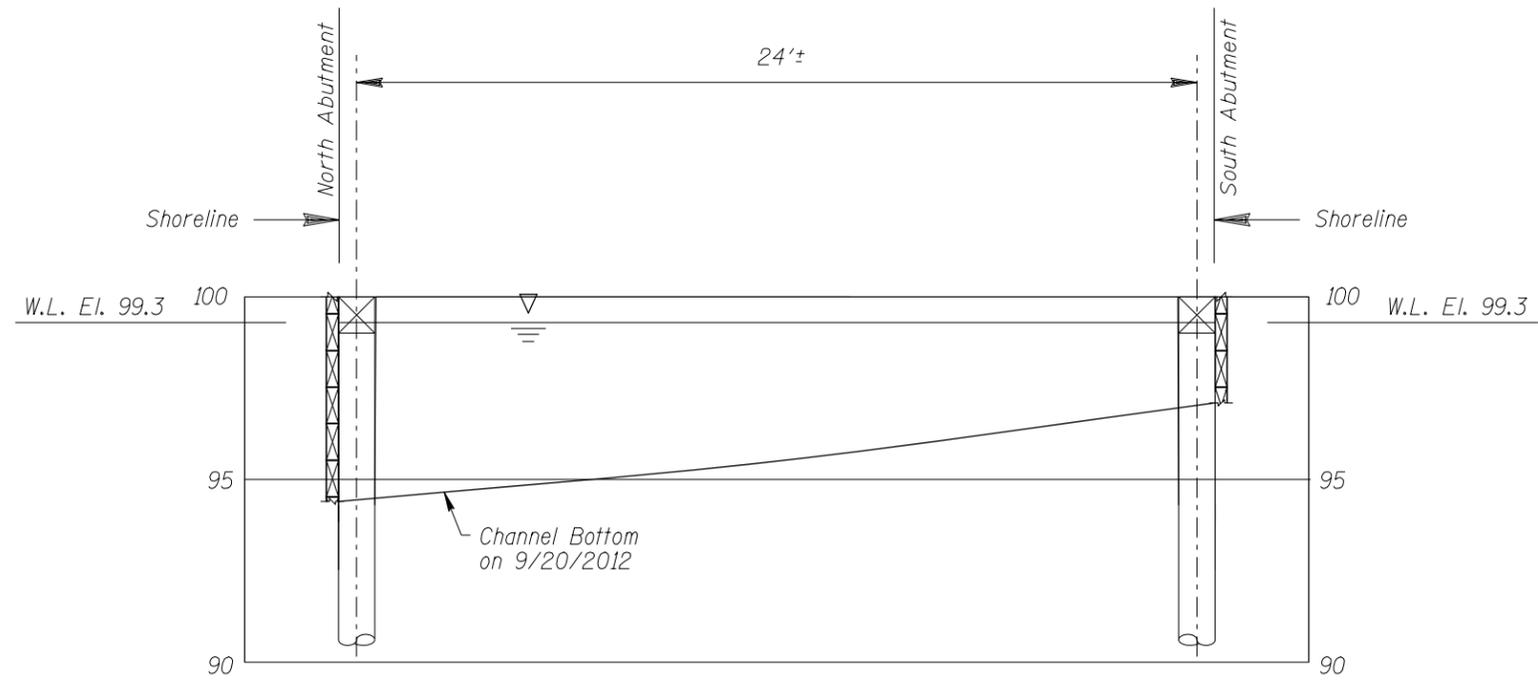
DOWNSTREAM FASCIA PROFILE

- 3 A split through the full height of the North and South Abutment pile cap was observed running the entire length of the cap. The split was typically 1/8 inch wide and up to 1 inch wide at the last 5 feet of the upstream and downstream ends. Both pile caps exhibited a minor rotation (less than 3°) as a result of the split.

- 4 The timber backwall was typically sound and tight with no noticeable loss of backfill or defects of structural significance.
- 5 A moderate accumulation of timber debris was observed at the South Abutment consisting of 4 inch diameter and smaller branches extending from the channel bottom to the deck underside and up to 10 feet off the face of the South Abutment.

The timber debris accumulation at the South Abutment did not appear to significantly affect the channel flow, and as a result, does not require removal at this time. If the debris accumulation increases in size or density, it may be necessary to remove the debris to reduce excessive lateral loads on the abutment, limit further debris accumulation, and reduce the likelihood of channel bottom degradation resulting from obstructed flow.

Monitor the split in the North and South Abutment pile caps. If noticeable settlement or rotation is found to be developing, consideration should be given to repairing or replacing the timber pile caps.
