UNDERWATER BRIDGE INSPECTION REPORT

STRUCTURE NO. 92698

CR 769

WILLOW RIVER

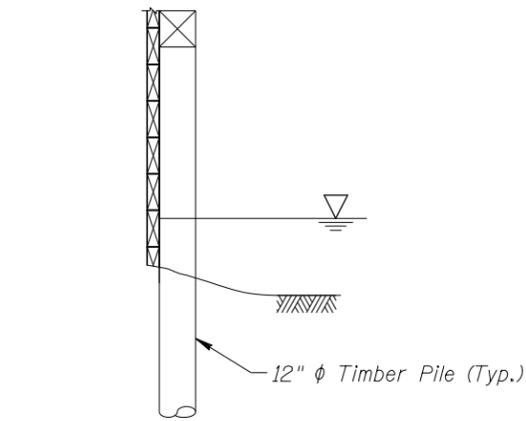
TYPICAL END VIEW OF ABUTMENTS

- ⑤ The metal straps holding the tin flashing in place on top of the piles have come loose. The flashing, however, is still all in place and still effectively protecting the tops of the piles.
