UNDERWATER BRIDGE INSPECTION REPORT

STRUCTURE NO. 93278

CSAH 52

PICNIC CREEK

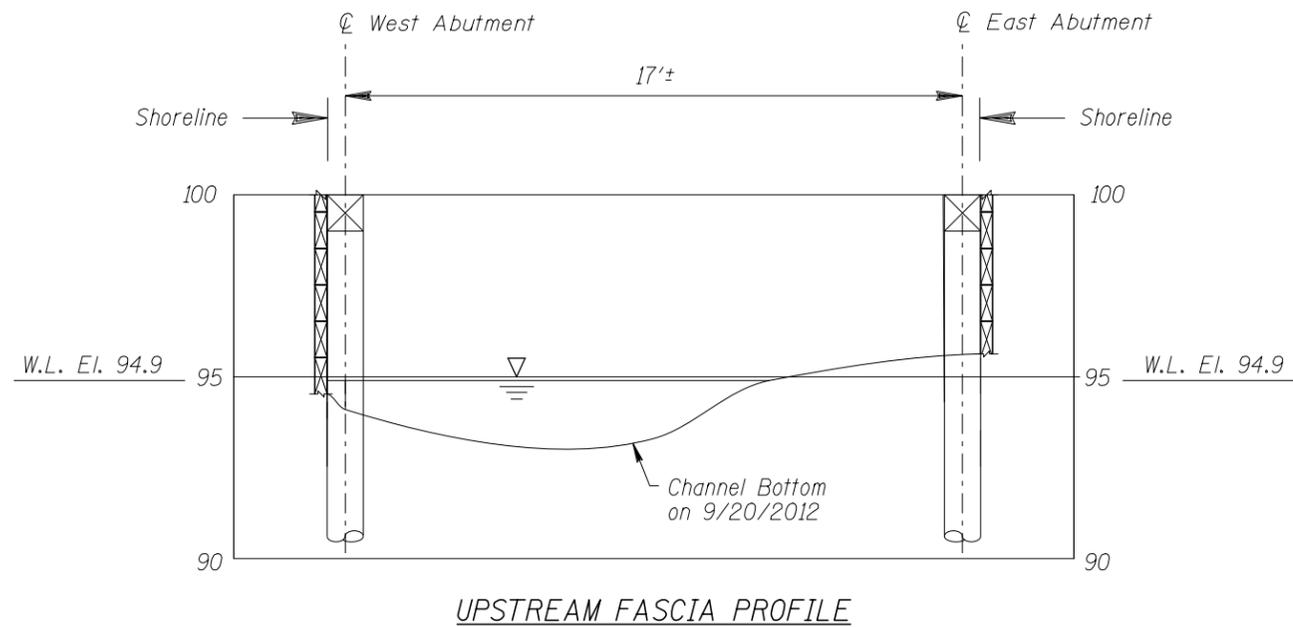
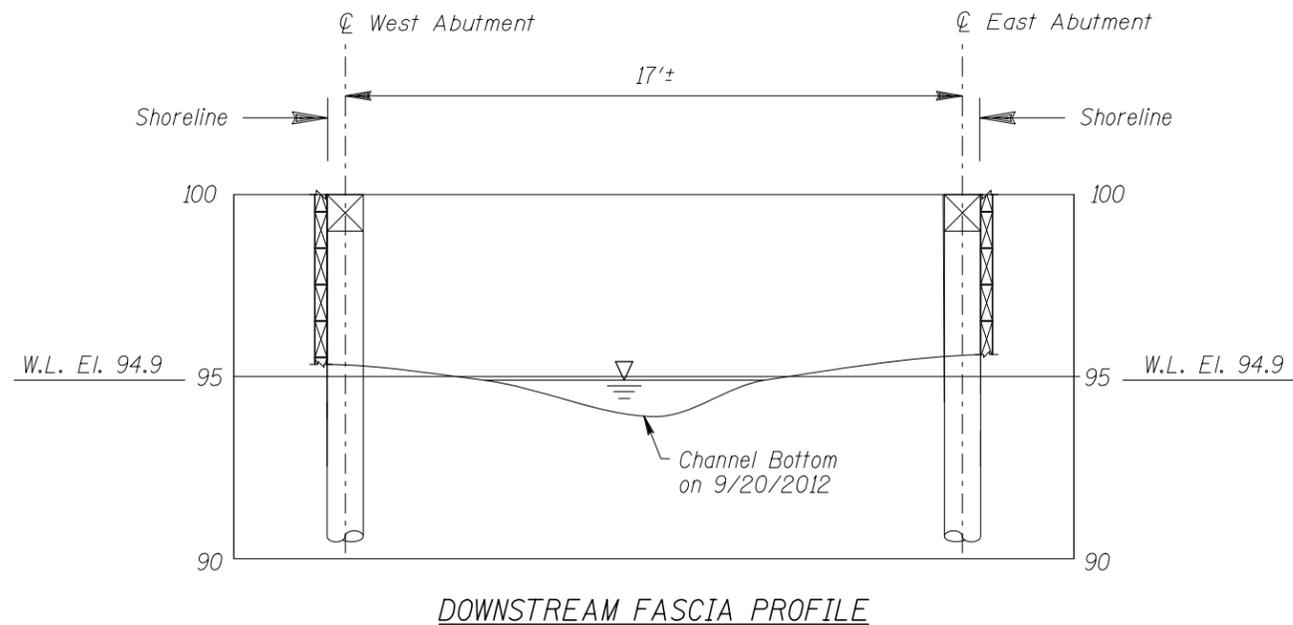
- 1 The channel bottom material typically consisted of rocks and stones up to 6 inches in diameter and silt infill with a maximum probe rod penetration of 6 inches.
- 2 The timber piles were typically sound with random splitting or checking up to $\frac{1}{8}$ inch wide and 1 inch deep.
- 3 The backwall boards were typically sound with random gaps between the boards up to 2 inches wide. No appreciable loss of backfill was observed.
- 4 A moderate accumulation of timber debris, consisting of 2 inch diameter and smaller branches, was observed across the downstream fascia and extending from the channel bottom to 1 foot above the waterline.
