UNDERWATER BRIDGE INSPECTION REPORT

STRUCTURE NO. 93280
CR NO. 119
OVER THE
EAST BRANCH OF THE RAT ROOT RIVER
DISTRICT 1 - KOOCHICHING COUNTY

AUGUST 13, 2012
PREPARED FOR THE
MINNESOTA DEPARTMENT OF TRANSPORTATION
BY
COLLINS ENGINEERS, INC.
JOB NO. 7423

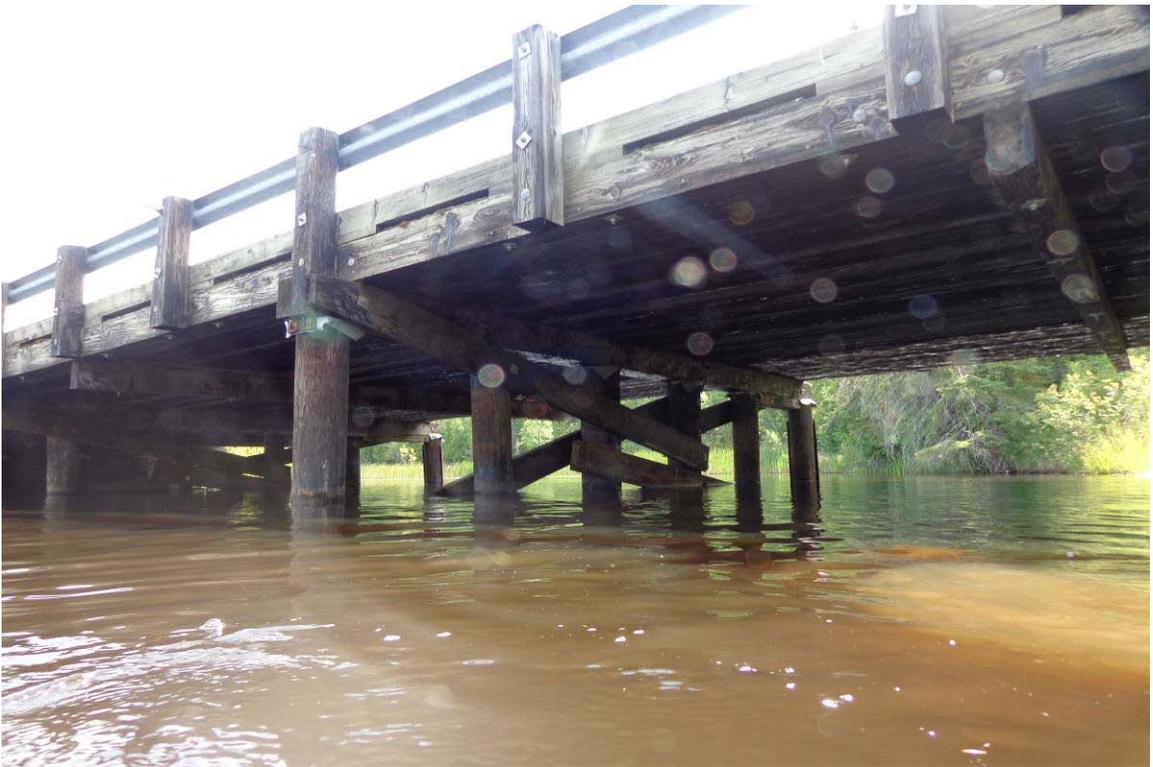
Photograph 2. View of Pier 1, Looking Southeast.

- (C) The east diagonal brace at Pier 1 exhibited a full depth split from Pile 2 extending 3 feet to the north, located 2 inches from the top face.
- (D) Curved steel ice-breaker plates from just below the pile caps down to approximately 1 foot below the waterline were attached to the south face of Pile 6 at Piers 1 and 2.

- (A) The diagonal timber cross braces that are split and/or deteriorated through the fasteners at Piers 1 and 2 should be replaced during routine maintenance.

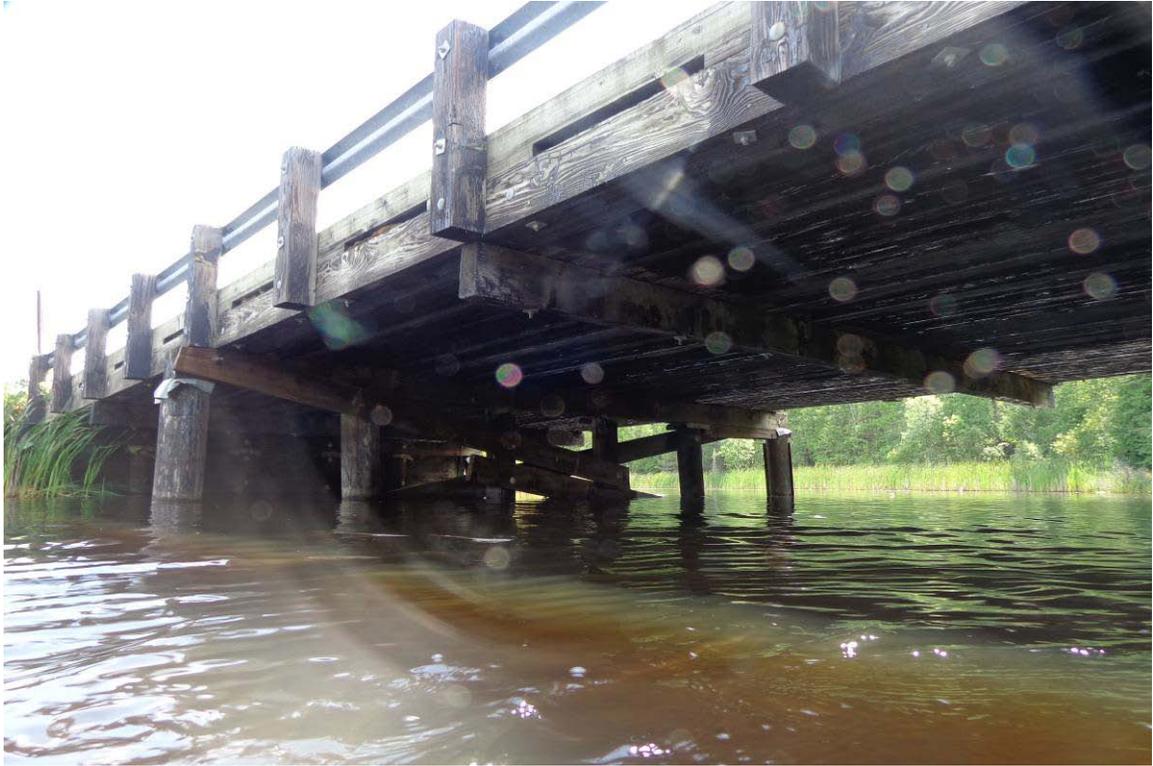
Photograph 3. View of Pier 2, Looking Southeast.

- (E) The east diagonal brace of Pier 2 exhibited a full depth split from Pile 1 to Pile 4, located 2 inches to 6 inches from the top face.
- (F) The pile cap of the West Abutment was slightly rotated back with 75 percent typical bearing on the piles.

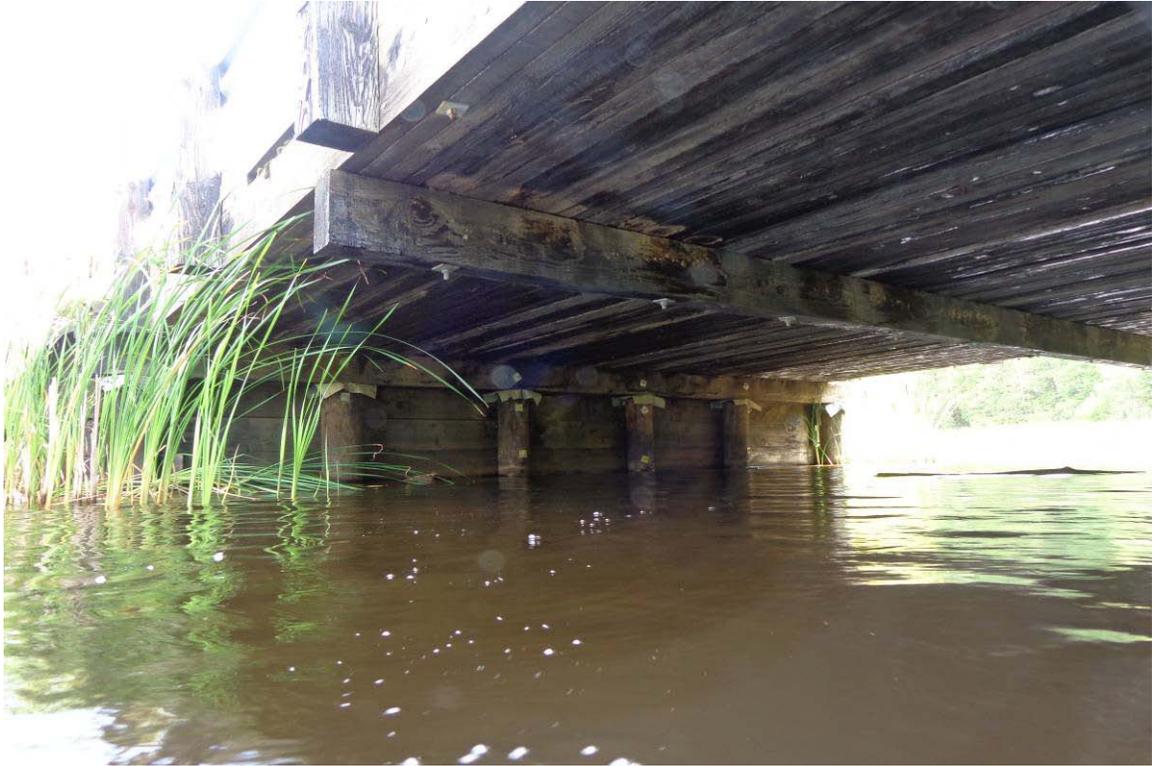
Photograph 5. View of East Abutment, Looking Southeast.

- (H) A large vertical split approximately 2 feet high by 1/4 inch wide, with 1 inch penetration located at top of Pile 1 of the East Abutment.
- (I) Light accumulation of timber debris at Piles 2 through 5 of Pier 2, with up to 6 inch diameter pieces, typically extending from the channel bottom to the waterline.
- (J) Escaping fill was observed at 1 inch gap in horizontal planking of the West Abutment, 4 feet above mudline, with 3 inches maximum penetration.
- (K) Escaping fill was observed at 1 inch gap in horizontal planking of the West Abutment, 3 feet above mudline, with 3 inches maximum penetration.

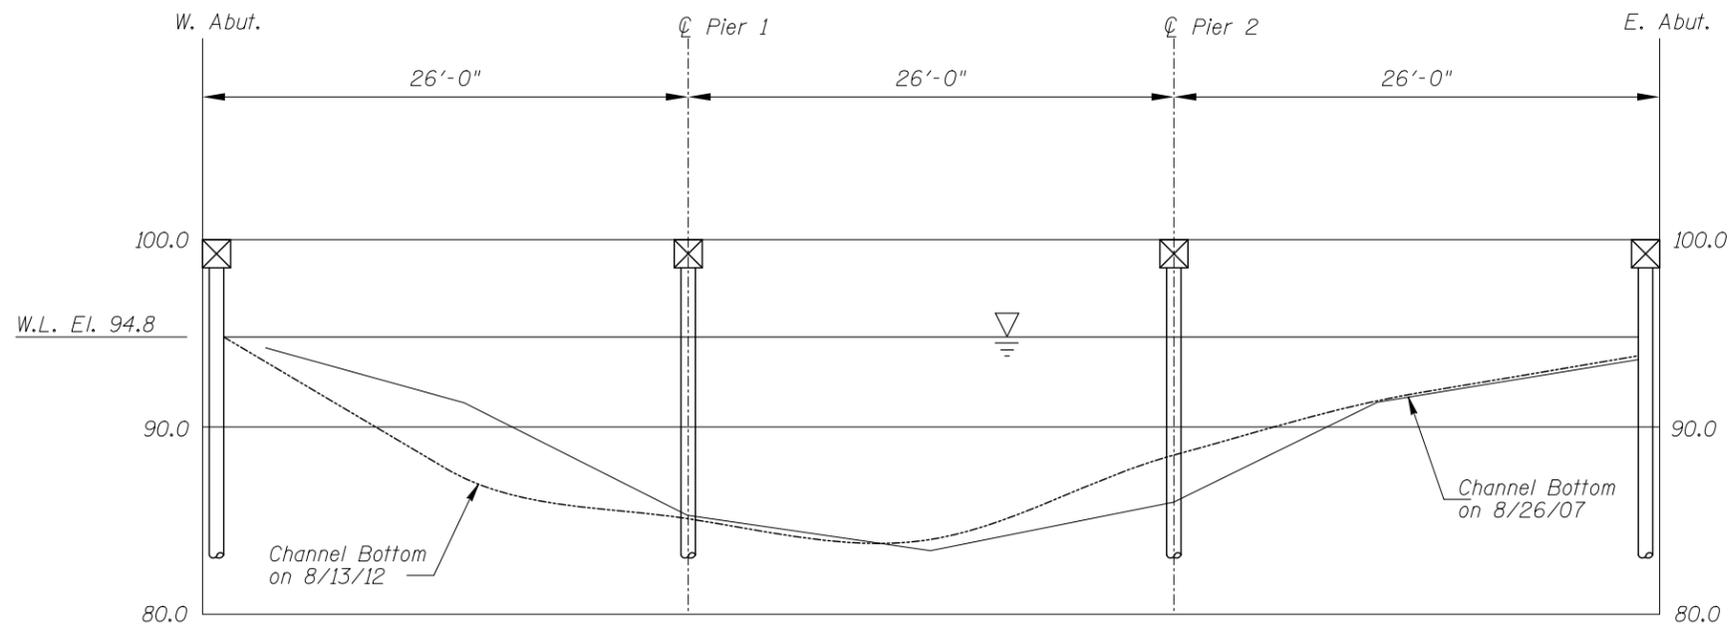
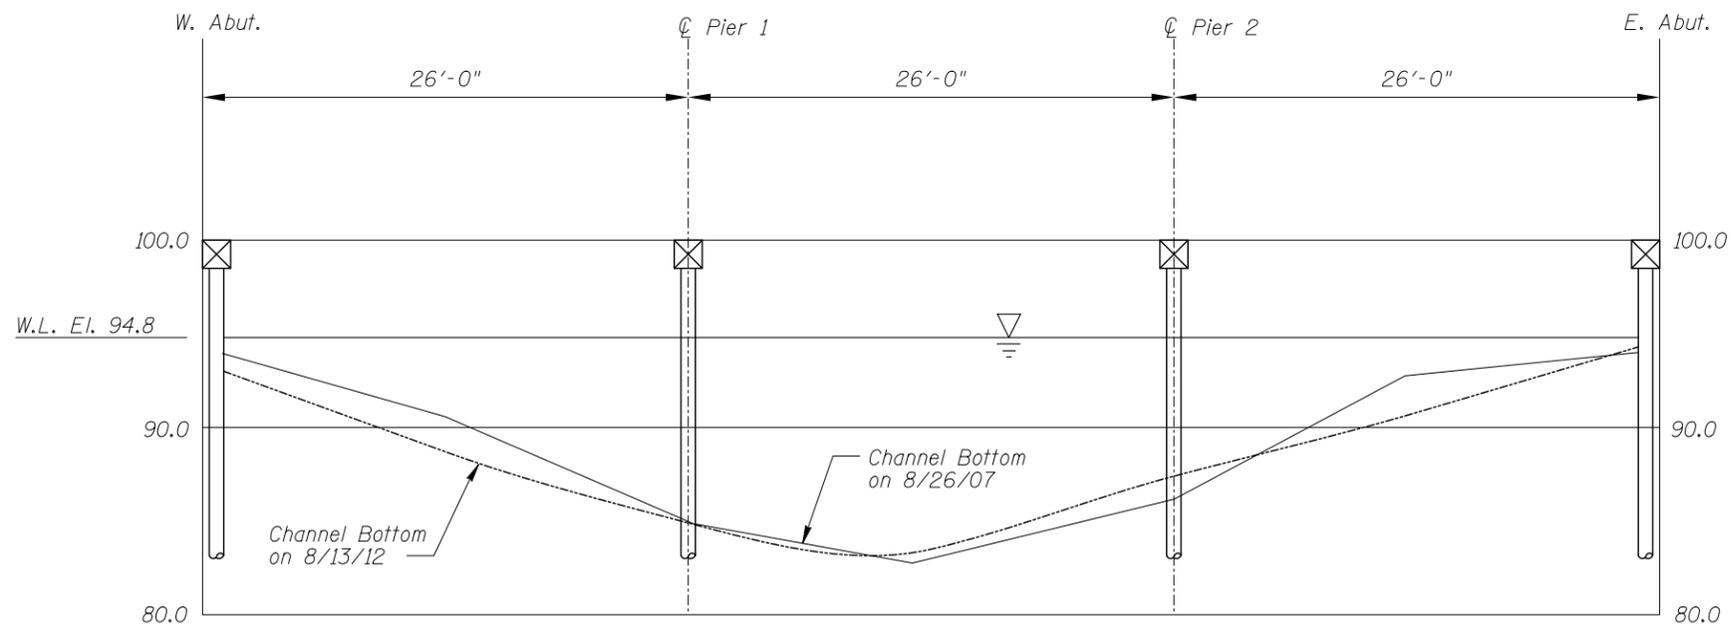
UPSTREAM FASCIA PROFILE
Vertical Scale: 1"=10'-0"

DOWNSTREAM FASCIA PROFILE
Vertical Scale: 1"=10'-0"
