# UNDERWATER BRIDGE INSPECTION REPORT

STRUCTURE NO. 93373

CSAH 52

WHITEFACE RIVER

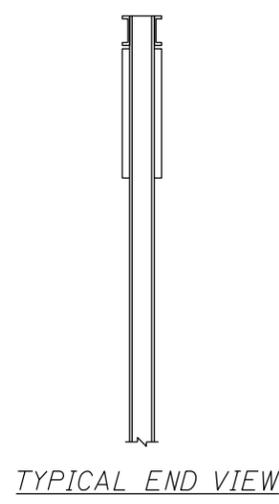
- ② The steel H-Piles of Bents 1 and 2 typically exhibited 100 percent loss of coating from 1 to 2 feet above the waterline to the channel bottom. The piles exhibited pitting, up to 1/16 inch deep, and random rust nodules, up to 1/2 inch in diameter, from the waterline to the channel bottom. Random rust delaminations, up to 1/8 inch thick, were observed above the waterline.

- ③ The steel channel cross-bracing of the bents typically exhibited rust delaminations up to 1/2 inch thick.
- ④ A light accumulation of timber debris, consisting of 6 inch diameter and smaller branches, was observed extending from the channel bottom to the waterline along the entire length of Bent 2 and extended 5 feet upstream and downstream from the bent noses.

- ⑤ The west cross-brace at Pile H of Bent 2 exhibited an area of heavier corrosion measuring 3 feet long with up to 100 percent web thickness loss of section.

- (A) Repair the heavily corroded cross-brace at Pile H of Bent 2.
- (B) Monitor steel H-Pile and cross-brace corrosion and if found to be worsening, consideration may need to be given to cleaning and recoating the steel H-Piles, along with the possible need for some localized strengthening repairs.
- (C) Reinspect the submerged substructure units at the normal maximum recommended (NBIS) interval of sixty (60) months.
