UNDERWATER BRIDGE INSPECTION REPORT

STRUCTURE NO. 93454
BARRETT ROAD NORTH
OVER THE
PAAVOLA CREEK
ST. LOUIS COUNTY

SEPTEMBER 17, 2012
PREPARED FOR THE
MINNESOTA DEPARTMENT OF TRANSPORTATION
BY
COLLINS ENGINEERS, INC.
JOB NO. 7423

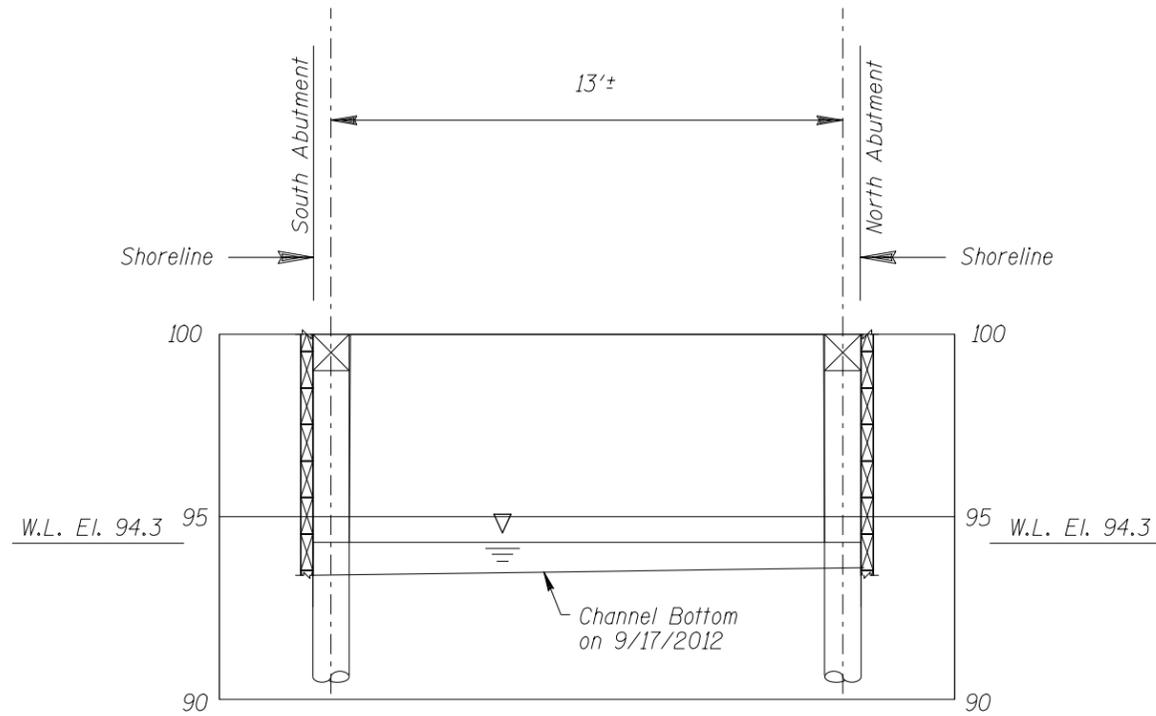
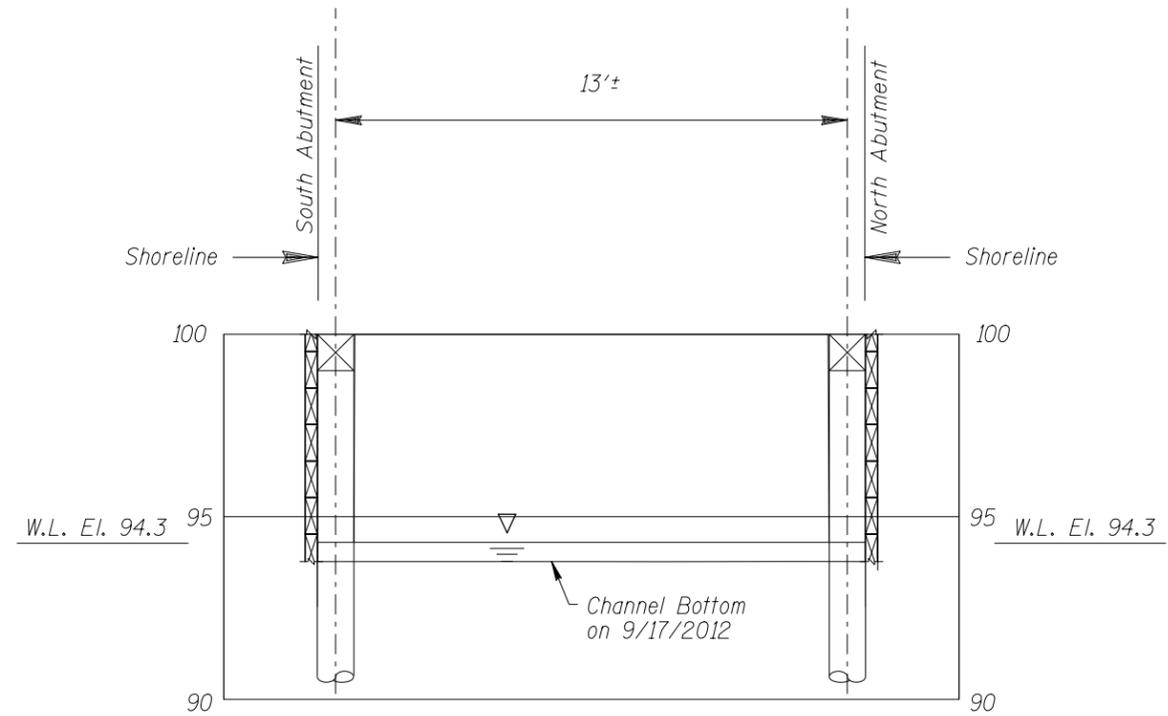
UPSTREAM FASCIA PROFILE

- 1 The channel bottom material typically consisted rocks and gravel with up to 3 inches of probe rod penetration.
- 2 The timber piles were typically sound with random splits or checks up to 1/4 inch wide and 1 inch deep.
- 3 The timber backwall and wingwalls were typically sound and tight with no noticeable loss of backfill or defects of structural significance. The backwall and wingwall boards exhibited random splits or checks up to 1/4 inch wide and 1 inch deep.
