UNDERWATER BRIDGE INSPECTION REPORT

STRUCTURE NO. L6106

CR 180

BOG CREEK

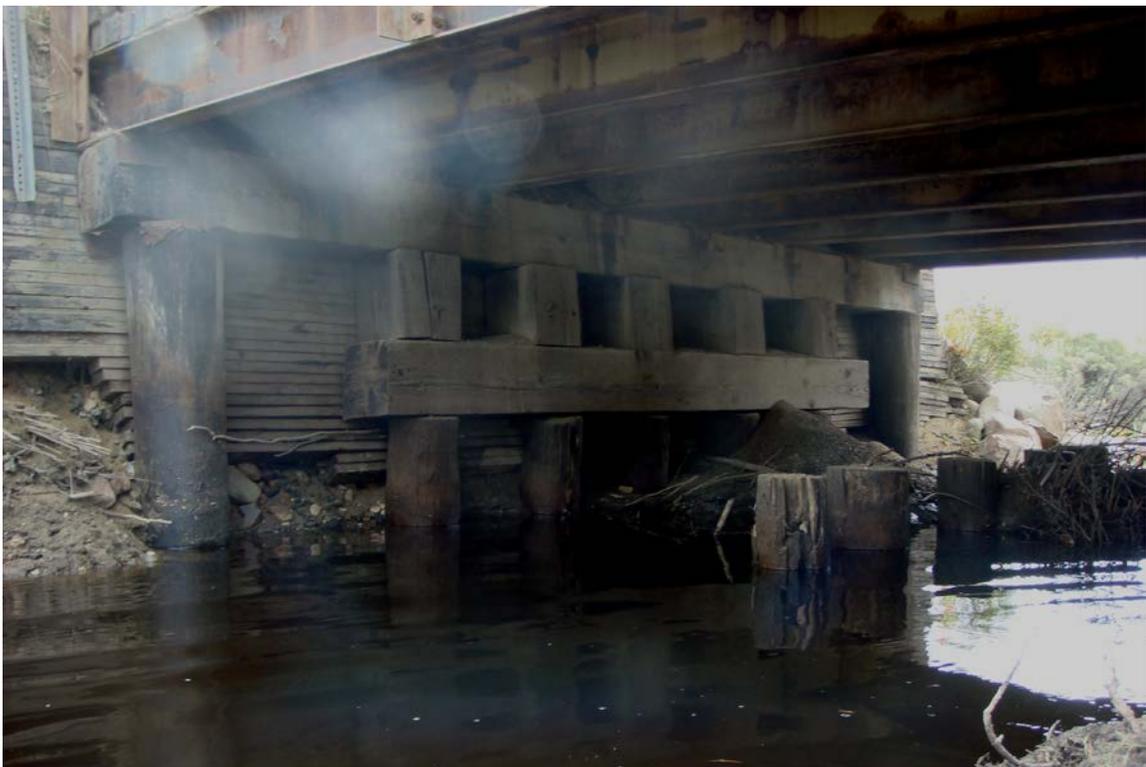
Photograph 2. View of the East Abutment, Looking Southeast.

- (K) The East Abutment was displacing out towards the channel and has rotated towards the east. As a result, only 1 inch on the east sides of the piles was bearing. A 1/2 inch to 1.5 inch wide gap was observed between the top of the piles and the bottom of the sill on the west face. The pile cap has shifted 1 inch to the east and appears to be a result of the loss of backfill behind the abutment. Backfill was observed mounded up to 2 feet high to the west of the abutment. The backwall consists of rough cut 2" x 4" boards stacked flatwise. The wall is rotating similarly to the cap, sill and pile extensions.

- (B) Shim all piles on the East and West Abutments as soon as possible to restore full bearing. Closely monitor the rotation/displacement of the backwall, sill, and piles until an above water inspection and/or further analysis can determine the necessary repairs and/or posting of the bridge for a maximum load limit.

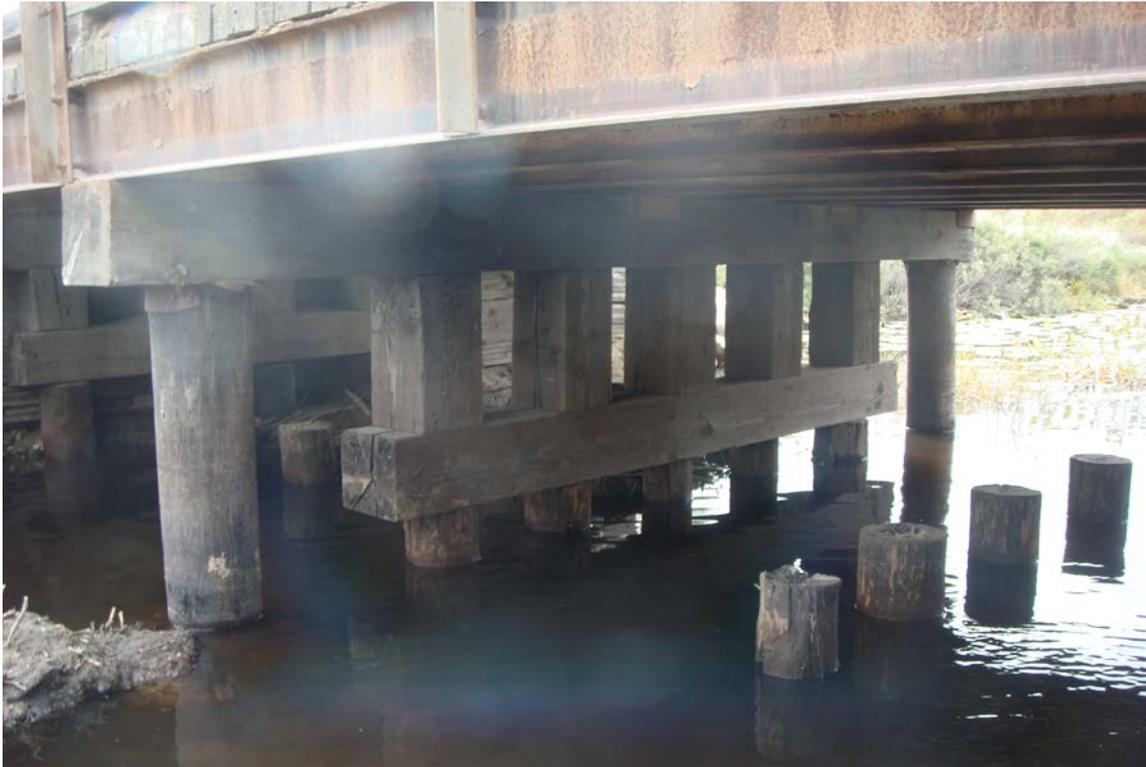
Photograph 3. View of Bent 1, Looking Southeast.

- (H) The timber of the sill and the pile extensions at the West Abutment and Bent 1 were in fair condition with random splits or checks up to 3/4 inch wide.

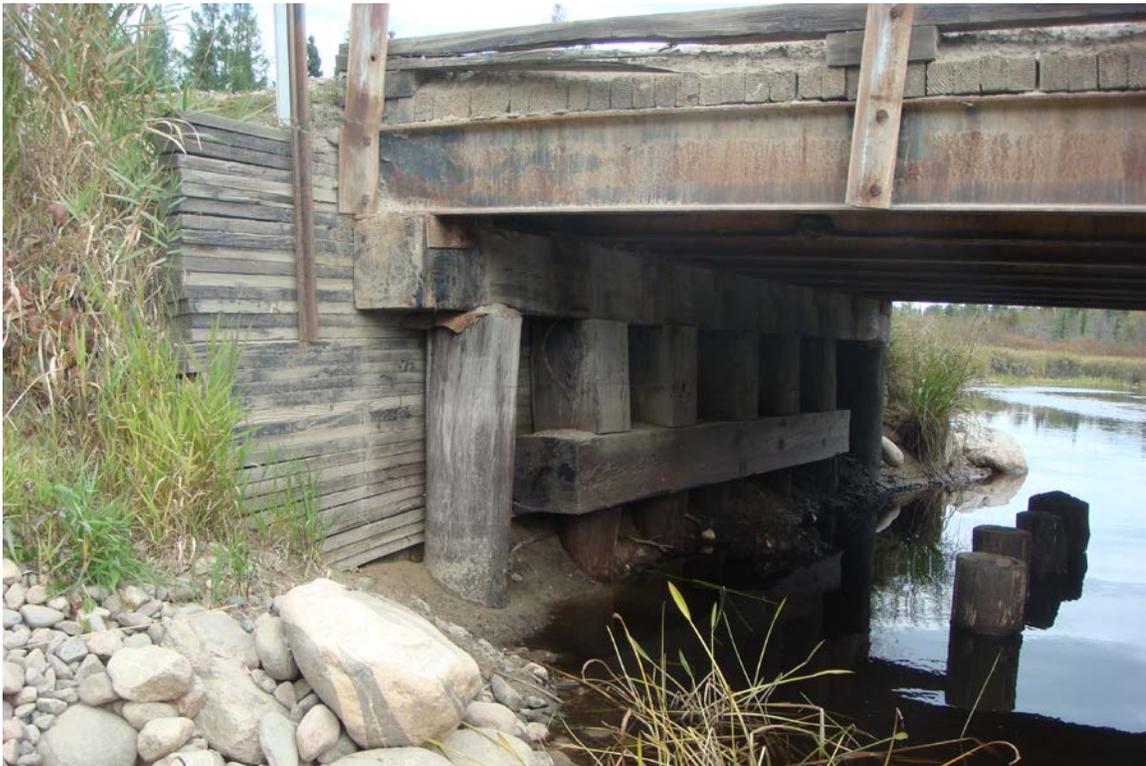
Photograph 4. View of the West Abutment, Looking Northwest.

- (I) The pile extension at Piles B, C, D, E, and F of the East Abutment exhibited splitting typically 1.5 inches deep.
- (J) The sill at the West Abutment was displacing out towards the channel and has rotated towards the west. As a result, the piles were only bearing on approximately 10 percent of the top surface area. A 1/2 inch to 3/4 inch gap was observed between the top of the pile and the bottom of the sill on the east face. The backwall consists of rough cut 2" x 4" boards stacked flatwise. The wall is rotating similarly to the cap, sill and pile extensions.
