UNDERWATER BRIDGE INSPECTION REPORT

STRUCTURE NO. L9222

TWP 6205

BREDA CREEK

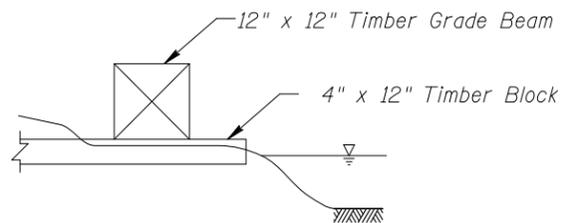
TYPICAL END VIEW

- ① The channel bottom material consisted of sand, gravel, and scattered rocks allowing a maximum probe rod penetration of 4 inches.
- ② The timber of the grade beam and block footings was typically sound.
- ③ The grade beam at the South Abutment was not bearing fully on the east three block footings. A 1 inch gap was observed between the top of the block footings and the bottom of the north face of the grade beam.
