UNDERWATER BRIDGE INSPECTION REPORT

STRUCTURE NO. 60506

RED RIVER OF THE NORTH

MINNESOTA DEPARTMENT OF TRANSPORTATION
UNDERWATER BRIDGE INSPECTION

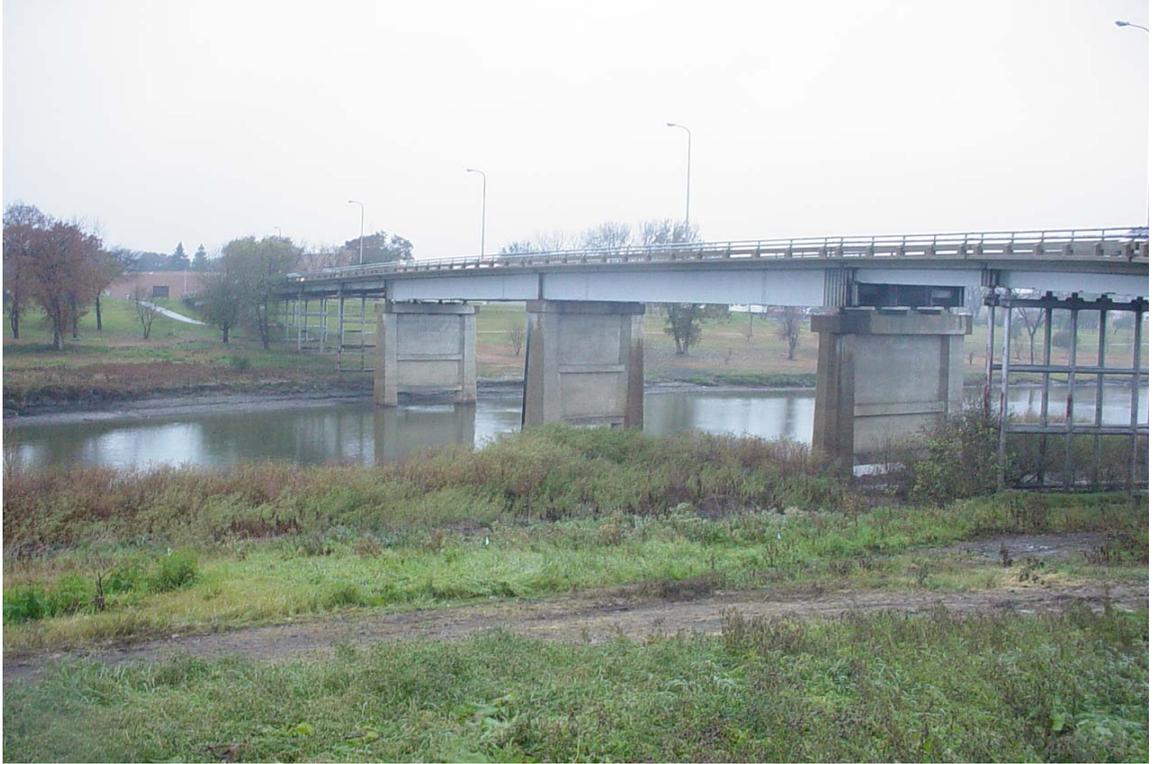
Photograph 1. Overall View of the Structure, Looking Northwest.

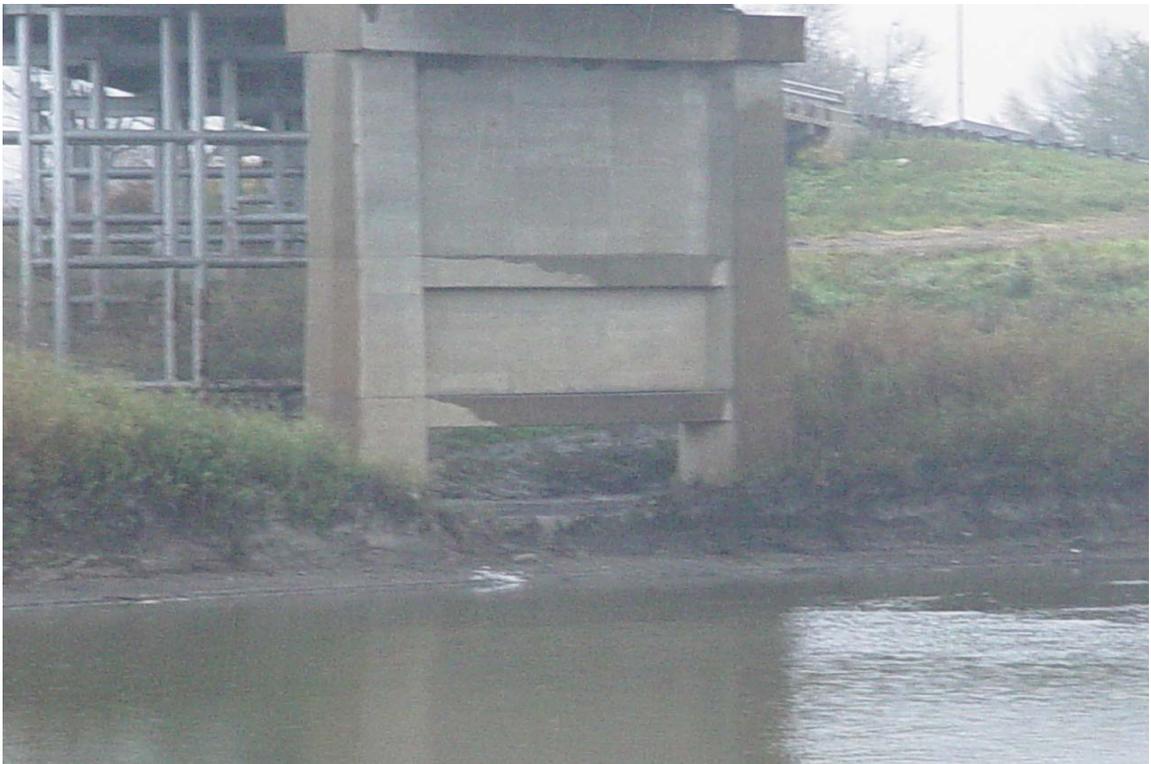
- ⑧ Both riverbanks of the channel exhibited moderate erosion.
- ⑨ Dry scour depression was observed around Pier 8 and measured approximately 3 feet in radius and 1 to 2 feet deep.

Photograph 4. View of Pier 8, Looking Southeast.
