UNDERWATER BRIDGE INSPECTION REPORT

STRUCTURE NO. 63516
CSAH NO. 13
OVER THE
RED LAKE RIVER
DISTRICT 2 - RED LAKE COUNTY

PREPARED FOR THE
MINNESOTA DEPARTMENT OF TRANSPORTATION
BY
COLLINS ENGINEERS, INC.
JOB NO. 3512 (CEI 172)

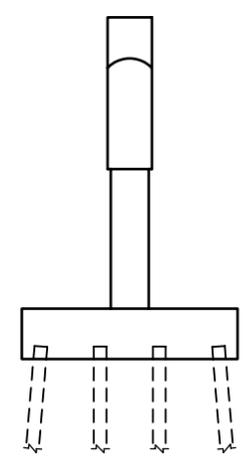
TYPICAL END VIEW OF PIERS

- INSPECTION NOTES:**
- 1 The channel bottom consisted of riprap and interspersed sandy gravel with no probe rod penetration.
 - 2 The channel bottom consisted of soft silt and scattered riprap with 1 foot of probe rod penetration.
 - 3 A 4-inch-diameter piece of timber was embedded in the channel bottom at the upstream nose of Pier 2.
 - 4 A light accumulation of 6-inch-diameter and smaller timber debris was observed at the upstream nose of Pier 1 extending from the channel bottom to 3 feet above the channel bottom.

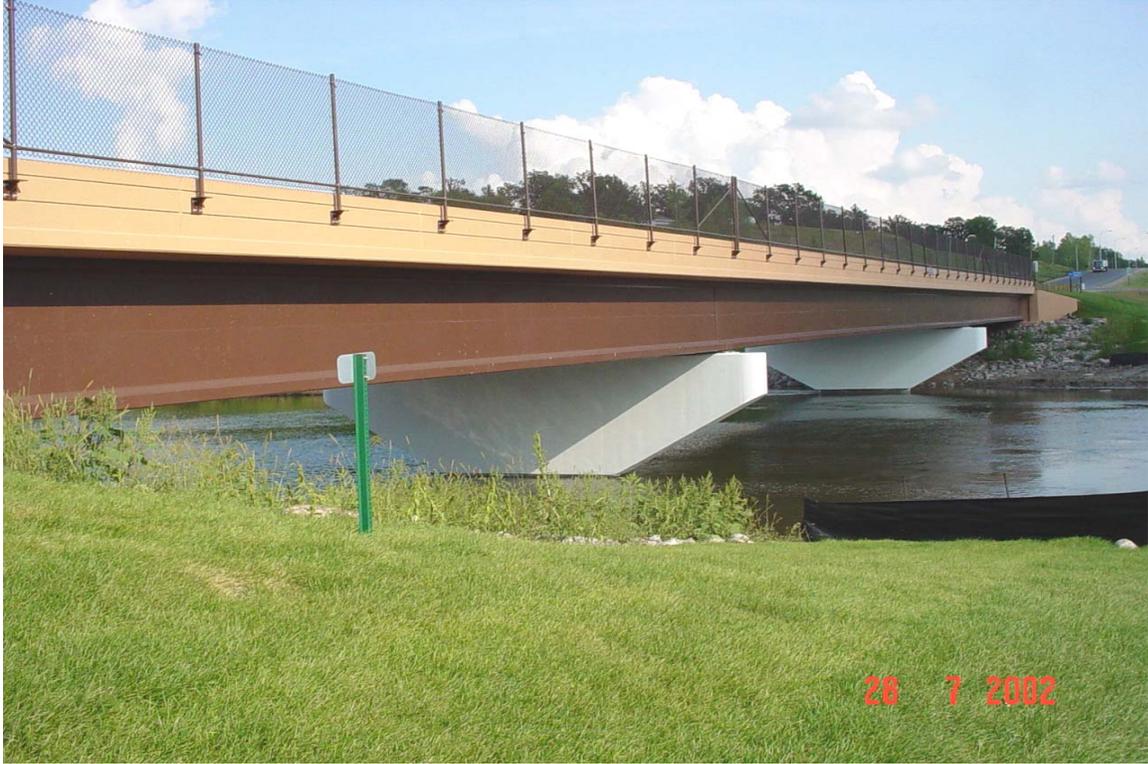
Photograph 1. View of Structure, Looking East.
