UNDERWATER BRIDGE INSPECTION REPORT

STRUCTURE NO. 57504

THIEF RIVER

DISTRICT 2 - PENNINGTON COUNTY

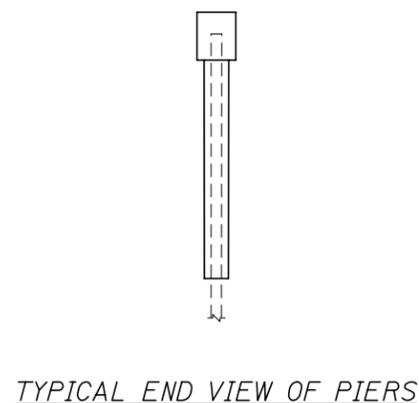
- 3 A light accumulation of timber debris consisting of 6 inch in diameter or smaller branches was observed around the entire Pier 1 shaft from channel bottom up 2 feet and up to 3 feet off the pier faces and noses.

- 4 A light accumulation of timber debris consisting of 12 inches in diameter or smaller logs and branches was observed from the upstream 1/4 point on north face around the upstream nose to the upstream 1/4 point on the south face of Pier 2. The debris extended from channel bottom up 4 feet and up to 2 feet off pier faces and 6 feet off pier nose.

- (A) Remove accumulations of timber debris at both piers and from within the channel to alleviate further accumulation, scour influence, and any excessive lateral force on the piers.
