UNDERWATER BRIDGE INSPECTION REPORT

STRUCTURE NO. 5767

RED RIVER OF THE NORTH

MINNESOTA DEPARTMENT OF TRANSPORTATION
UNDERWATER BRIDGE INSPECTION

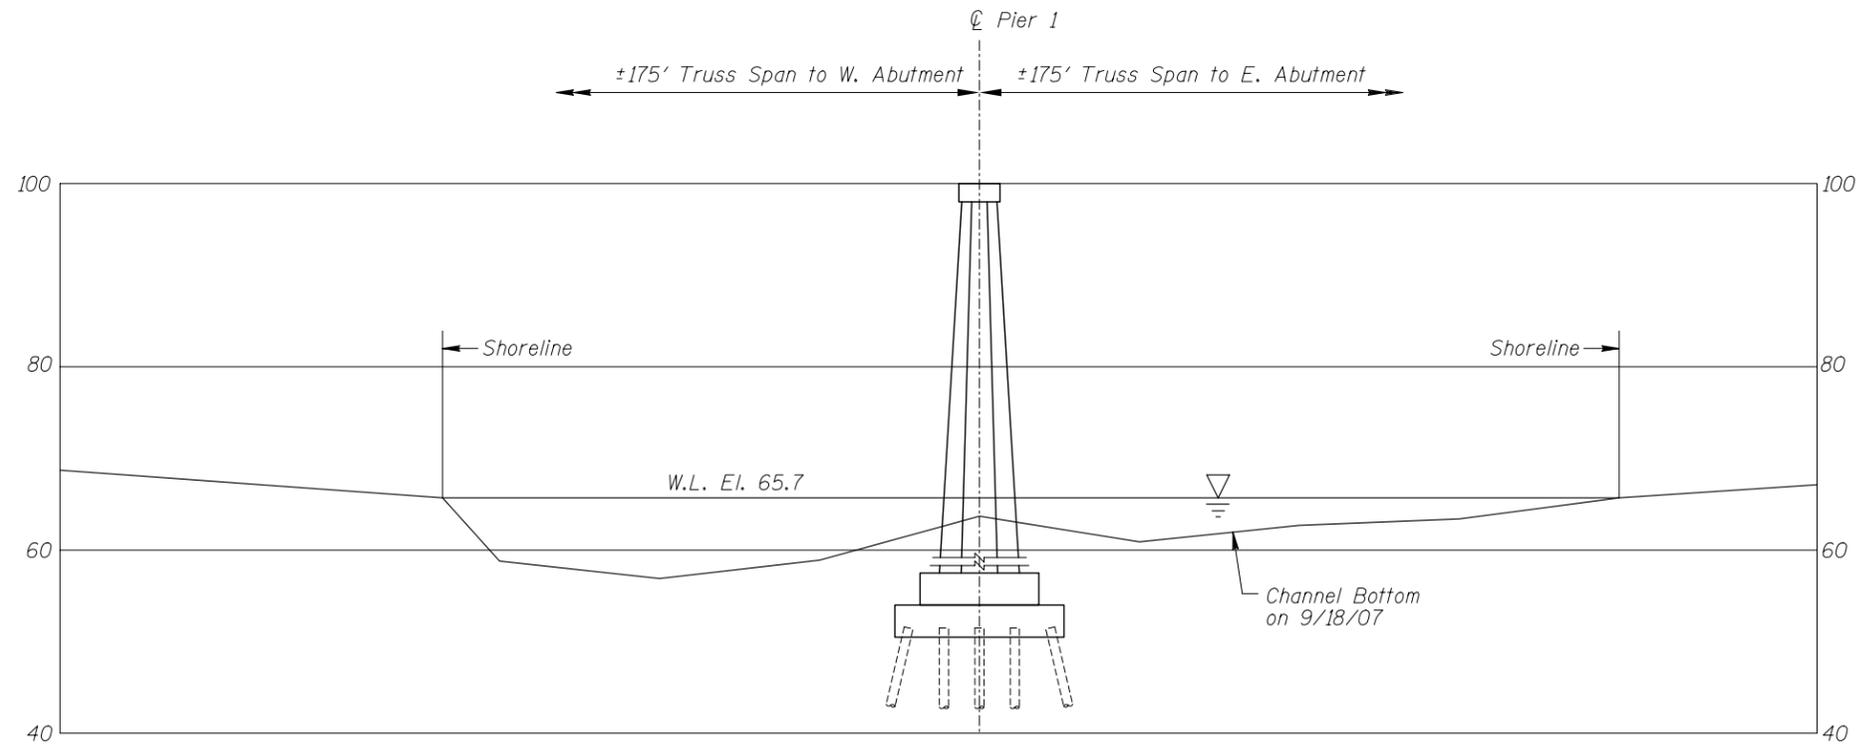
DOWNSTREAM FASCIA PROFILE
Vertical Scale: 1"=20'-0"

- ① Overall, concrete was smooth and sound with no significant defects.
- ② The channel bottom consisted of sandy silt.
- ③ Timber debris consisting of logs and branches 3 feet in diameter and smaller was observed at the south end of Pier 1. The debris extended from channel bottom up 3 feet 6 feet off the upstream nose towards east. On east face, debris extended above water from upstream nose to midpoint, and from midpoint to downstream nose, it was present from waterline to channel bottom.
- ④ Vertical crack up to 1/8 inch wide was located on both faces of Pier 1 at midpoint extending from strut to channel bottom.
- ⑤ Light scaling was observed at waterline along the entire perimeter of Pier 1 with 1/8 inch of maximum penetration.
- ⑥ A scour depression 1 foot deep by 4 foot radius was observed at upstream column of Pier 1 underneath the debris.
