UNDERWATER BRIDGE INSPECTION REPORT

STRUCTURE NO. 5871

RED RIVER OF THE NORTH

MINNESOTA DEPARTMENT OF TRANSPORTATION
UNDERWATER BRIDGE INSPECTION

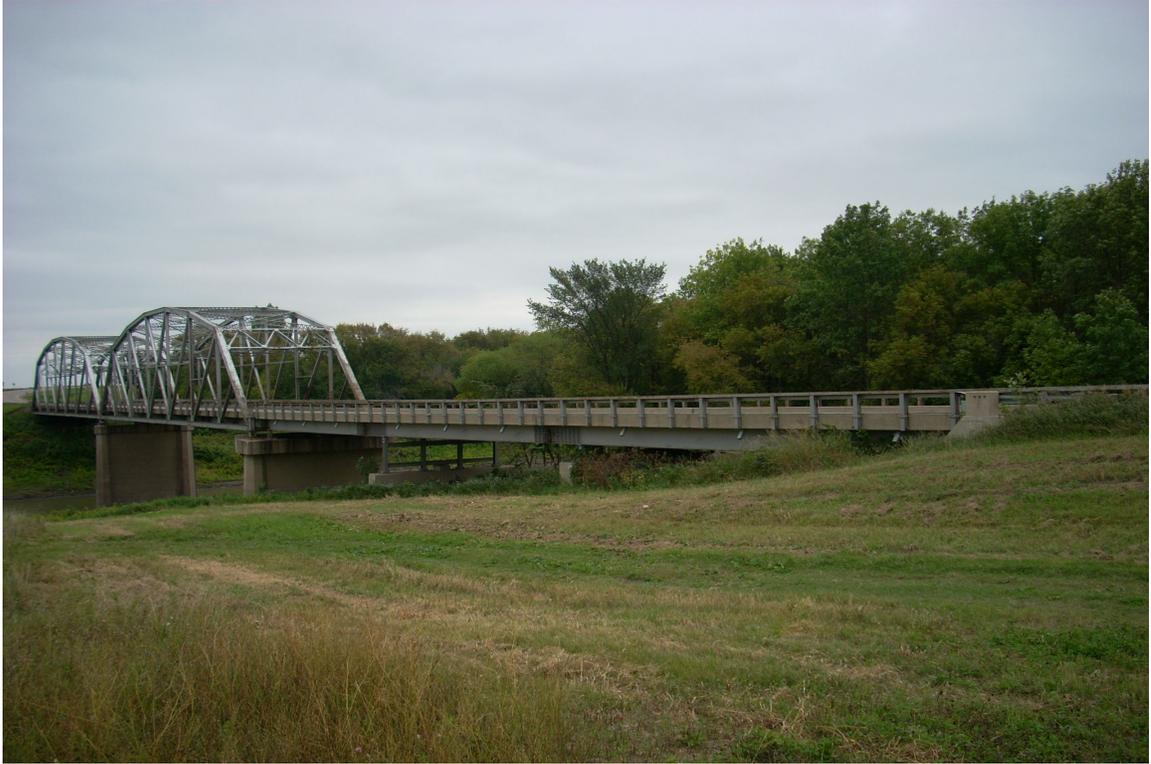
Photograph 1. Overall View of the Structure, Looking Southeast.

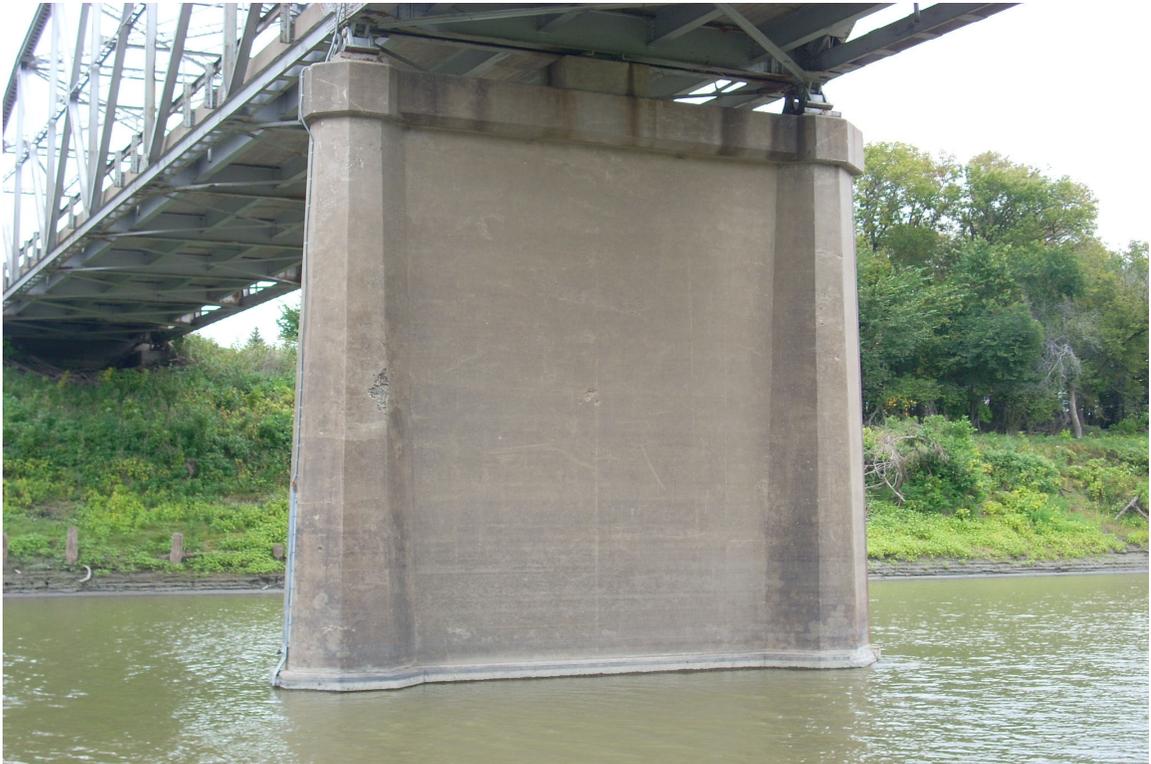
The substructure unit inspected at Bridge No. 5871, Pier 1, was in good condition with no structurally significant defects observed. The channel bottom appeared stable with no significant scour, or other deficiencies.

Photograph 2. View of Pier 1, Looking East.
