UNDERWATER BRIDGE INSPECTION REPORT

STRUCTURE NO. 57503
CSAH NO. 7
OVER THE
RED LAKE RIVER
DISTRICT 2 - PENNINGTON COUNTY

AUGUST 28, 2012
PREPARED FOR THE
MINNESOTA DEPARTMENT OF TRANSPORTATION
BY
AYRES ASSOCIATES & COLLINS ENGINEERS, INC.
JOB NO. 7423

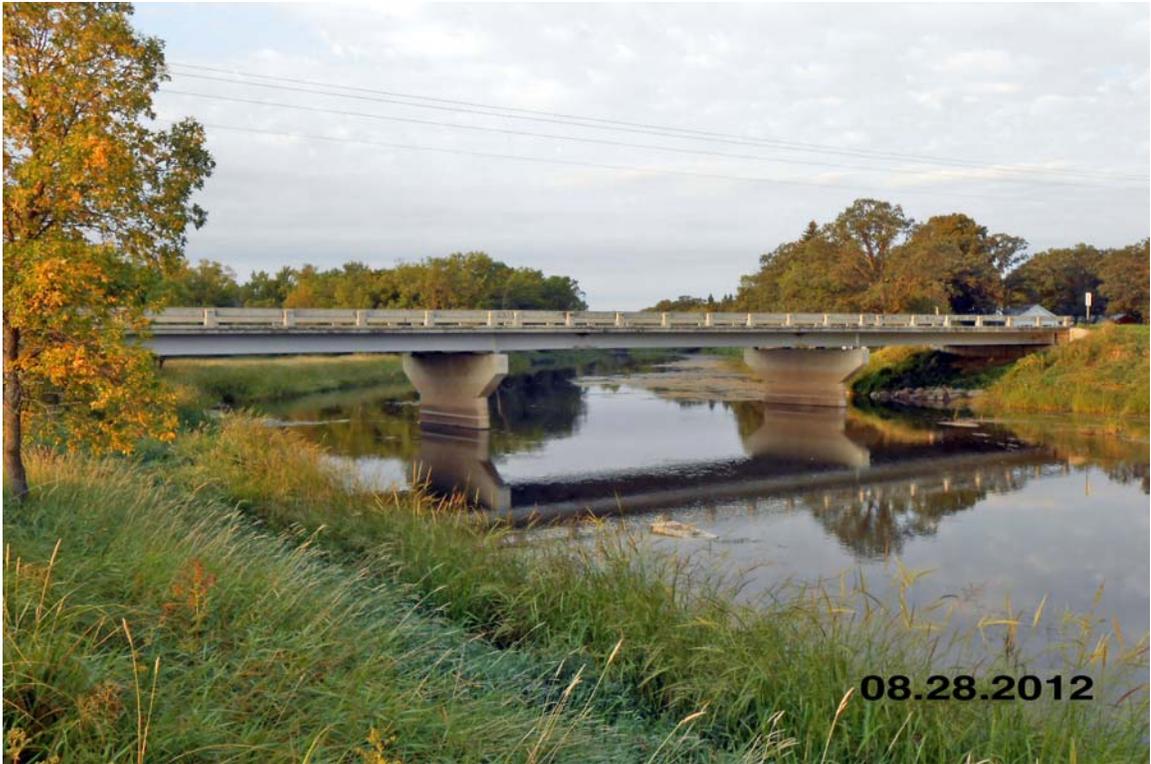
Photograph 1. Overall View of the Structure, Looking North.

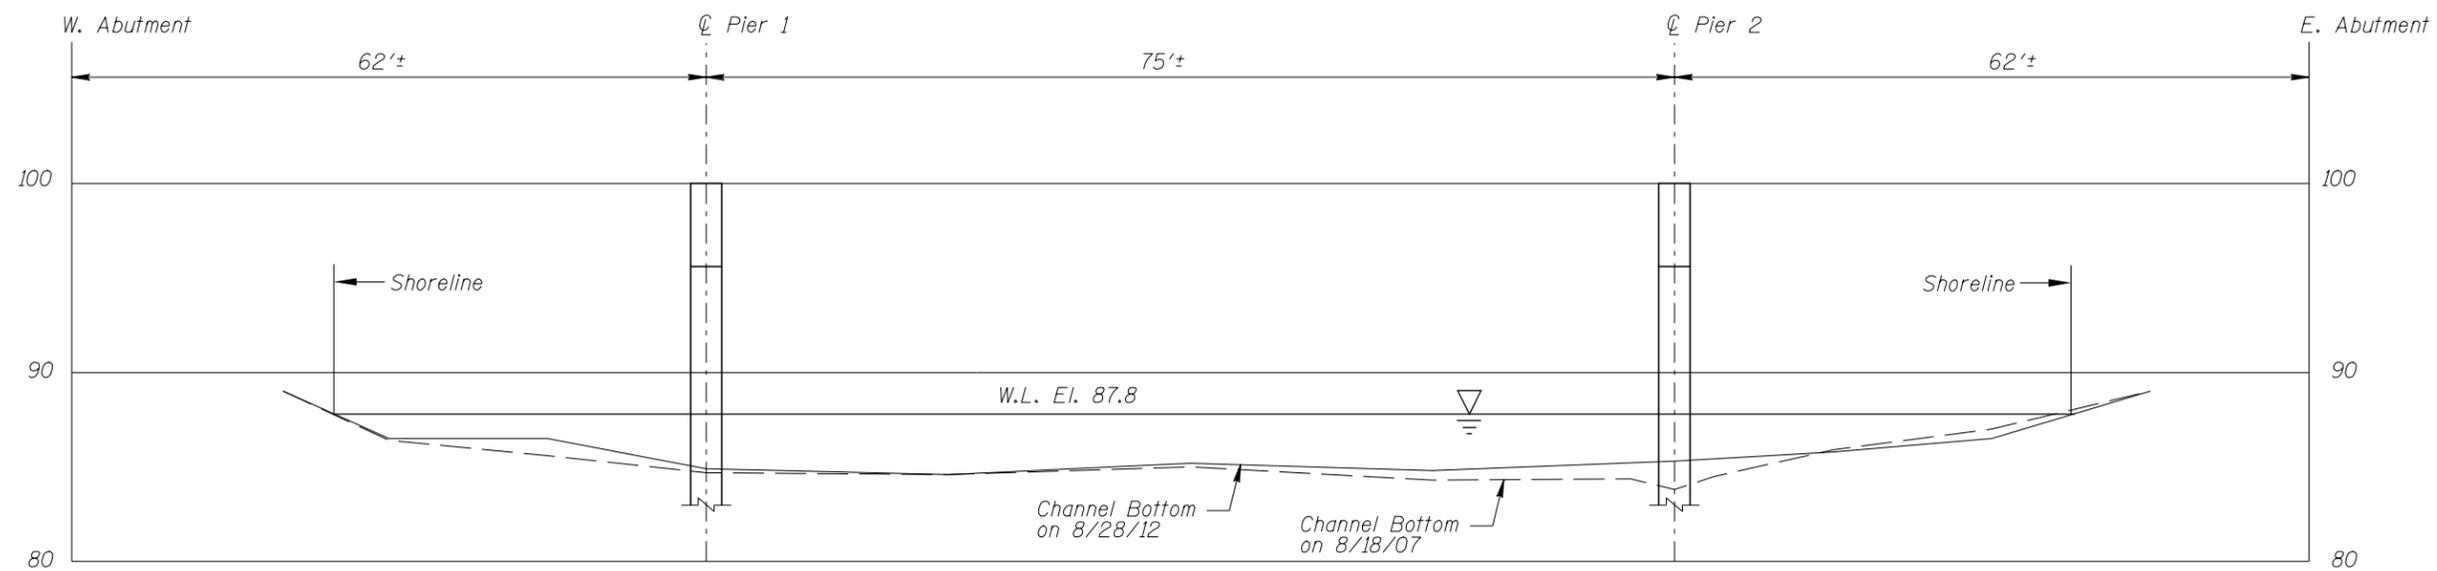
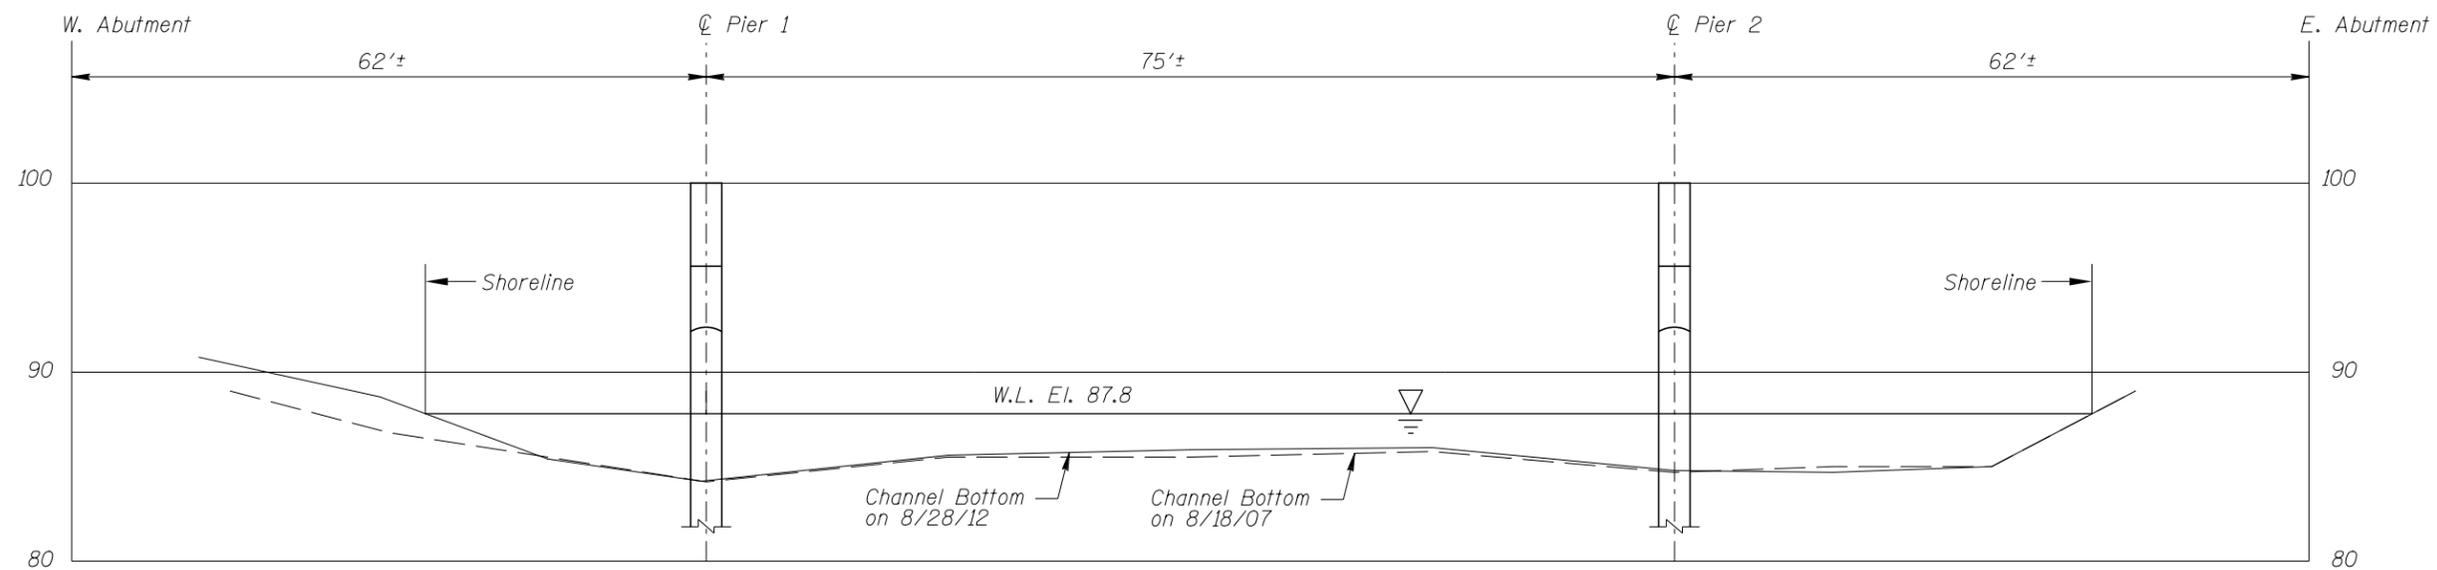
Date: SEPT, 2012
Scale: NTS
Figure No.: 1

- ① Overall, the concrete piers were smooth and sound with an 8-inch length of exposed reinforcing steel located at the waterline at the upstream end of Pier 1. In addition, minor scaling was observed at the upstream nose of Piers 1 and 2 from channel bottom to 4 feet above the waterline.

- ② A minor scour depression, 1 foot deep with a radius of 3 feet, was observed at the upstream end of Pier 2.
- ③ A moderate accumulation of timber debris, which included drift up to 1 foot in diameter, was observed around the entire perimeter of Pier 1 from the channel bottom to the waterline and up to 10 feet off the pier faces and noses.

- ④ A minor accumulation of timber debris build-up was observed at the upstream nose of Pier 2.
- ⑤ The channel bottom around the entire perimeters of Piers 1 and 2 consisted of sand and gravel and random rip rap up to 1 foot in diameter with up to 6 inches of probe rod penetration.

The timber debris accumulation at Pier 1 did not significantly affect the channel flow, and as a result, does not require removal at this time. If the debris accumulation increases in size or density, it may be necessary to remove the debris to reduce excessive lateral loads on the pier, limit further debris accumulation, and reduce the likelihood of channel bottom degradation resulting from obstructed flow.

Reinspect the submerged substructure units at the normal maximum recommended (NBIS) interval of sixty (60) months.
