UNDERWATER BRIDGE INSPECTION REPORT

STRUCTURE NO. 57517

THIEF RIVER

AYRES ASSOCIATES & COLLINS ENGINEERS, INC.

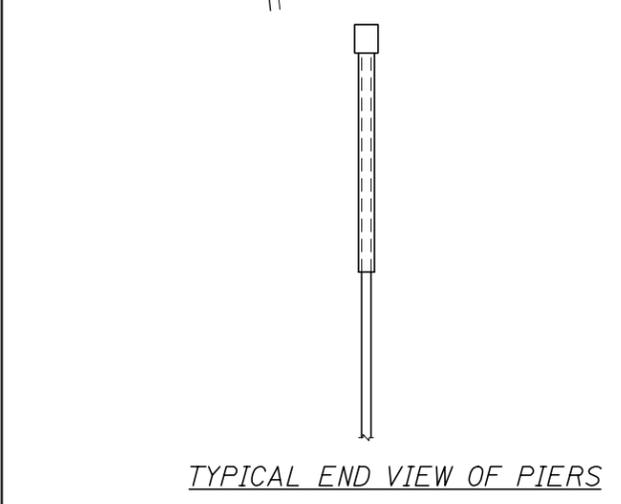
- (C) A light accumulation of timber debris consisting of 3 inch diameter and smaller branches was observed along both sides and in between all piles at Pier 2.

- (D) A moderate accumulation of timber debris consisting of 1 foot diameter and smaller branches was observed along both sides and in between all piles at Pier 1.

- (A) Monitor the timber debris, and if found to be increasing in the future, removal operations may become warranted.
- (B) Reinspect the submerged substructure units at the normal maximum recommended (NBIS) interval of sixty (60) months.
