UNDERWATER BRIDGE INSPECTION REPORT

STRUCTURE NO. 57521

CSAH 27 OVER THE

RED LAKE RIVER

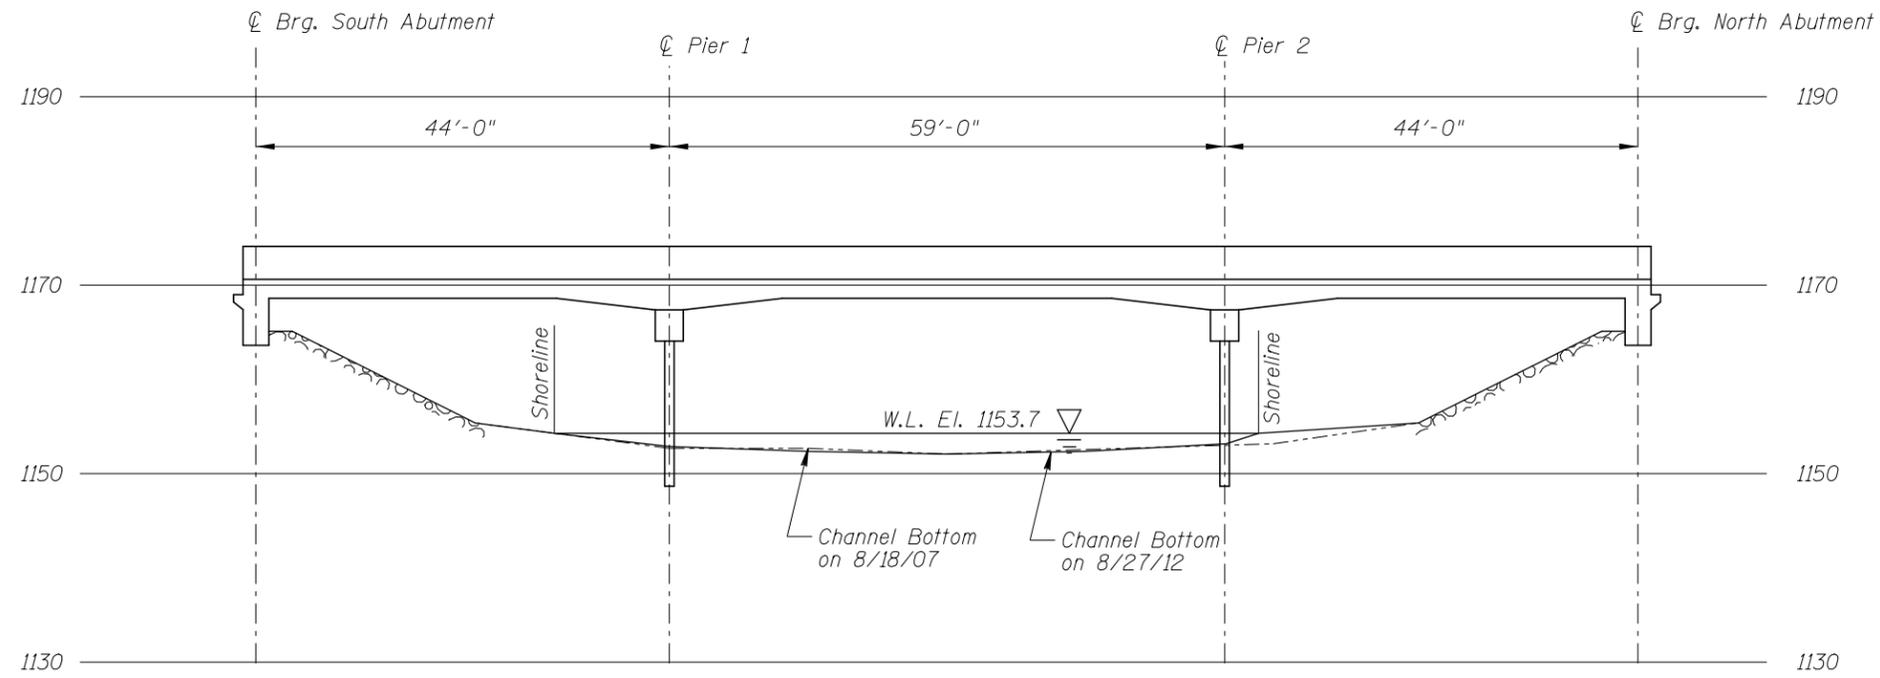
UPSTREAM FASCIA PROFILE

- 1 The channel bottom material consisted of sand, gravel, cobbles up to 6 inches in size, and riprap up to 2 feet in diameter with up to 3 inches probe rod penetration.
- 2 A minor accumulation of timber debris consisting of 3-inch-diameter and smaller branches and a steel I-beam were observed intermittently extending from the shoreline to the upstream pile of Pier 1 and from the channel bottom to the waterline.
- 3 The steel pipe pile encasements had random minor areas of coating failure from the top of the piles down 5 feet. The piles were uncoated (primer only) from 5 feet below the top of the pile to the channel bottom, with minor surface corrosion observed on over 75 % of the surface area with up to 1/4-inch-diameter rust nodules and minor pitting up to 1/32 inch deep.
