UNDERWATER BRIDGE INSPECTION REPORT

STRUCTURE NO. 05525  
CSAH NO. 29  
OVER THE  
MISSISSIPPI RIVER  
DISTRICT 3 - BENTON COUNTY

PREPARED FOR THE  
MINNESOTA DEPARTMENT OF TRANSPORTATION  
BY  
COLLINS ENGINEERS, INC.  
JOB NO. 3512 (CEI 82)

MINNESOTA DEPARTMENT OF TRANSPORTATION  
UNDERWATER BRIDGE INSPECTION

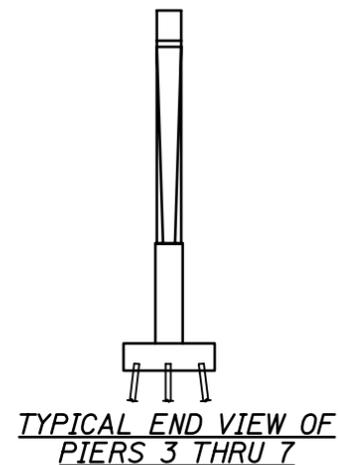
- 1 The channel bottom consisted of 6-inch to 1-foot-diameter rock with sand and with up to 3 inches of probe rod penetration.
- 2 Piers 3 through 7 exhibited a hairline crack on each face at the midpoint of the shaft that extended from the top of the shaft to the channel bottom.

- 6 A 1-foot-diameter log was observed on the channel bottom at the upstream end of Pier 6.
- 7 Portions of the top of footing at Pier 7 were exposed along the west face with up to 1 foot of vertical face exposed.

- 8 Light scaling was observed around the entire perimeter of all the piers with a maximum penetration of 1/8 inch, extending 1 foot below to 2 feet below the waterline.

- 9 Two hairline cracks were observed on the east face of Pier 7 at the quarter points.
