UNDERWATER BRIDGE INSPECTION REPORT

STRUCTURE NO. 18501
CSAH NO. 16
OVER THE
PINE RIVER (CROSS LAKE / RUSH LAKE)
DISTRICT 3 – CROW WING COUNTY

PREPARED FOR THE
MINNESOTA DEPARTMENT OF TRANSPORTATION
BY
COLLINS ENGINEERS, INC.
JOB NO. 3512

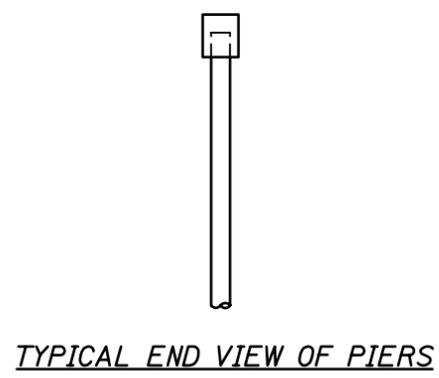
- 1 The channel bottom around Piers 1 and 3 consisted of 1 to 2 foot diameter riprap.
- 2 The channel bottom around Pier 2 consisted of gravel and 4 to 6 inch diameter cobbles with up to 2 inches of probe rod penetration.
- 3 The piles exhibited coating failure covering 15% to 20% of the surface area below the waterline. All piles exhibited a layer aquatic growth from the waterline to the mudline.
